IMTO – Italian Mission to Oman

SUMHURAM

Preliminary Report

June – July 2011 (SUM11B)

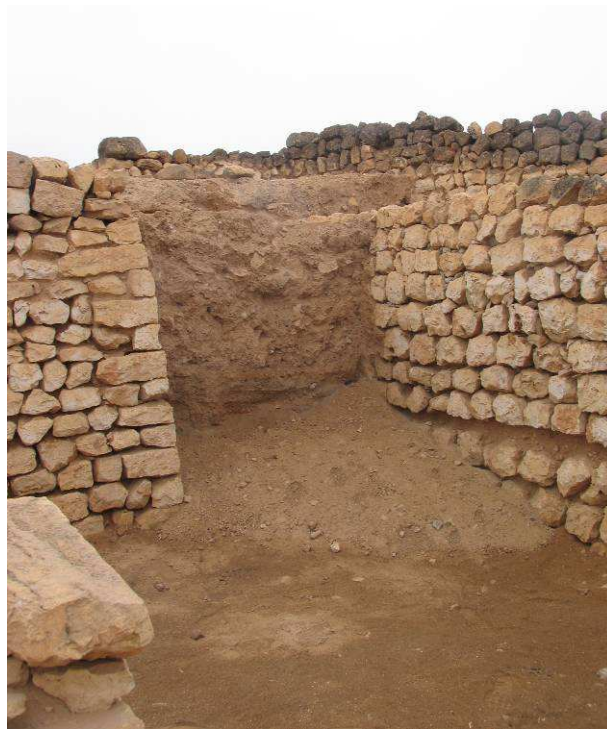
Fig 4 View of square A20 after the demolition of wall M87

During the SUM11B campaign the wall M87 was removed for stability reasons. One of the internal walls of the temple has partly collapsed and it was cleaned too.

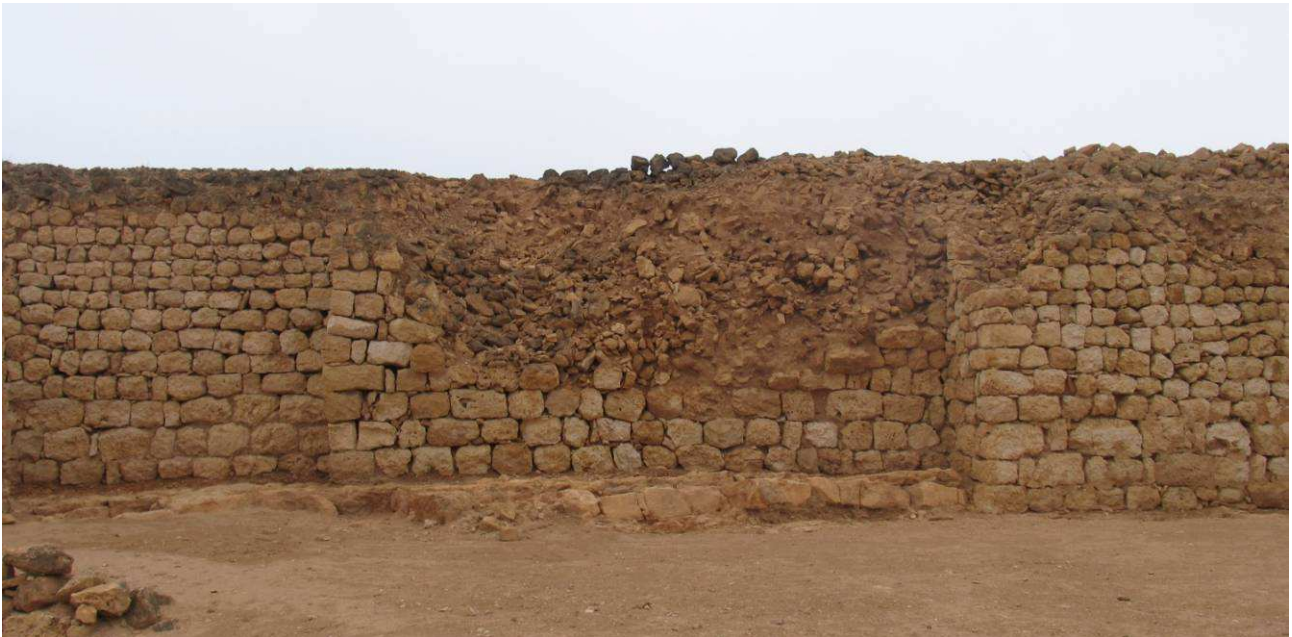
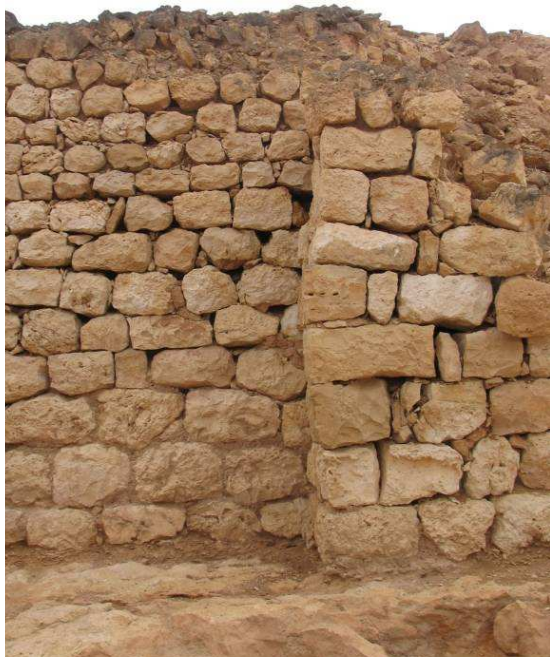
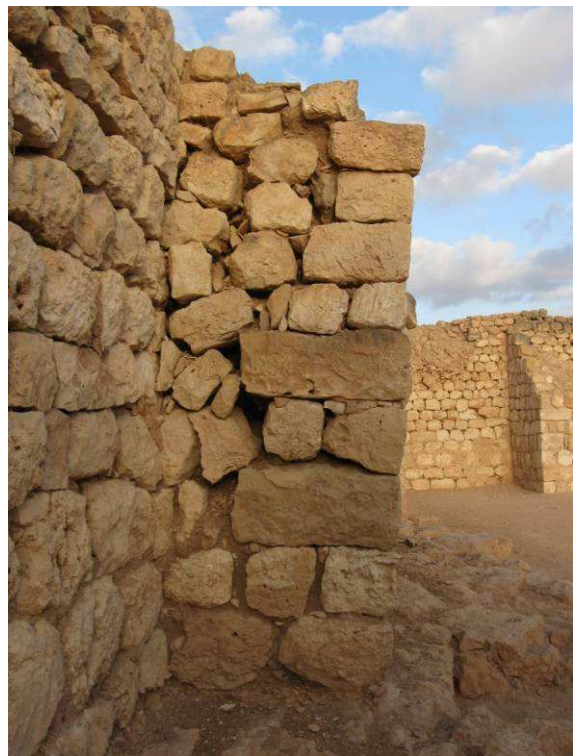
RESTORATION OF WALL M 133
Before Restoration

The local mortar was of poor quality/standard and it was used to ensure the closure of gaps between the stone elements, by preventing the filtration of water. The state of abandonment led to such a degradation that it was easily visible the erosion of mortar joints and biological attacks of mosses and lichens too. The presence of earth in the walls finally allowed the raising of vegetation, whose roots had already and would have destroyed the wall during the spending of the time. The intervention program was characterized by the following aspects:
