IMTO – Italian Mission to Oman

SUMHURAM

Preliminary Report

**RESTORATION WORKS AT SUMHURAM
(ARCHAEOLOGICAL PARK OF KHOR RORI)
(Sultanate of Oman)
CAMPAIGN JANUARY-MARCH 2012**

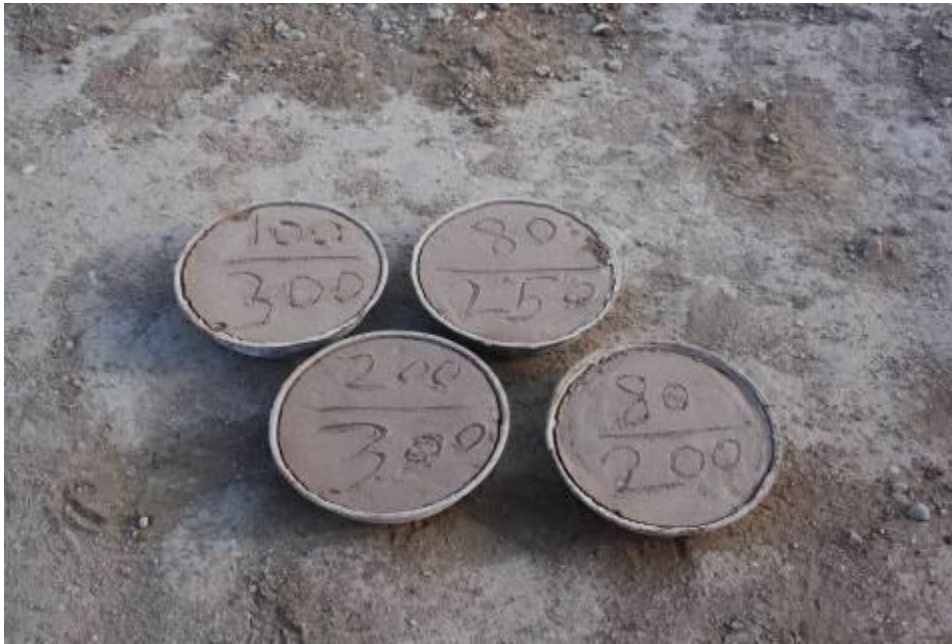
Before starting the reconstruction of the walls, we provided several samples of composition for the mortar. We tried different percentages of brown and yellow colour in order to reach the same chromatic tone as the mortar previously used in the restoration. We prepared four different samples using the following mix:

1. **80** parts of brown colour with **200** parts of yellow colour
2. **80** parts of brown colour with **250** parts of yellow colour
3. **100** parts of brown colour with **300** parts of yellow colour
4. **200** parts of brown colour with **300** parts of yellow colour

As soon as the mortar dried, we chose the composition n. 2 that was the more similar to the previous used mortar.

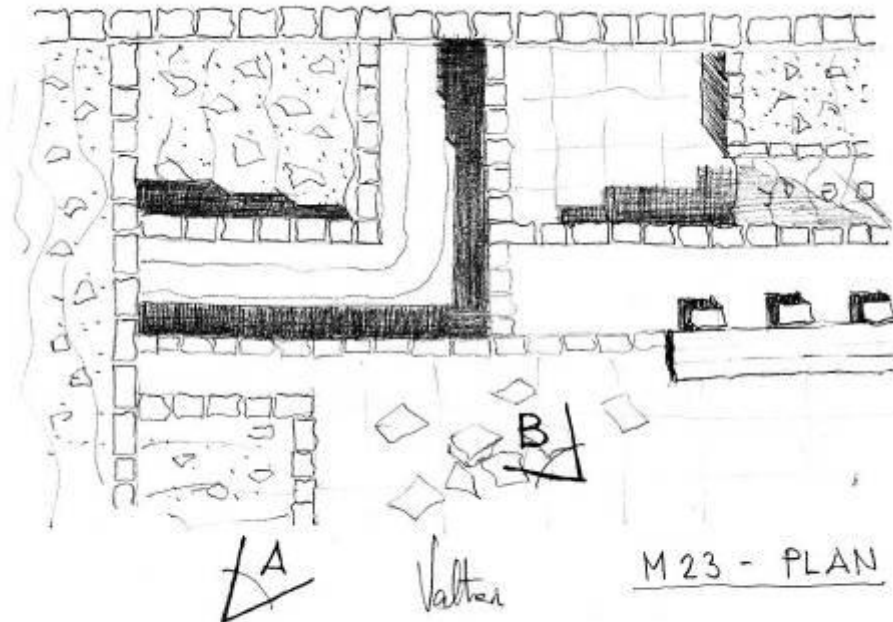
On 18th February 2012, we received confirmation to our suggestion to modify the shape of the walls beside M23 as follows:

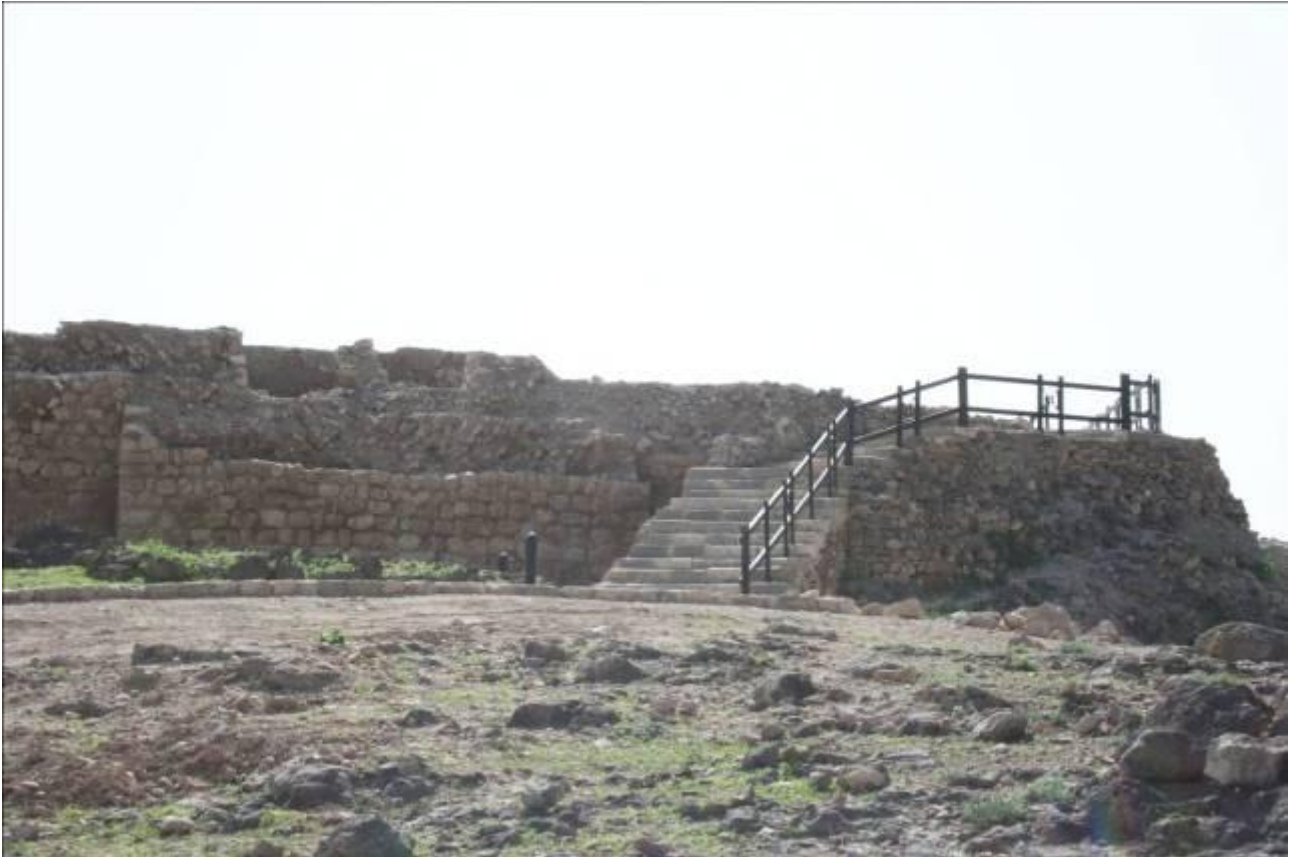
The demolition of the staircase was necessary to uncover the original walls and to modify the pedestrian path around the west and south walls of the city.

The situation on 29th January 2012 was the following:

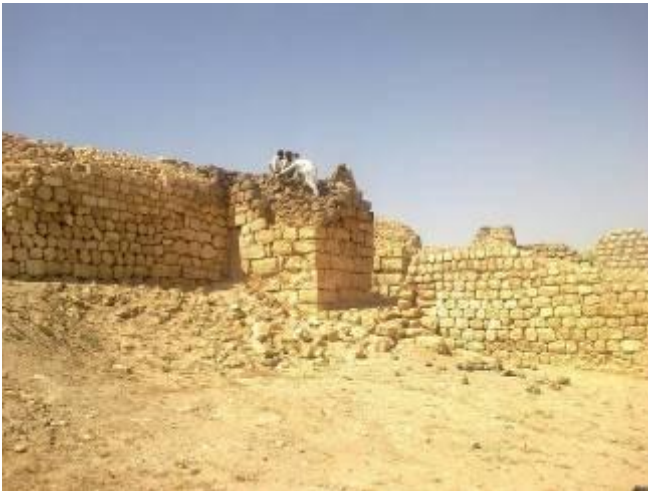
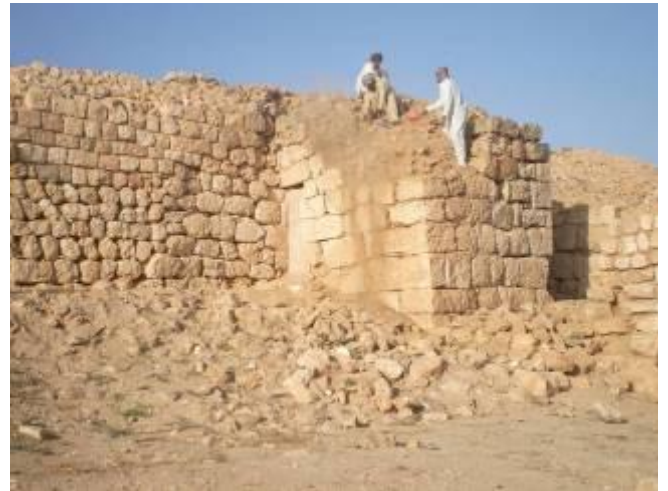
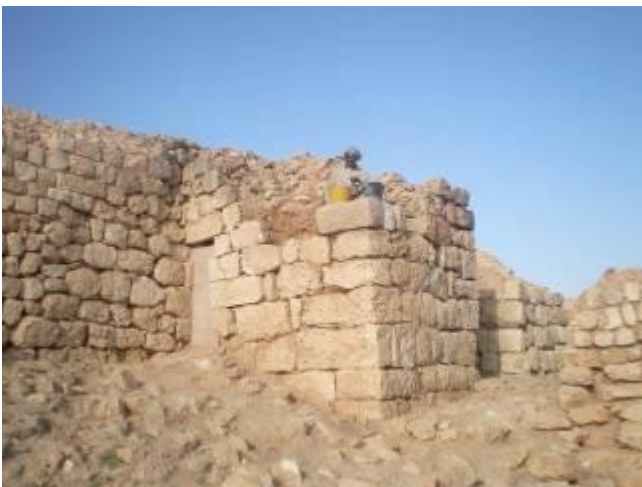
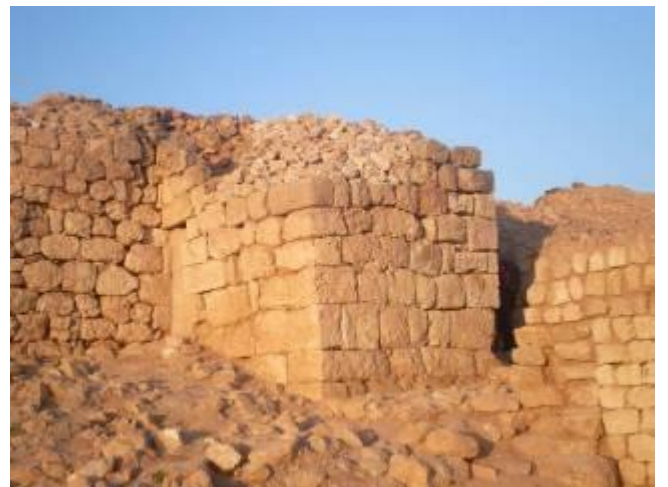
Sequence of photos on the wall M14 – up to 23rd February 2012

On 18th February 2012, the black stones on the wall M14 have been dismantled for their cleaning and then mounted again at the same position. The beautification has been remade by the use of new small stones. In the meantime, the slope of the ground in front of the M14 has been reduced for a better view of the front elevation of the city.

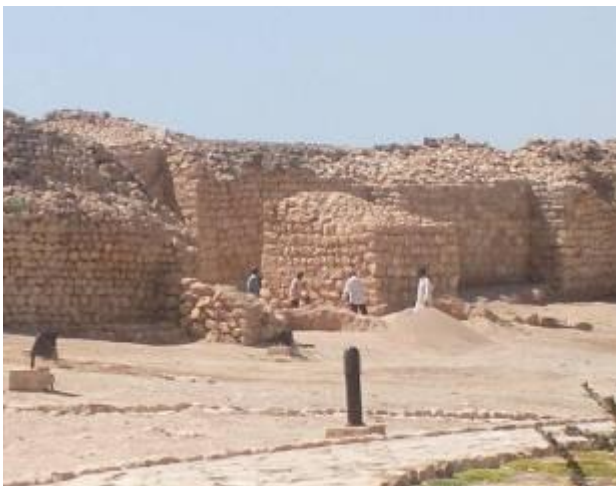
On 7th March 2012, the restoration of the two towers A61 and A97, the first on right side and the second on the left side of the main entry of the city, had taken in place. We started with the A61 tower but, due to the bad condition of the foot stones (the stones on the runs beneath 70cm. from the ground), we decided to rise the tower with two runs instead of four runs as we were asked.

We verified the stability using a safety factor not more than 6kg/sqcm as follows:

- a) actually the high of the tower is 2,7m. (2 meters over the bad stones). The load per square centimetre is 4,4kg/sqcm.
- b) we supposed to increase the high of the tower with 60 centimeters and therefore the load per square centimetre will be 5,72kg/sqcm.
- c) With four runs the final high of the tower will be 3,9m. (3,2 meters over the bad stones). In this case the load per square centimetre will be 7,04kg/sqcm.

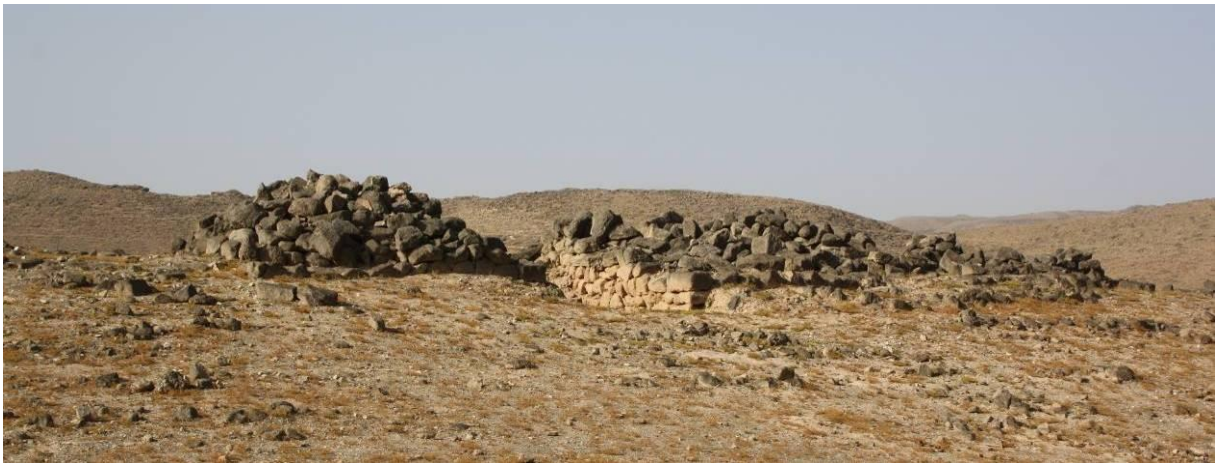
Fig. 2, General view of the ruins

Despite the interest of the ruins, the general state of the site appears rather spoiled, with garbage pits and numerous collapses.

To avoid further damages and for a better conservation of the ruins prior to eventual archaeological researches, a protection of the site, at least with a fence, is strongly suggested.

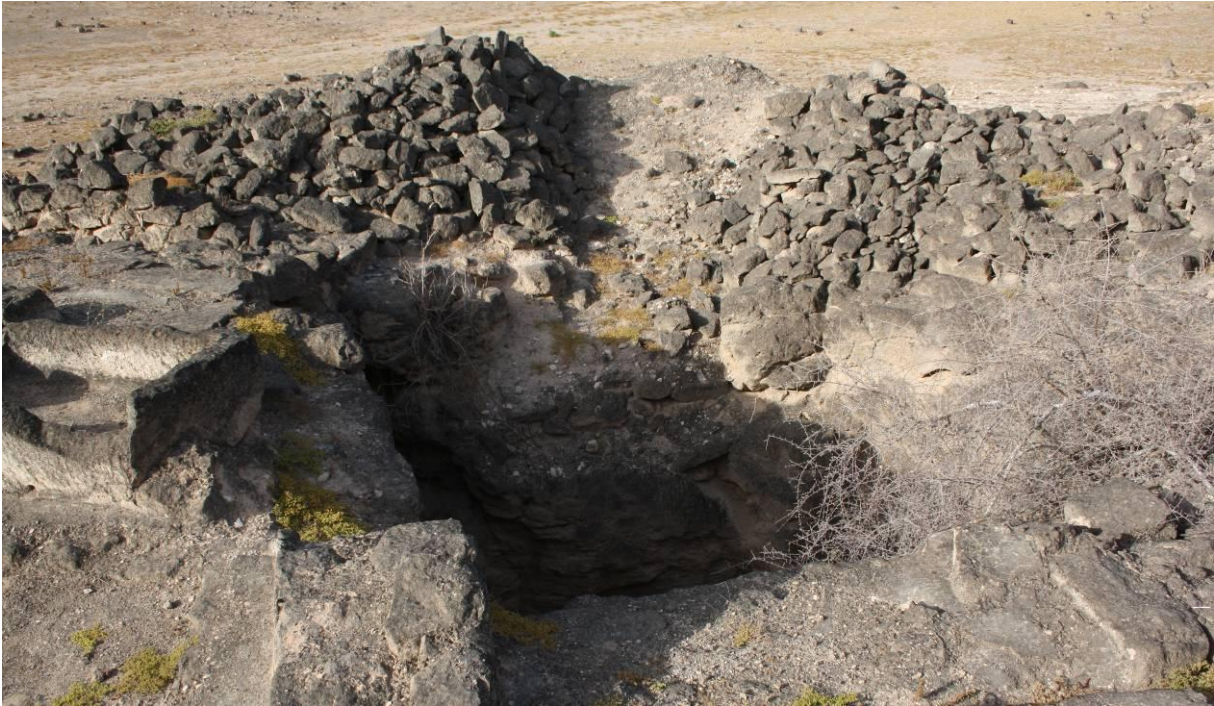
Fig. 3, The well

Currently, the most interesting feature is the well (fig. 3), measuring 2x3 m. and cut into the bedrock, linked with an area devoted to the ablutions made from stone basins (general dimensions: 1x0,50) (fig. 4). The well, with its noticeable size, was supposed to provide water for all the inhabitants of the village.

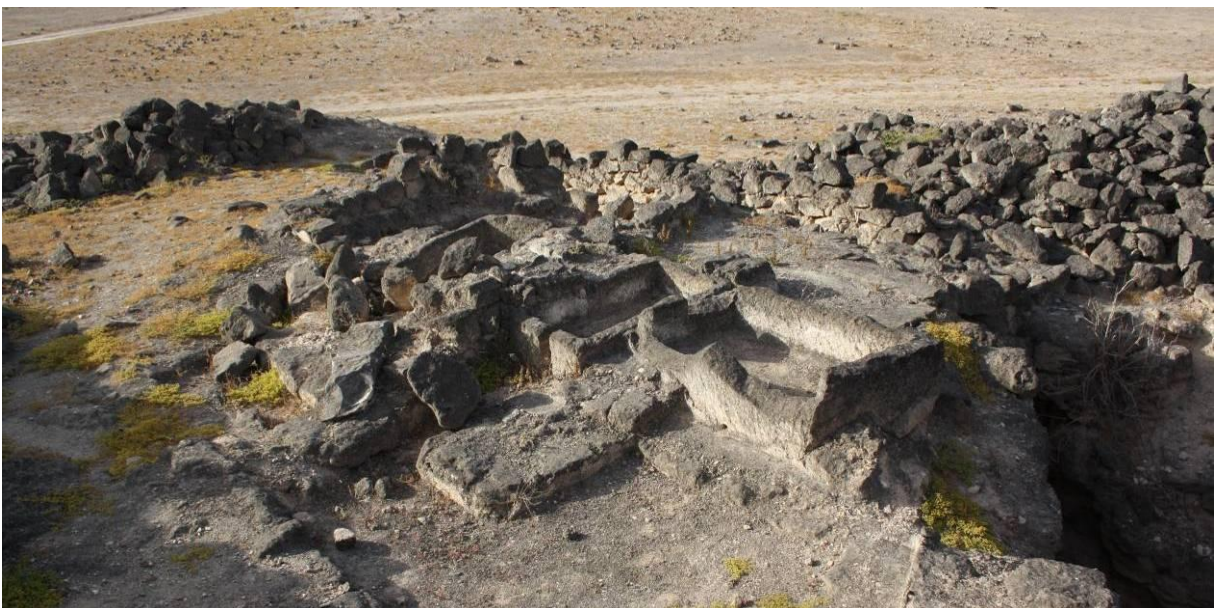
Fig. 4, The stone basins used for ablutions

The tanks were connected with the mosque, placed in strict connection with the well. The three basins were linked and water passes from one to the others through a series of holes and drainage features. It could not be excluded (Albright 1982: 79) that the tanks belonged originally to an ablution area connected with a pre-Islamic structure, a kind of open-air templar area.

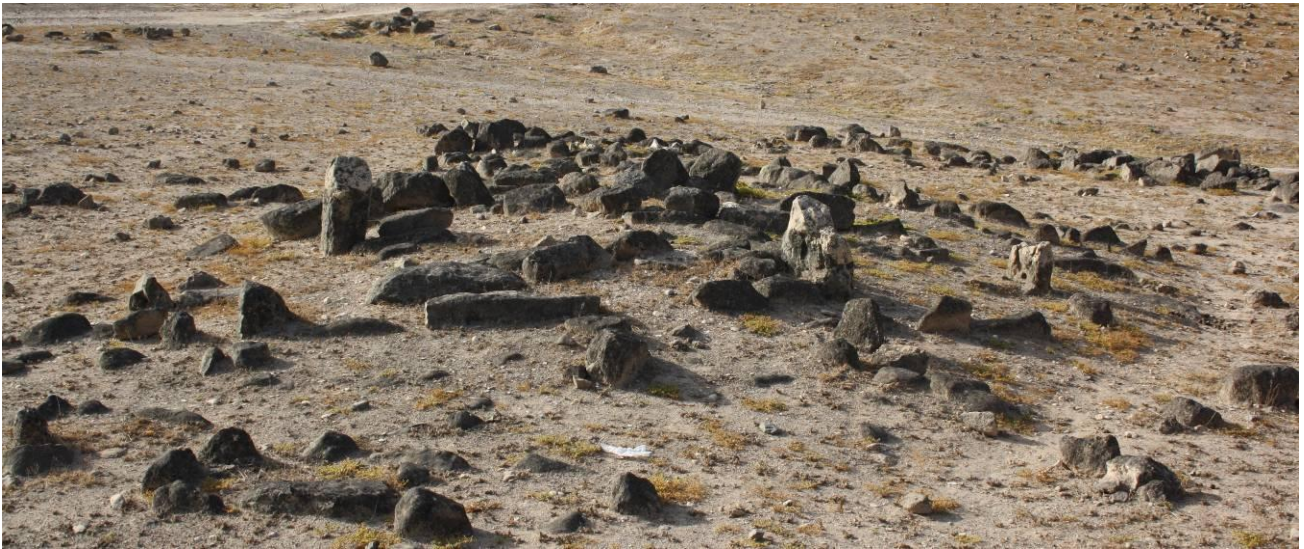
Fig. 6, Boat-shaped grave on the east of the site.

Some boat-shaped graves are visible eastern ward from the settlement (fig. 6).

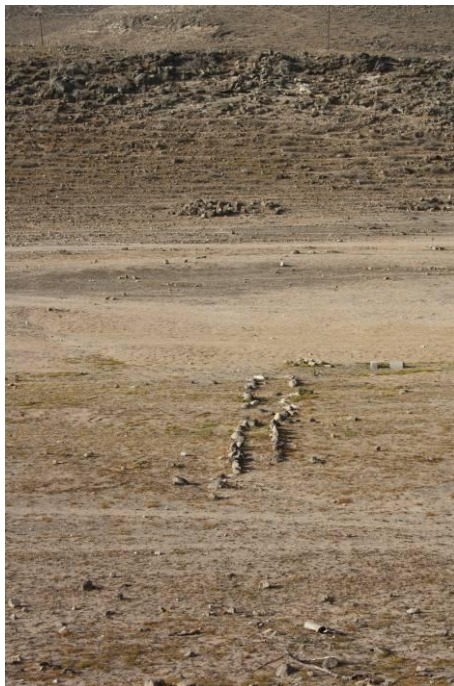
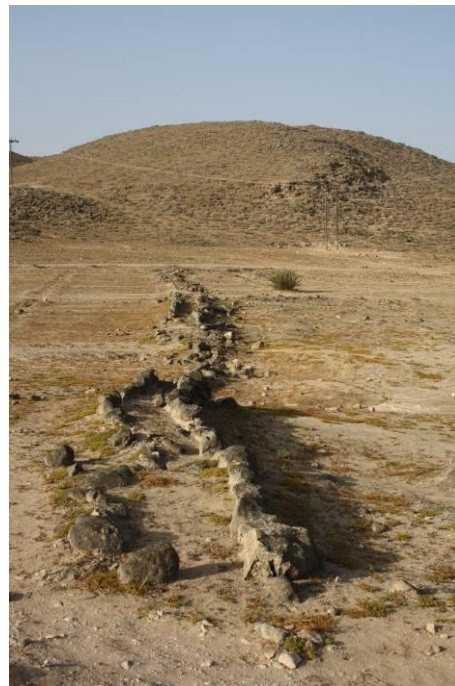
Figs. 7-8, Breakwaters north from the site.

Moreover at least two breakwaters (figs. 7,8) are visible northern from the main settlement, confirming the existence of agricultural practises in the area.
