**EVO XXII-XXIII (1999-2000)**

**EXCAVATIONS AND RESTORATION  
OF THE COMPLEX OF KHOR RORI  
MID'S INTERIM REPORT (1999-2000)**

ALESSANDRA AVANZINI, VITTORIA BUFFA,  
ALESSANDRA LOMBARDI, ROBERTO ORAZI, ALEXANDER SEDOV  
With a note by VITTORIO CASTELLANI

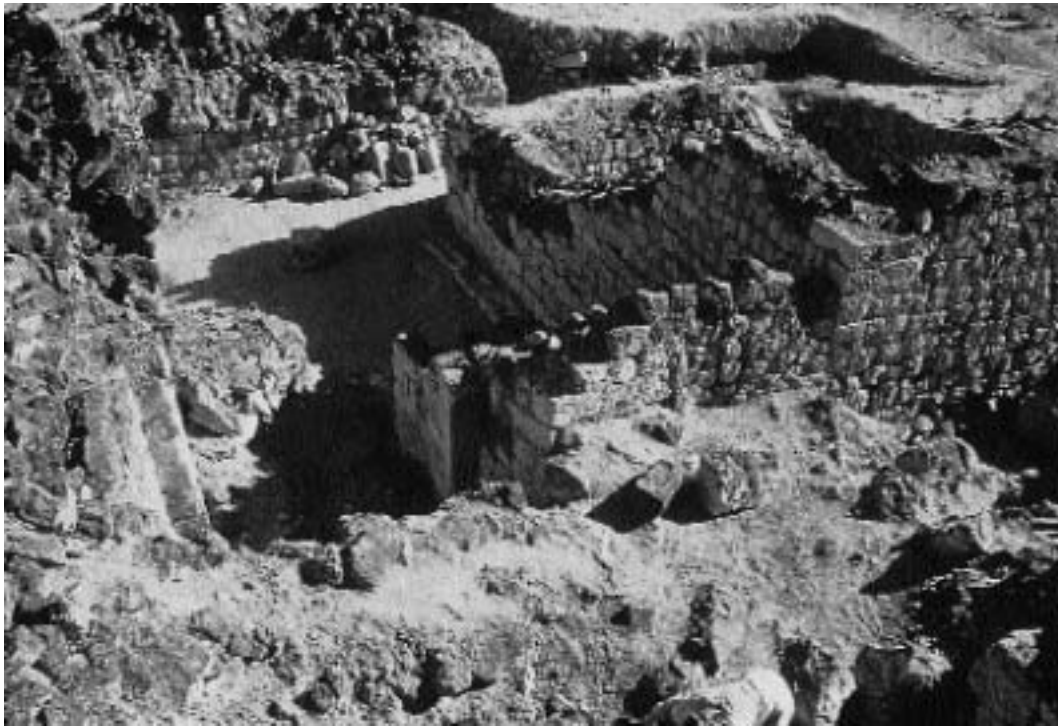
Fig. 4 - City gate, general view from the South, during the excavation work.

The entrance path of the city gate complex rises from the outside to the inside of the city to a height of more than 4 m. Three different doors block a bayonet path controlled by a central tower (A6) and protected towards the outside by a solid isolated wall (M1) (Fig. 4 and 5).

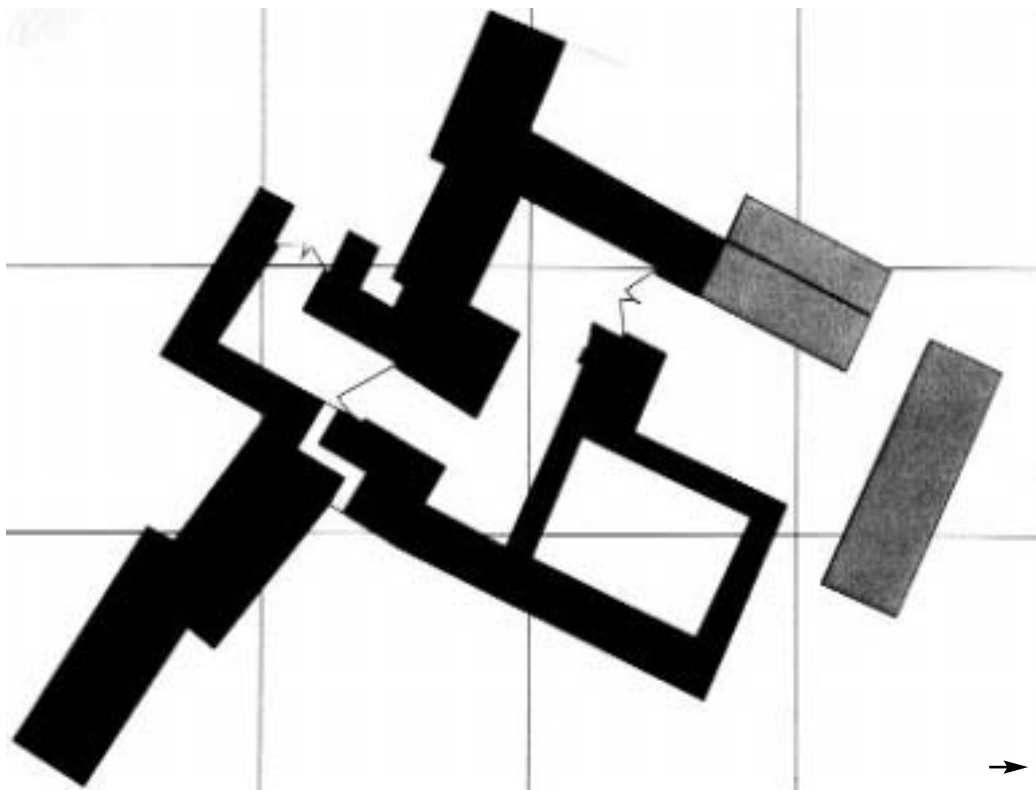
Fig. 7 - City gate, plan of phase 2.

This landing is probably to be seen in connection with the first phase of the door and with its external «L» shaped wall. At that time, that is before the construction of the tower and the third door, a passage between the Eastern buttress and the «L» shaped wall allowed to enter the town also from the East (Fig. 7).

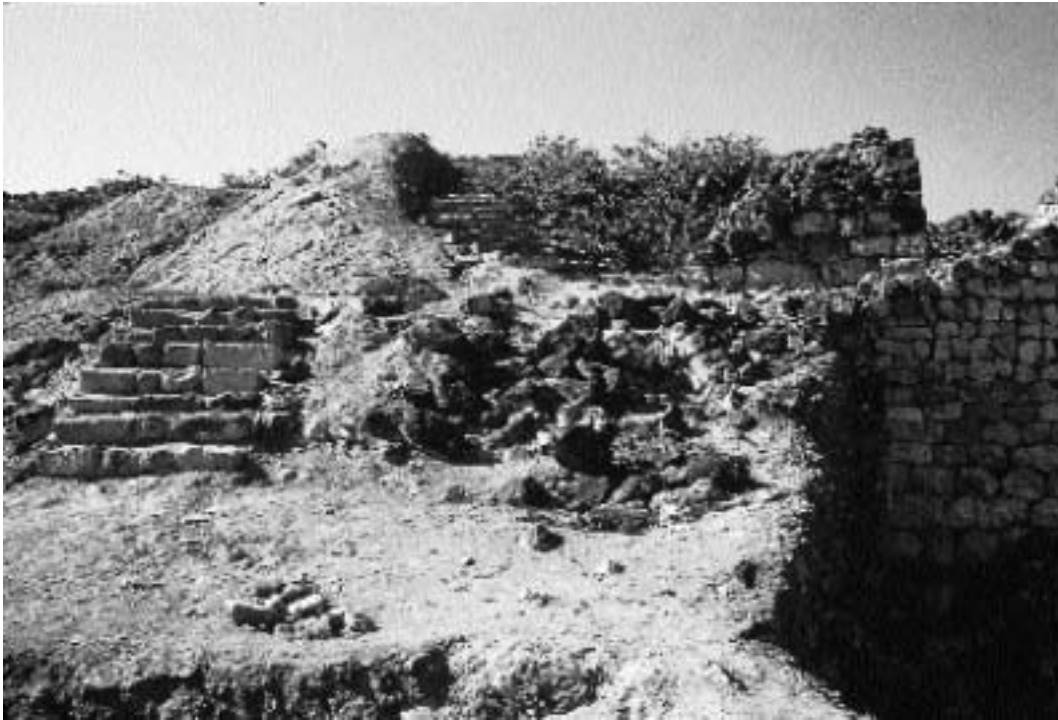
Fig. 8 - Area (A7) between the city wall and the Eastern buttress before the excavation work.

As far as this first area is concerned, after surveying and removing the recent stone steps, we set to eliminate the back-fill earth found next to the walls (Fig. 8).

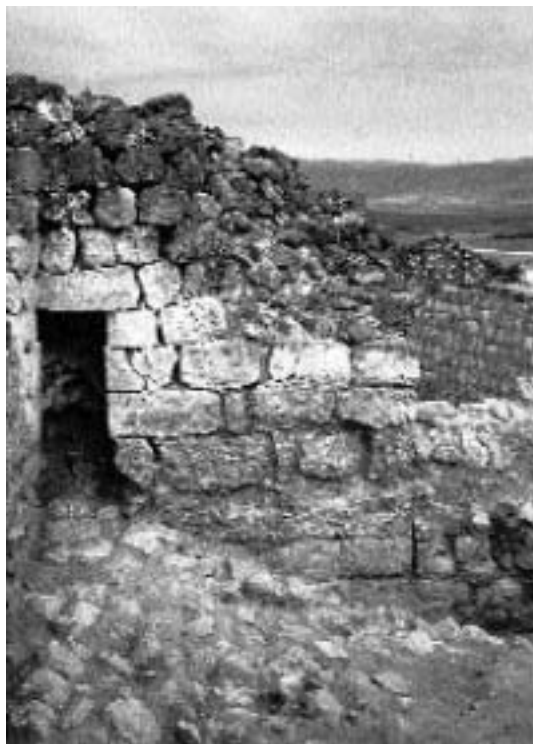
Fig. 10 - View of the area A7, with the postern's exit.

We have continued the excavations Northward, starting from the Eastern side of the Eastern buttress. In this point we brought to light few steps that lead to the postern. These steps are made of polished stones of different dimensions placed along the sloping ground, with an inclination of about 18°, and probably cemented with mortar (Fig. 10 and 11).

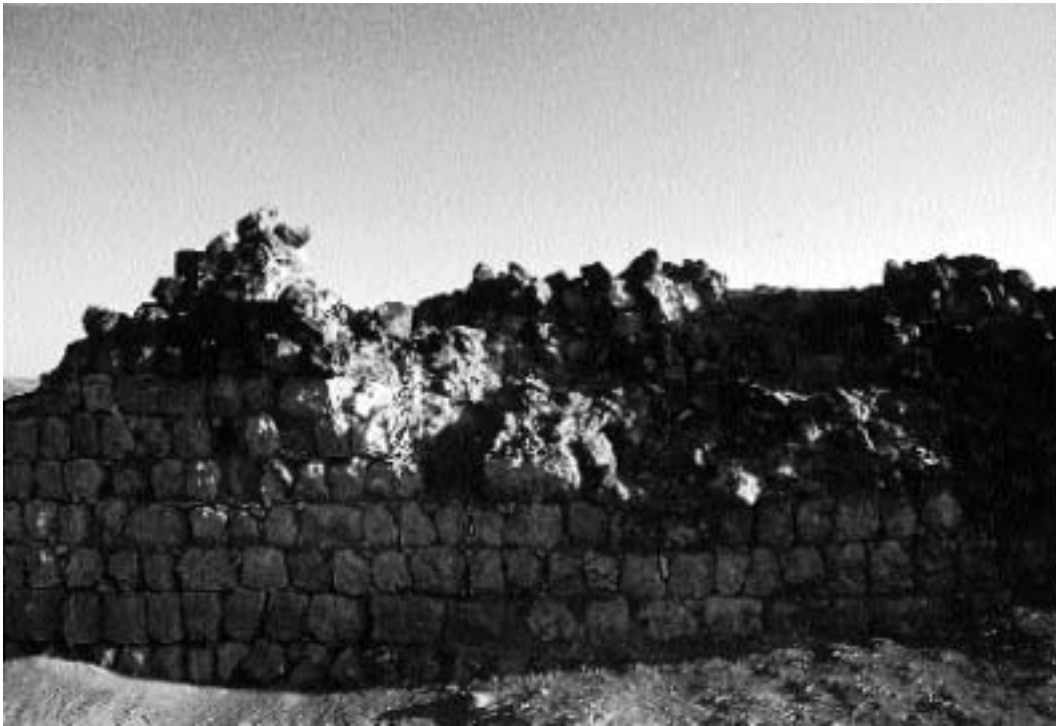
Fig. 12 - City gate. Northern side of the external barrier.

The cleansing of the Northern wall barrier of the back-fill earth and debris has brought completely to light both the Western corner and the Northern side which seems to be very well preserved, at least in the case of the two lower rows of calcareous blocks, above which, particularly in the central part of the wall, the masonry is missing (Fig. 12).

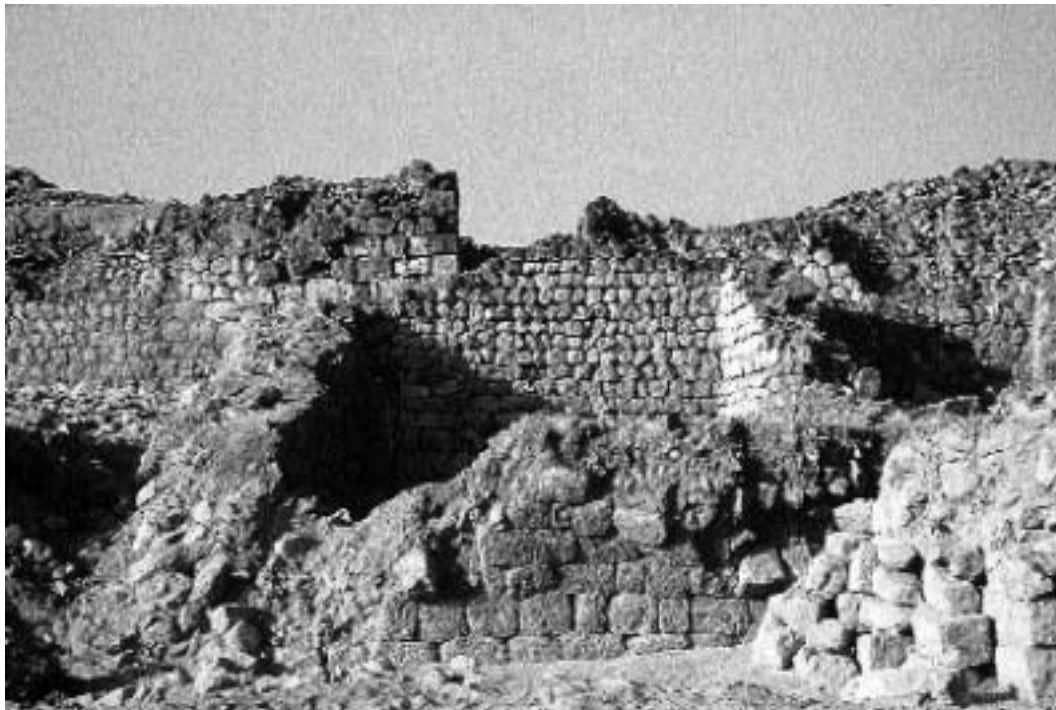
Fig. - 13 Northern side of tower.

During this operation also the Northern side of the tower has been completely brought to light (Fig. 13). This side of the wall (M12) seems to be very ill-preserved, especially in the central part where the stones slipped forward. Only the first three rows of the lower part are well-preserved and this led us to bring to light the door, already described by Albright<sup>6</sup>, that led into the tower (A6). The small-dimensioned door is situated on the far Eastern side of the wall and its threshold is placed at about 60 cm above the floor, analogously to what occurred to the storehouses in the South-Eastern part of the city.

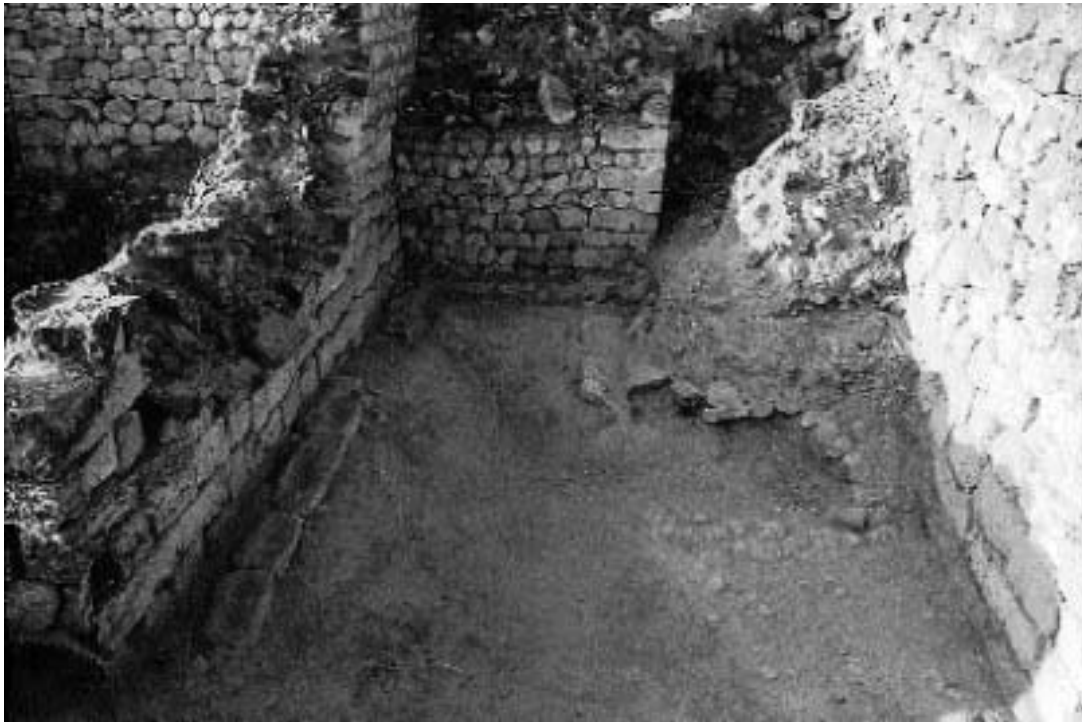
Fig. 14 - City gate. Area in front of the third door: on the left, the stone bench.

At the same time we proceeded to the cleansing of the area A2 of the back-fill earth and we brought again to light the stone bench, that runs along the tower's Western wall (Fig. 14).

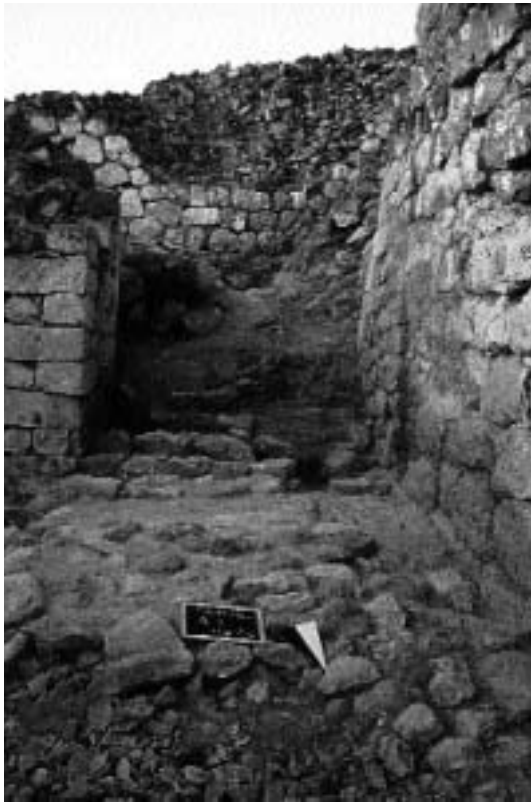
Fig. 15 - City gate. The third door with platform and steps.

In order to enter the third door and reach its higher level, a platform was built. This platform, the initial part of which is partly lost, is made of big rounded pebbles and rises very sharply towards the third door, running along the Western side of the complex. It is 4.10 m long, 2.20 m wide and it ends, near the door, with some large stone steps on the Western side of which a small drainage channel has been brought to light (Fig. 15).

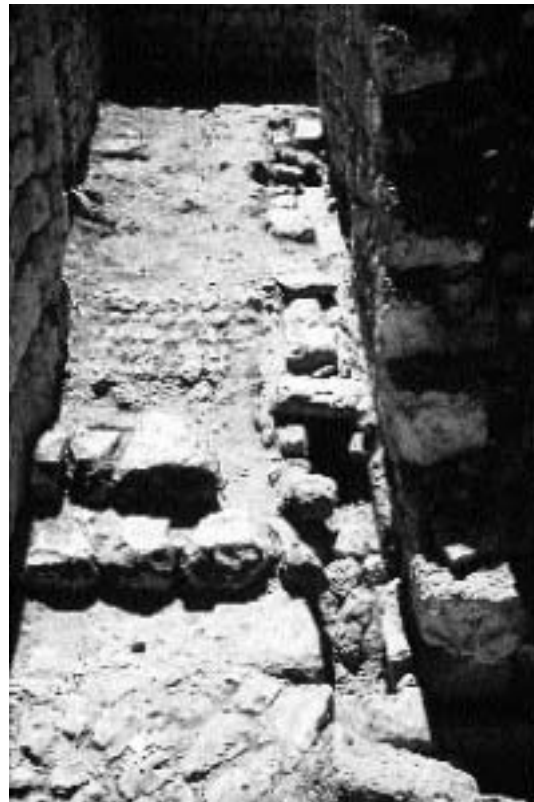
Fig. 16 - City gate. General view of A4; on the right the small conduit.

Along the Western wall of the area A4, we brought again to light the small drainage channel that runs along the wall and its buttress. It looks as if this small channel sometimes runs uncovered and sometimes covered by flagstones (Fig. 16).

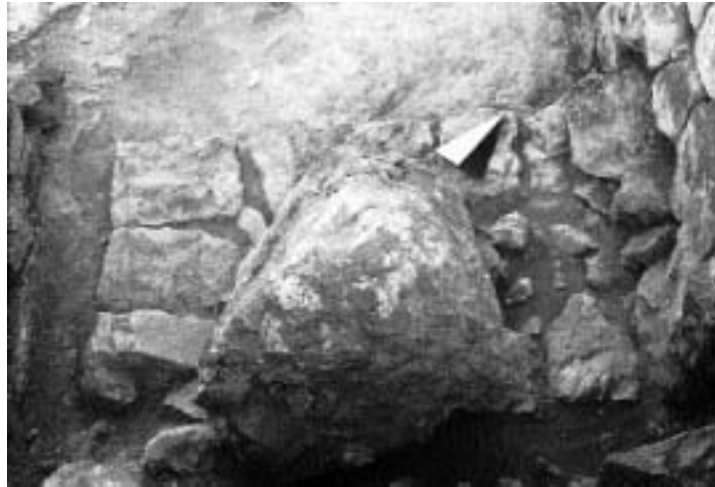
Fig. 17 - City gate. Area A3, view of the platform once part of the «L» shaped wall that protected the city gate during its first building phase

As far as the Eastern corner of the area A3 is concerned, between the buttresses of the middle door and the Southern wall (M10) of the tower, our excavations brought to light some stone elements that at first sight seem to constitute a kind of platform. A more accurate cleansing of the above-mentioned platform shows that the original part of the Southern side of the wall and the platform itself are connected and therefore contemporary (Fig. 17).

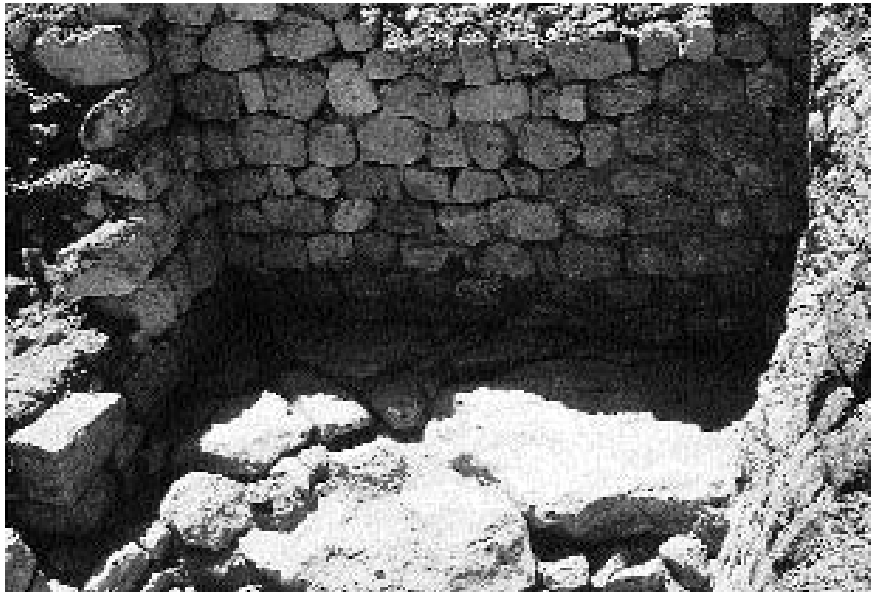
Fig. 18 - City gate. Area A3, view of the bedrock on the Western side of the western buttress.

This layer (US31) covered the whole Western half of the area, including the steps that led from the outside to the third door. In the South corner of the area, that is near the city wall (M15), this stratum was about 15 cm high and covered a large surfacing calcareous rock that slopes down towards the third door for about 1.70 m and the surface of which was flattened by means of the addition of some large stones (Fig. 18).

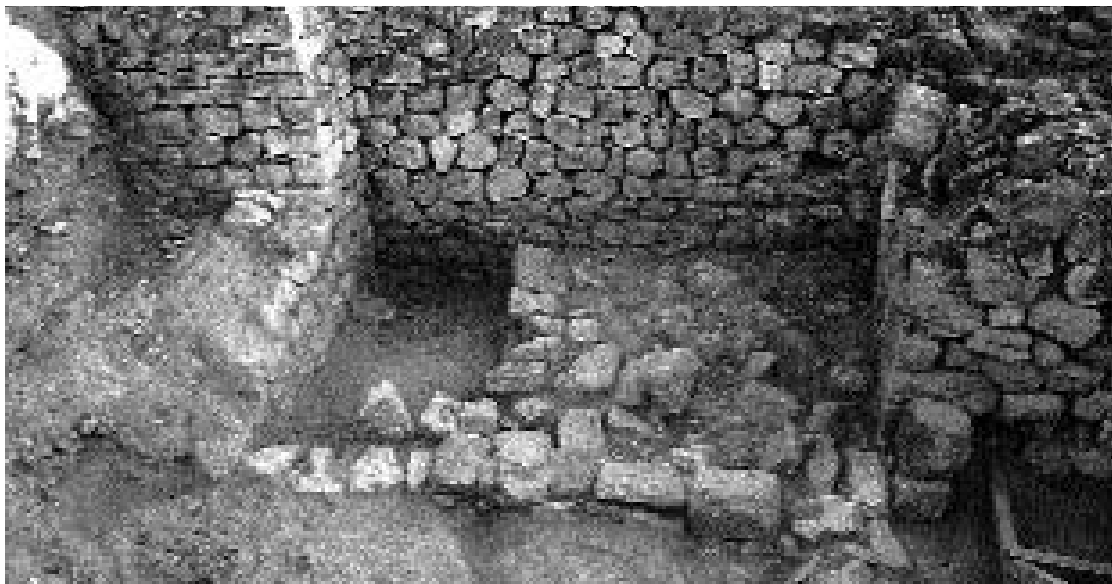
Fig. 19 - Area near the most internal door, with stone structure in the NE corner.

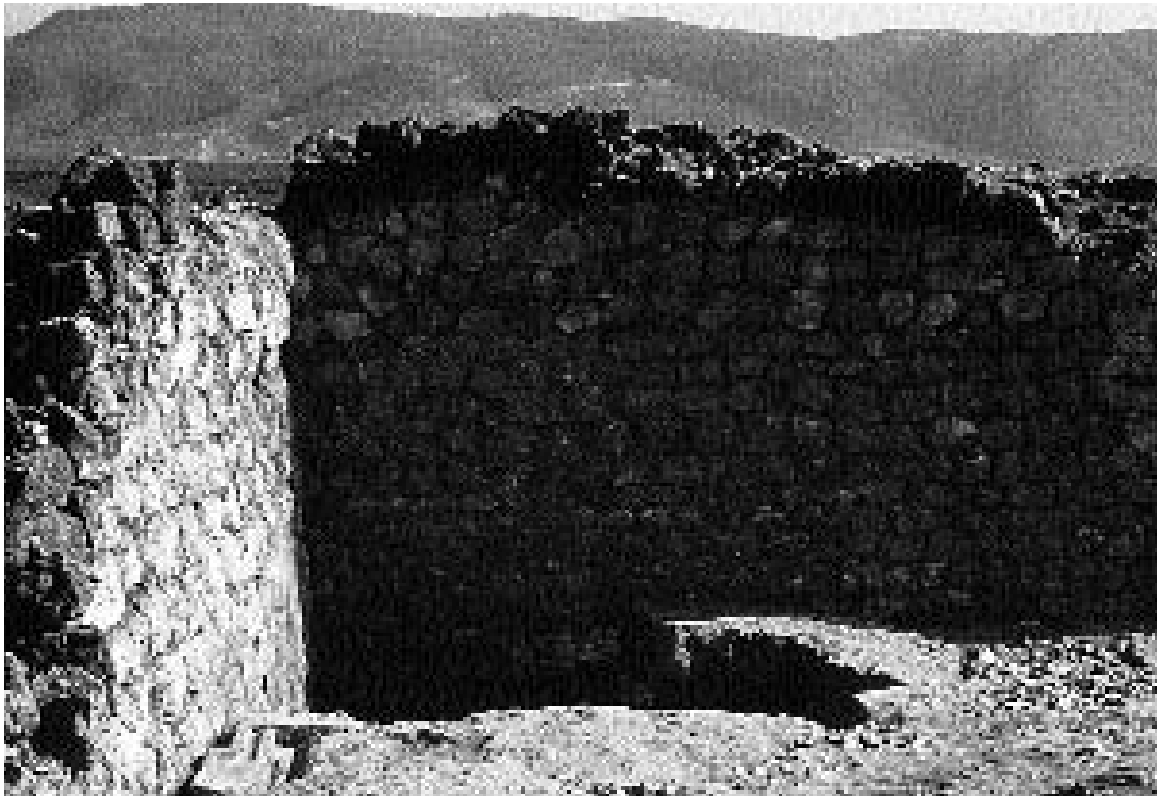
Fig. 22 - Area between the city gate and the palace – temple.  
View of the interred room: on the left, the offering table is visible.

As stated above, the NW part of the area was occupied by the subterranean (?) almost square room, c. 3.1 x 2.6 m in size (Fig. 22).

Plastered low parts of palace-temple and city walls were used as the Northern and Western walls of the room. The plaster of the temple wall has traces of fire or smoke. The Eastern and Southern walls of the room were made of roughly dressed stones facing, most probably, the walls of the pit initially dug for the room's construction (a kind of a corner pillar) which was carefully plastered (as well as adjacent part of the city wall). An amorphous bench, c. 60 cm wide and c. 20 cm high, made of stones covered by clay, was

constructed along the Western wall of the room.

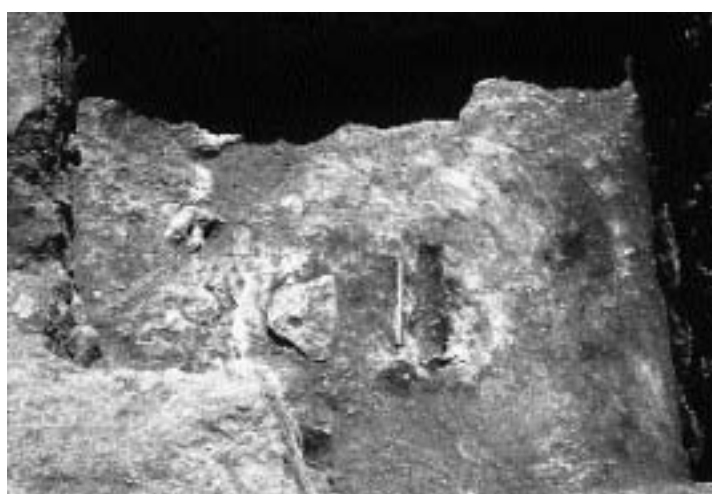
Fig. 23 - Area between the city gate and the palace-temple.  
The interred kitchen room with the fire-place.

An open fireplace dug into the floor occupied the centre of the room. Its core was an oval pit, c. 30 cm in diameter and c. 20 cm deep, with a small channel, 13x32 cm in size and 10 cm deep, attached to it from the South (to put firewood inside the fireplace?). The floor next to the East of the fireplace was covered with plaster. A trapezoidal stone, 40 x 32 x 5 cm in size, using, probably, to cut some foodstuff was found *in situ* on this plastered square (Fig. 23).

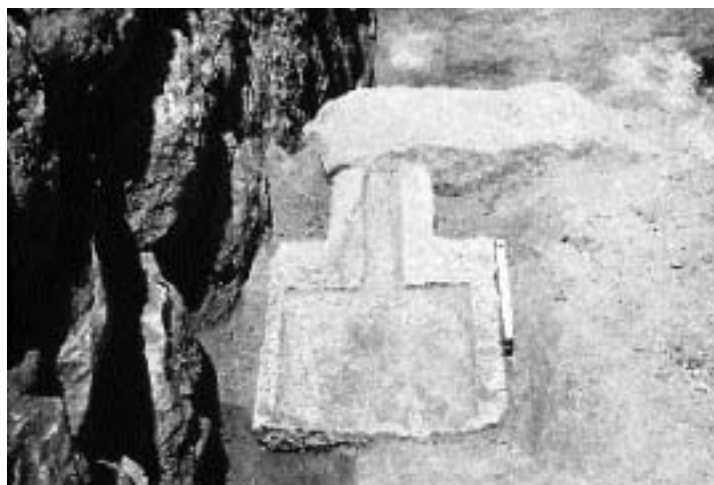
Fig. 24 - Area between the city gate and the palace-temple. The offering table..

An offering table connected to the final phase of the greyish «floor» was brought to light in the SW part of the square, against the outer face of the Eastern wall of the palace-temple (US41). A flat stone, 60 x 30 x 10 cm in size, was dug into the «floor» placed perpendicularly to the temple's wall. It was very likely used as an altar. A part of secondary used offering table with gutter, 60 x 38 x 8 cm in size, was placed next to the stone to collect liquid (blood? water with incense? milk?) from the altar and to drain it into a small channel, 17 cm wide and 15 cm deep, dug along the wall. The channel was filled with ashes, charcoal and small fragments of animal bones. Its sides were cemented probably thanks to regular flows of sacrifices (Fig. 22). The offering table was in use by the last inhabitants of the city, and definitely after the abandonment of the kitchen-room: the stone «altar» was placed in the room's entrance on the top of its filling.

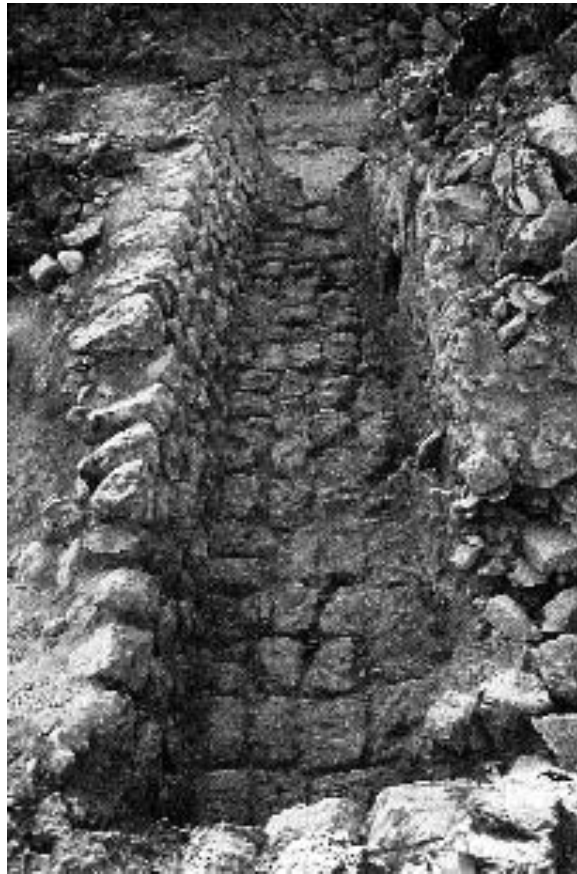
Fig. 25 - Area inside the palace-temple.  
View of the mud-brick wall.

After bringing to light the stones fallen from the adjacent walls, we found a mud bricks filling accurately arranged in rows of three stones each. The horizontal layers were separated by around 5 cm of very compact soil. The size varied from 33 x 22 x 6-8 cm. Towards the Western wall of the palace-temple the mud bricks appeared to lie under some fallen stones of the wall. The top layers of mud bricks did not cover the entire area; in the Eastern and Western part only hard reddish soil was present; this is probably due to the destruction of the mud-brick layer by the stones that had fallen on the wall. Once reached the first complete layout of bricks, half filling was left *in situ* for a length of 3.35 m, while the Eastern part was removed, for a length of 1 m (Fig. 25).

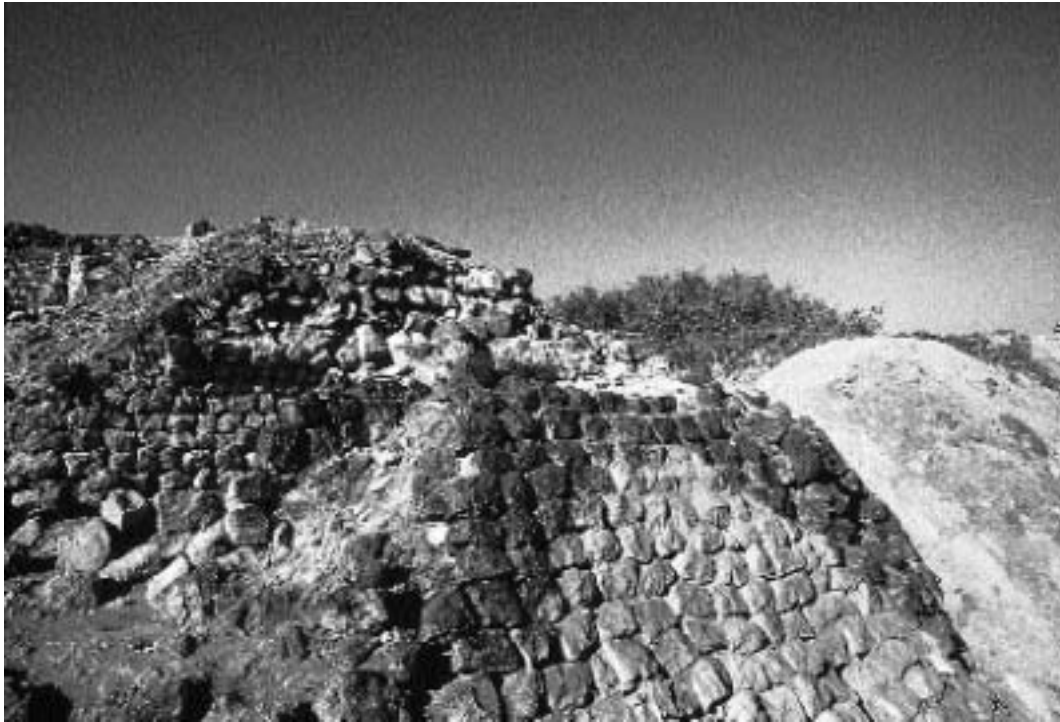
Fig. 26 - Area outside the palace-temple. View of the rampart on the NE corner.

With regard to the external buttress and its adjoining internal wall, there is evidence that they have been built at the same time to strengthen the Northern city wall or in order to create a further defence tower. They must have been shaped like a semicircle of about 19 m (fig. 26).

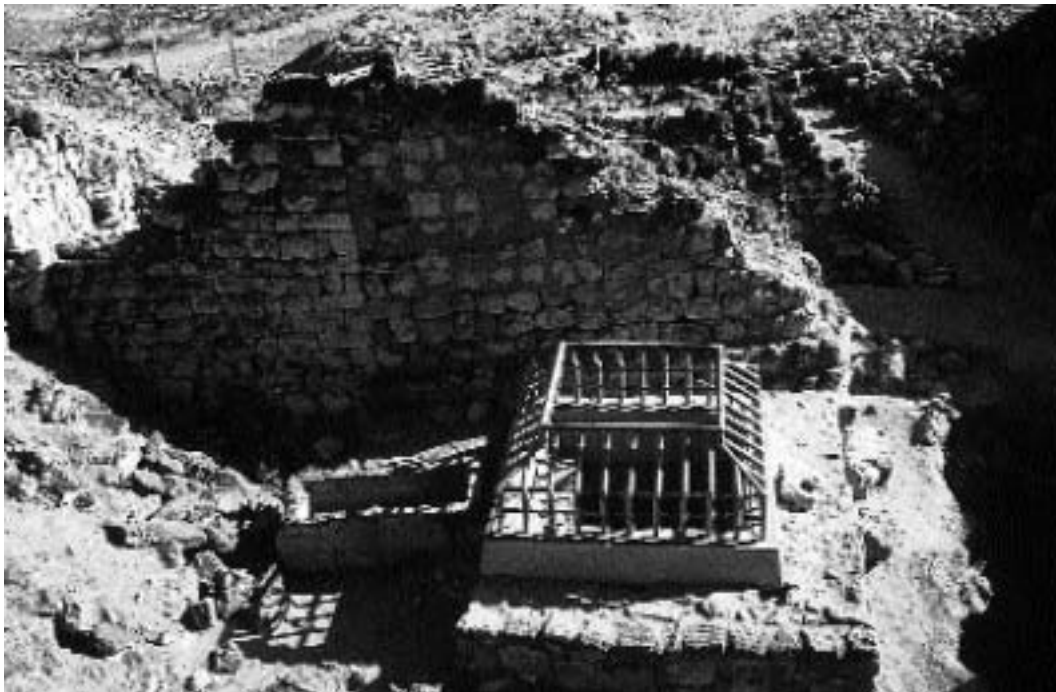
Fig. 27 - Internal part of the palace-temple. View of the well and the recent additions.

We have to mention here the fact, a detail that strangely is not mentioned by Albright, that the well's sides, even though they are covered, indicate how the well itself had a «telescope» section, that is a section that appears at regular intervals, once every 5 rows of covering stones, progressively decreasing from top to bottom.

Photographs taken in a later period, published recently, show also that after Albright the fencing of the well was seriously damaged. On the leaflet published in the Oman Daily Observer «Dhofar, land of frankincense» in 1997 there is a photo (p.19) in which we can clearly see that the wall is not there any more and that the opening of the well opens directly on ground level. Already in 1979 in the text «Oman, a seafaring nation», published by the Omani Ministry of Information, we can find a photo (p. 21), where the opening of the well is already seriously damaged: the first stone of the SE corner of the internal protective covering of the well is missing. We can thus draw the conclusion that not only the cement and metal structure that today protects the wall but also its external structure have been built recently: they should be removed and substituted with something more appropriate (Fig. 27).

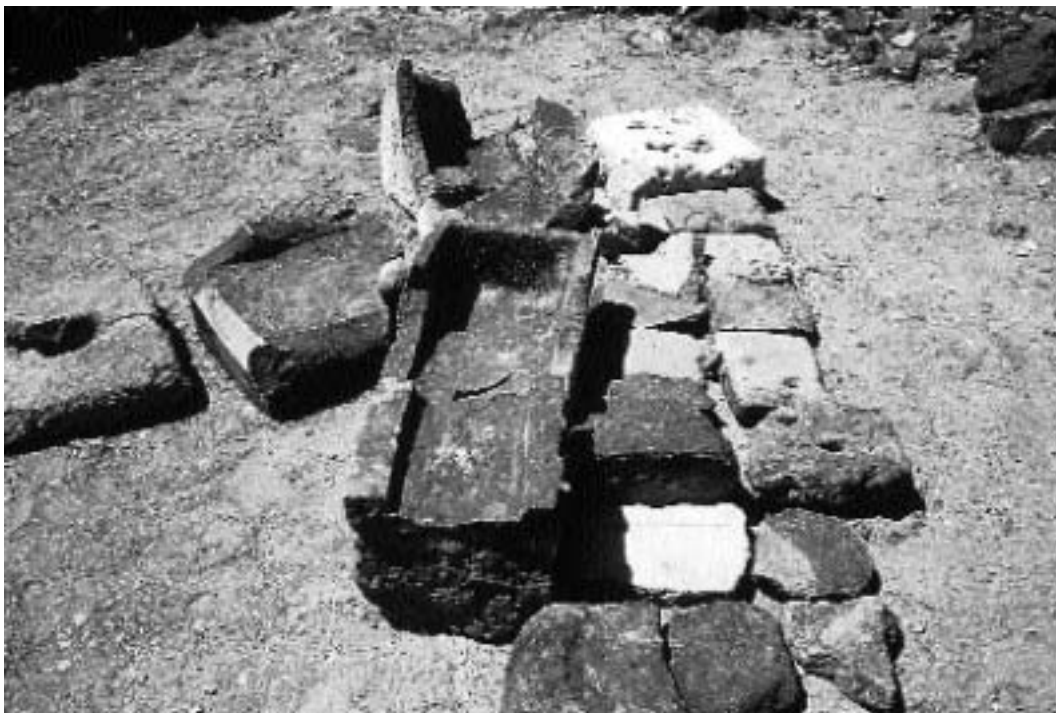
Fig. 28 - Several architectonic elements regarding water conservation procedures found in the town.

The tanks deserve a few words apart. So far we have found no room with mortar coverings that might suggest the fact that it was used as a water reserve. It would be surprising, though, if we found out that the city did not have such reserves. A clue indicating the presence of such tanks is the finding of a squared stone with a hole in the middle, the shape of which is very similar to the one of the leads that cover the tanks, like the ones that for a long time have been in use in many cultures (fig. 28).

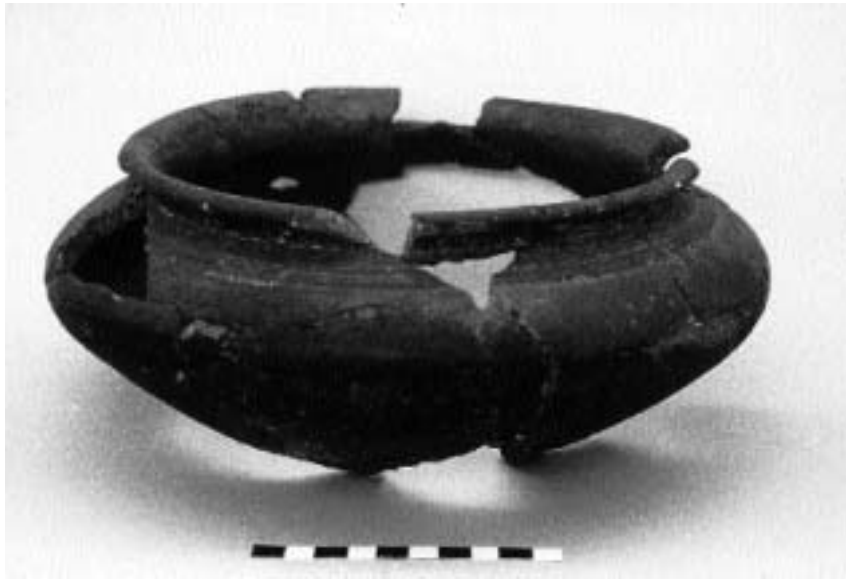
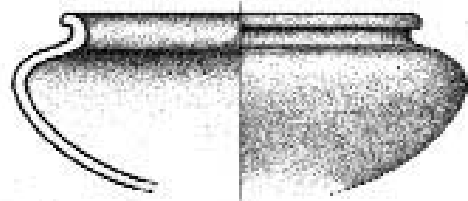
Fig. 30 - Indian RPW vessel.

Sumhuram<sup>17</sup> – inside the filling of the kitchen-room (US 29). It is a kitchen olla, with a carinated profile and a flaring rim, that belongs to the so called Indian Red Polished Ware (Fig. 30 and 31).
