IMTO – Italian Mission to Oman

*PRELIMINARY REPORT*

October 2004

(SUM04B)

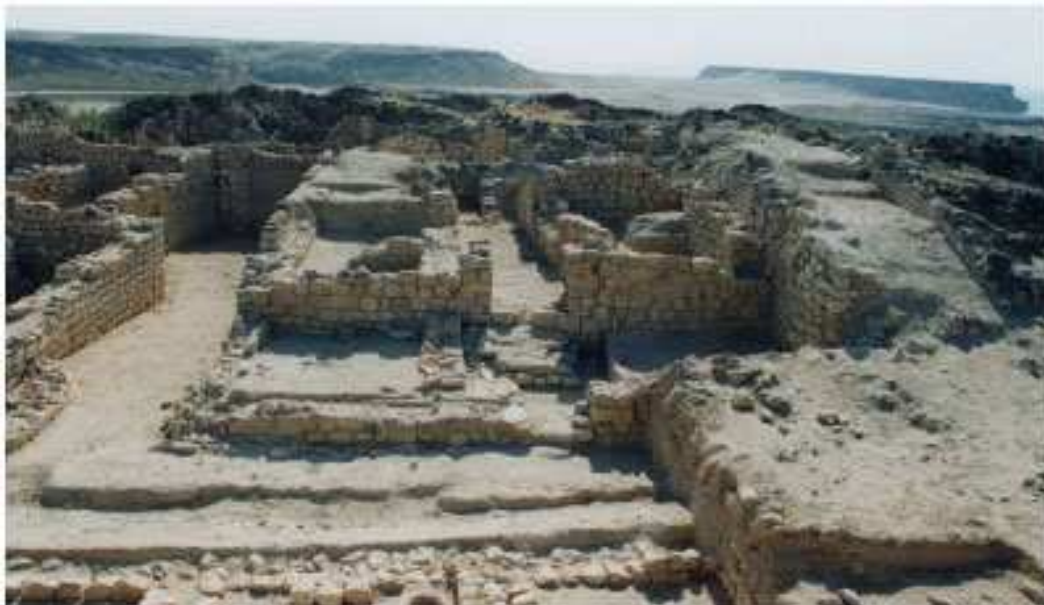
Fig. 1 Sumhuran, Area A, Building BA6

The Building BA6 seems to consist of four rooms (A59, A60, A63 and A56), a courtyard (A58), and an outside porch (room A51). The latter was excavated by IMTO during SUM04A campaign (fig. 1).

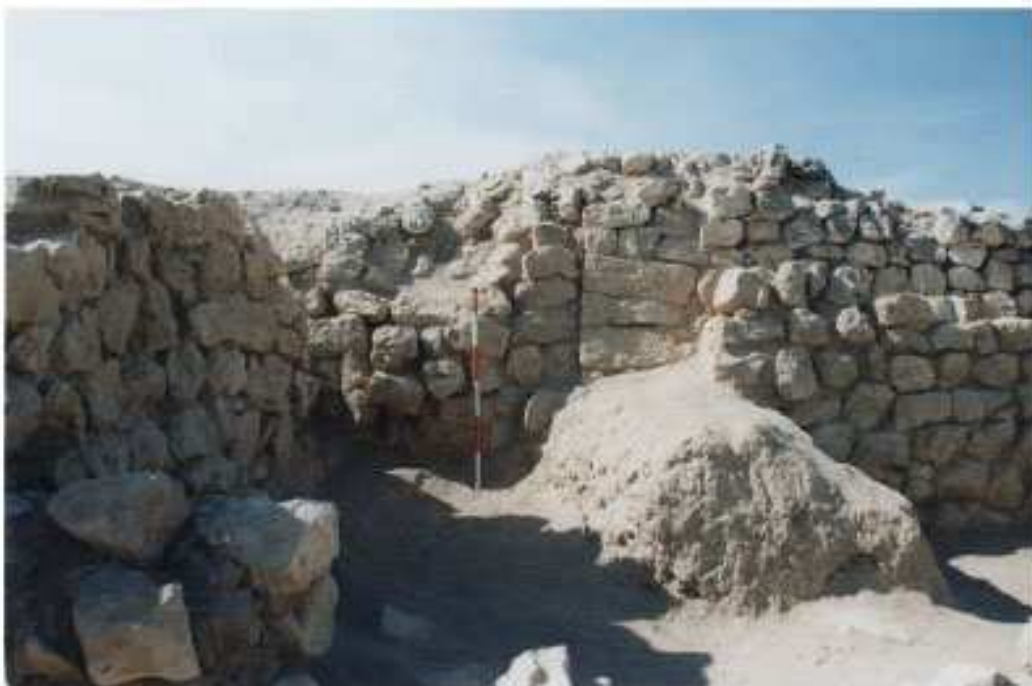
Fig. 2 Sumhuran, Area A, Building BA6, room A56

The access to the room (part of the room F21 on the Albright's sketch) was from the corridor A60 through a door in the wall M124 (fig. 2). Walls M58 and M128 closed the room which was 5.10x2.10 in size. Wall M124 was made from sandstone blocks in its NW part, and from limestone blocks in its SE part. The other walls were made from roughly dressed limestone blocks. The corner between wall M58 and wall M126 collapsed and the entire wall M126 was reinforced with a shorter wall M125. Wall M125 was made from one row of roughly dressed limestone blocks, and was filled with small stones against wall M126.

The deposits in the room A56 were disturbed by the AFSM expedition probably only along the wall M124. The layer US21 was still *in situ*, and was excavated down to the badly preserved US21 floor. The floor was made from hard beaten reddish soil. It slopes down from SE to NW from the wall M128.

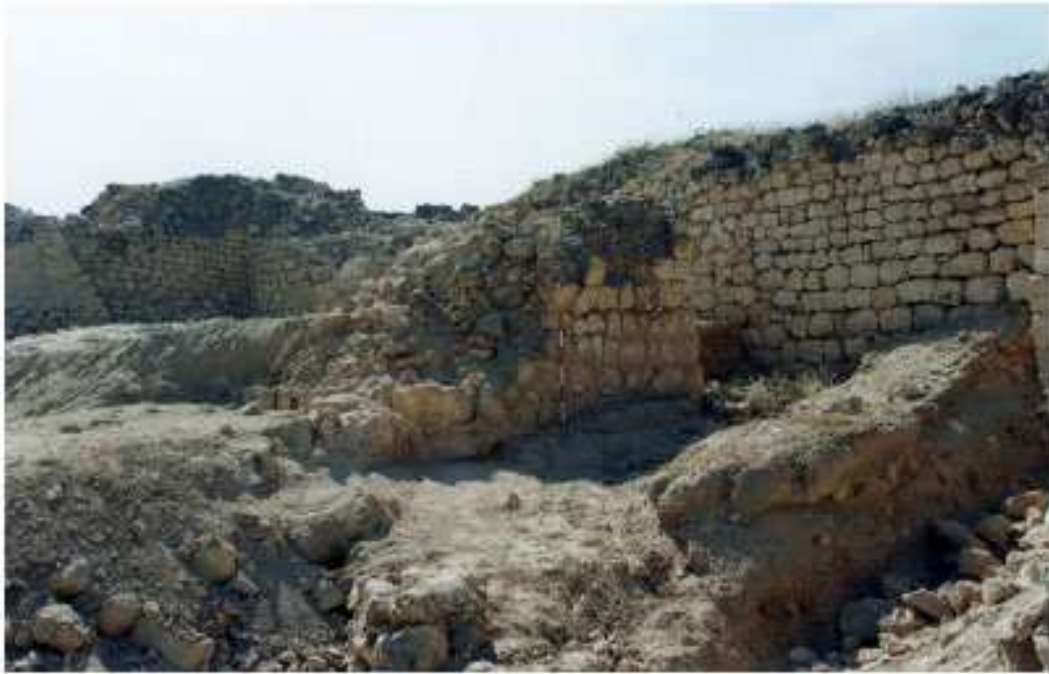
Fig. 3 Area A, tower A61

The main goal of the present campaign was to continue the clearing the external façade of the defence wall of the ancient town, which we started already in this area during the SUM03B campaign (fig. 3, 4). For this purpose the dumps from previous excavations accumulated in the area were removed down to the ancient surface. The exposed façade of the defence wall M134-M135 as well as façade of the last repairing of the external corner of the monumental building 1 (M24-M25) was made from nicely cut limestone blocks regularly placed in the masonry. The blocks were fastened with clay and lime mortar.

A separate standing tower A61 was also cleaned also not down to its foundation. Apparently it was excavated by AFSM expedition in 1960, but later was almost completely covered with dumps. It should be noted, that most probably the tower A61 was very late addition to the fortification system of the ancient town: its foundation stands not on the bedrock like defence walls but on the surface of the ancient accumulation above the bedrock and against the city-walls. This is a good indication,

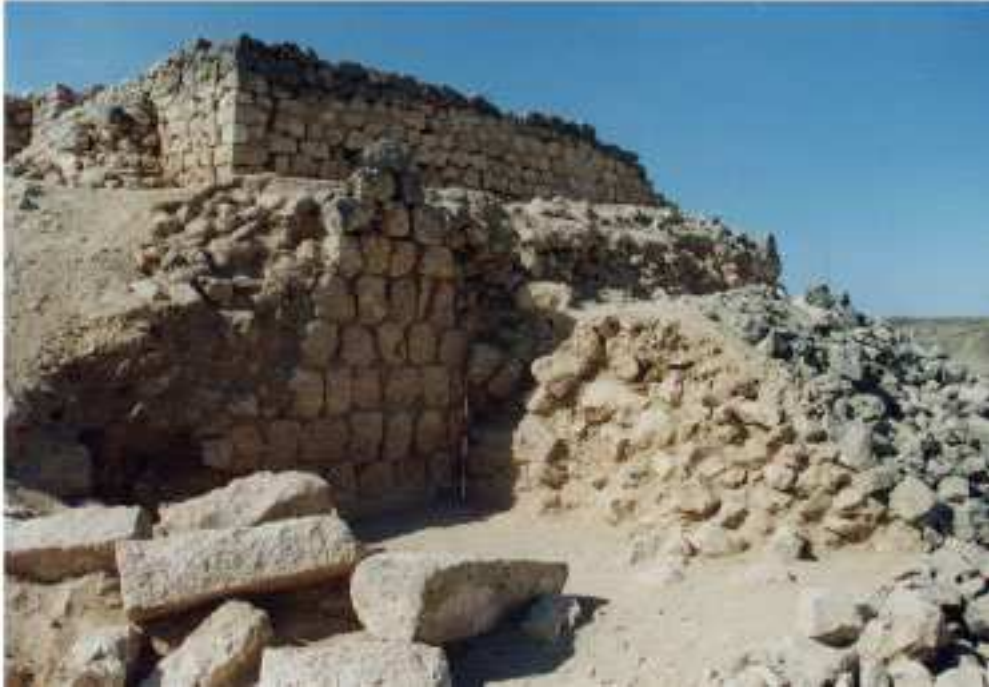
Fig. 5, Area E, tower A62

During the clearing of the northern wall M130 of the corner tower A62 the most surprising discovery was made (fig. 5). Already AFSM expedition (ALBRIGHT 1982: 29) noticed the presence of “shell reinforcement” around the tower A62. Our excavations revealed that it was not a simple “reinforcement” but a significant enlargement of the tower, which allowed, in fact, doubled its space. For this purpose, a monumental wall M132 made from huge limestone monoliths was constructed in *c.* 3 m north of the tower’s wall. Apparently, it was set directly on the bedrock, exposing the height of more than 4 m. The bottom rows of huge limestone blocks were fastened with lime mortar, while the upper rows – with clay mortar. In the present campaign we succeeded to clean *circa* 6 m of its northern façade almost on entire preserved height, and to discover the NE and NW corners of the structure. The space between the additional wall M132 and walls M130 and M132 of the tower was filled with roughly dressed stones and mud. The bottom part of the additional wall M132 was leaned to the older walls (M129 and M131) of the tower as could be very clearly seen in the SW part of the trench, while the top rows of the wall M132 were tied with the masonry of the tower (see façade of the wall M129 of the tower A62). Such construction was only possible if the entire tower A62 was completely rebuilt during the erection of the additional wall M132.

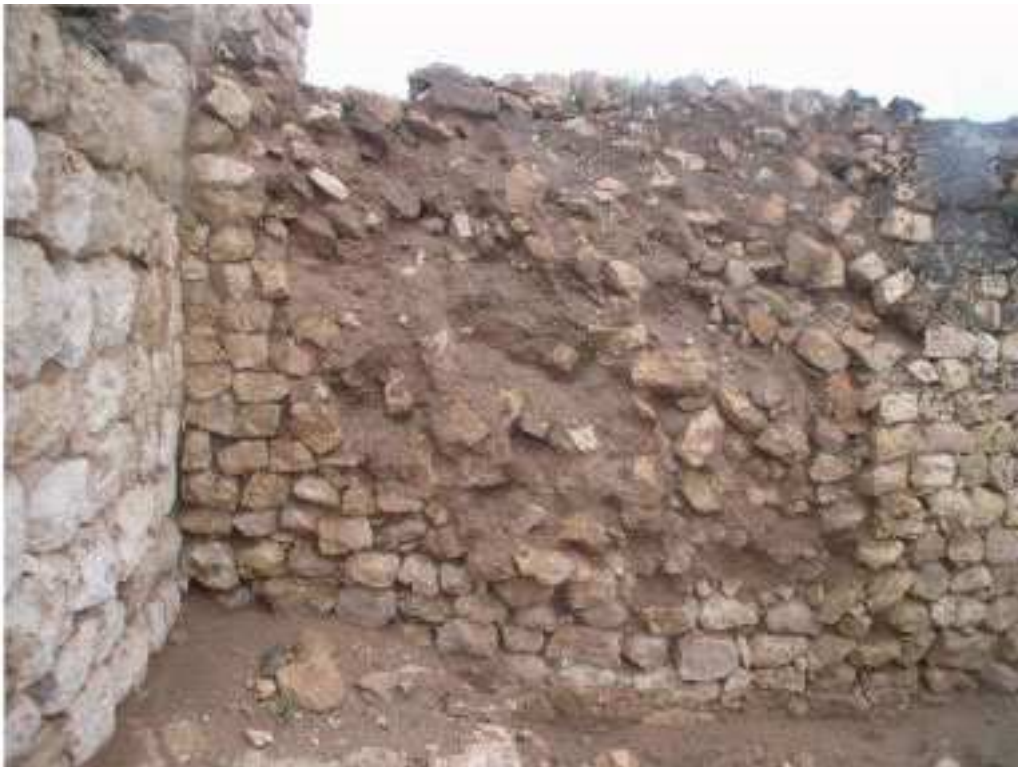
Fig. 6, Area A, wall M8

During the archaeological campaign a general monitoring of the architectural structures was made by Mauro Sassu, professor of the Department of Structural Engineering of Pisa University. This kind of monitoring was requested since the masonry walls are, in some points, very badly damaged (fig. 6). Some of them in fact show structural deficiencies which are due, above all, to the lack of protection on the top of the walls and to the lack of plaster on the surface which in antiquity ensured the cohesion to the masonry.

Two kinds of settlements have been individuated:

- expulsion of the surface due to a transverse pressure of the interior caotic mixture of clay and sand because of washing away;
- expulsion of the external bricks layers according to collapsed surfaces with a “spoon shape”, typical of slides phenomena with a mechanical behaviour similar to soils.

After the monitoring it appears clear that in some cases the structures are so compromised that it should be necessary an accurate dismantling and re-assembly of the masonry since a reinforcement-on-site would change too much the esthetical and architectonical characteristic features. As well in consideration of the next opening of the site to the tourists it's important to provide the site with the right safety measures.

The following interventions are suggested in order to respect the geometry of the masonry and the original features:

- partial calcification of the internal caotic mixture to fix the materials adding lime mortars similar for colour and composition to the original remains;
- protection of the top of the walls with a kind of lime similar to the one above described;
- sealing of the interstice between the blocks.

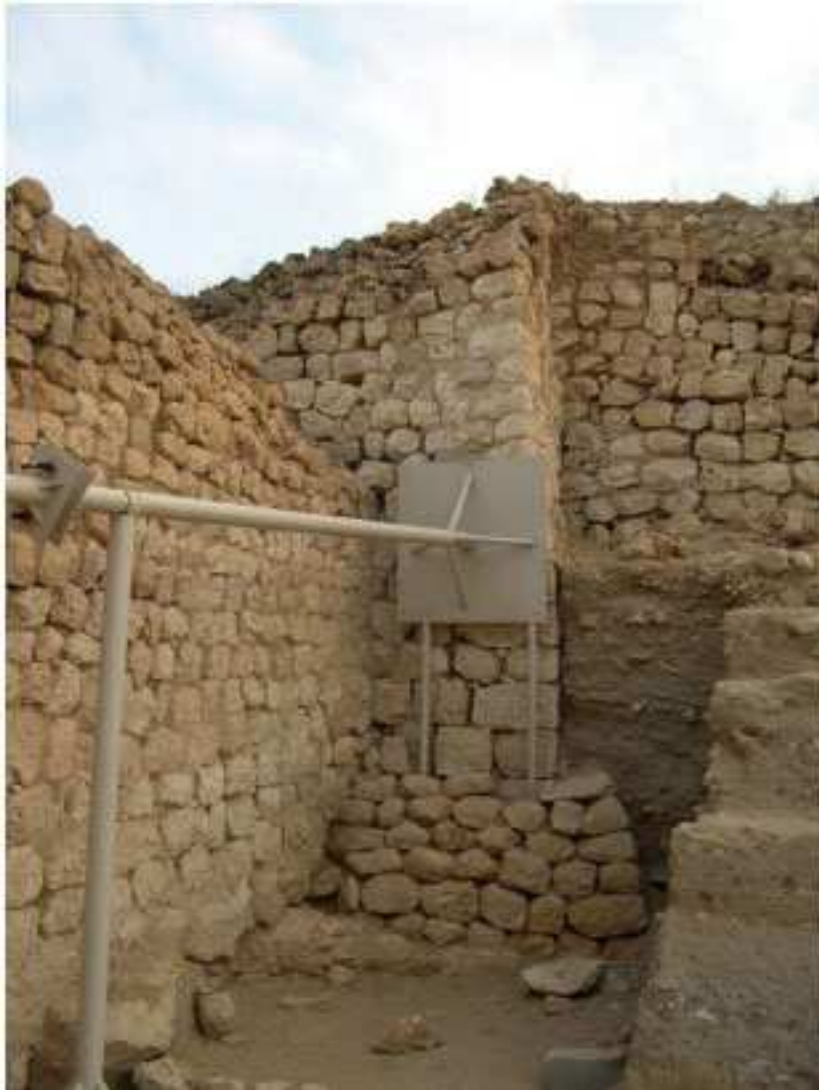
Fig.7 Area A, wall M15

Both the phenomena have macroscopic evidence and show a quickly and irreversible deterioration. In one case it was already necessary to provide the wall (M15) with an emergency steel framework to stop a collapse in progress (fig. 7).

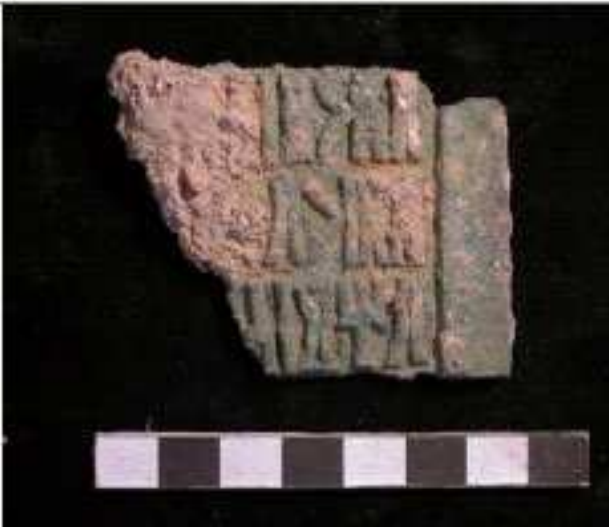
<b>Registration Nr.</b> SUM04B US155,1 MB337

<b>Provenance</b> Area A, f7-8				
<b>Definition</b> Inscribed plaque	<b>State of preservation</b> fair	<b>Measures</b> l. 5.8 w. 5 h. th. 0.7 diam.		<b>Shape</b>
<b>Material</b> bronze	<b>Preserved part</b> fragmentary			<b>Section</b>
<b>Description</b> Fragment of molded bronze plaque with inscription. The preserved part is almost trapezoidal and the section slightly convex. It's not easily readable since there are many encrustations on the surface. The right margin is constituted by a flat frame. The plate is an offering object in which compares the expression "in the land of Sakalan". The style of the letters seems to date the object to the III century A.D.				
<b>Responsible</b> A. Pavan			<b>Date</b> 20/10/2004

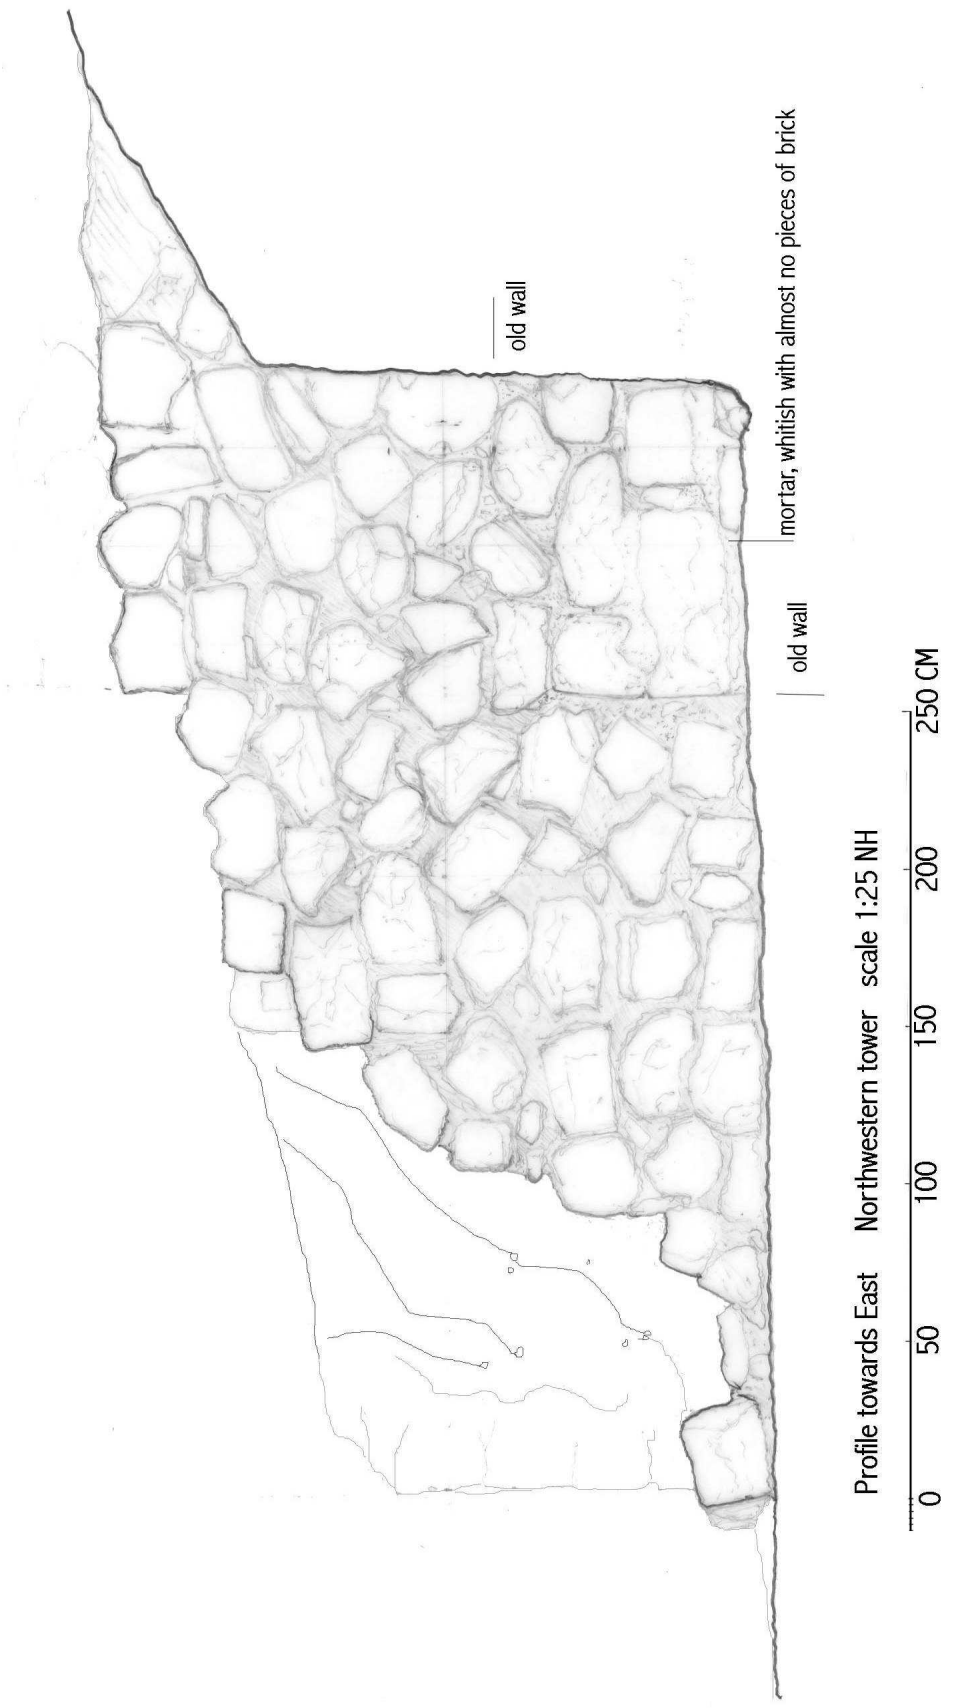
Plate 1: Section of wall M132.

In the US152 a part of very badly preserved wall (M132 eastern side) was discovered. As we understood later, it represented a much wider structure connected with significant reconstruction of the tower A62. This wall M132 eastern side leans on the eastern tower wall M131.
