**IMTO – Italian Mission to Oman**

**SUMHURAM**

**PRELIMINARY REPORT**

**(SUM07B)**

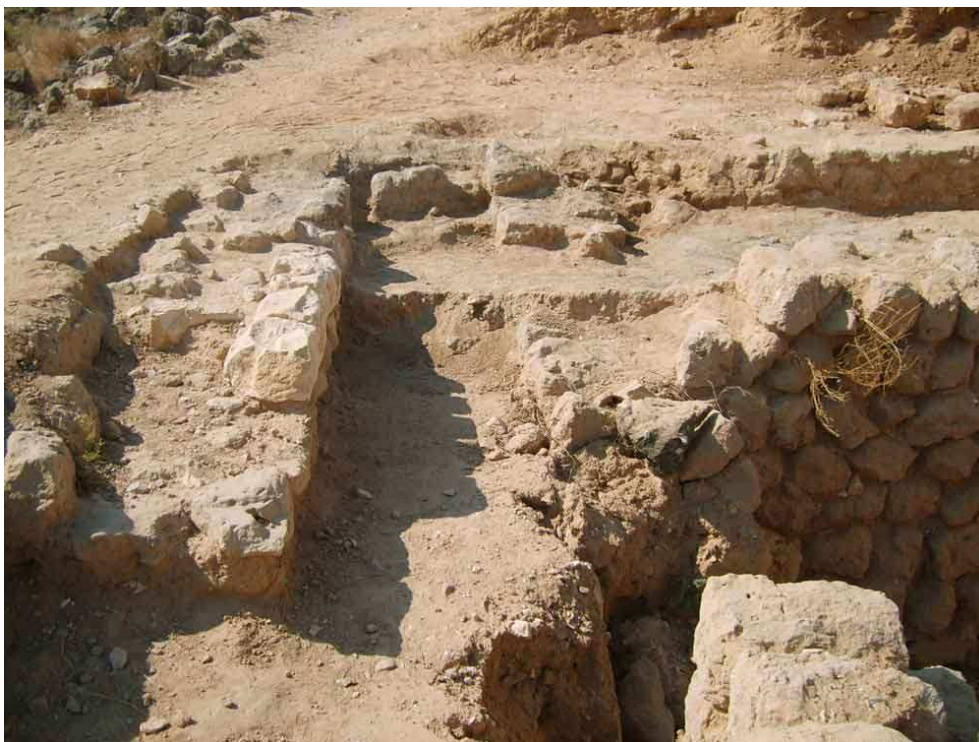
Fig. 3: Area A during excavation, US206 (in section, and in the middle of the picture) partially covers M241, reaching M194 ground level

On the other side of wall M242, US203 had partially removed and currently covers US206, a reddish-brown loose loam layer, some 20 cm. thick in its eastern part but slightly raising westward. US206 is characterized by the scanty quantity of materials found inside it, something that seems to strengthen the idea that it was an artificially laid down soil meant to raise walking levels in a late building phase. It obliterates the upper part of the original entrance to room A108, located between M241 eastern end and M192-M193 corner, and serves as foundation ground for wall M194 and M243. It covers wall M241 (fig. 3).

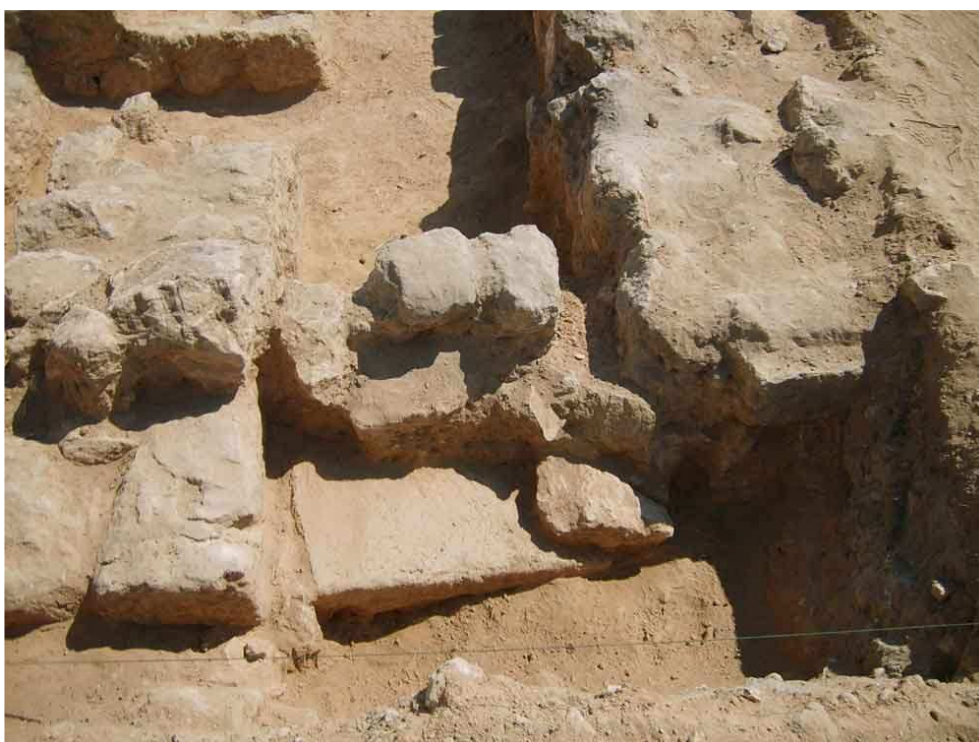
Fig. 4: Area A, M243 laying on a possible threshold, upon US206 still *in situ* on this side of the structure

Excavations have been suspended leaving the most uniform situation possible (figg. 2, 5). US206 has been removed, between walls M194, M242, M243, almost reaching the starting level of wall M242 (fig. 4), where a new layer could be properly distinguished with further excavations (final depth is 20 cm under wall M194 foundation). North of wall M242, the floor US243 has been left *in situ*, with its northern part near wall M17 broken through by US240, which probably represents the outcome of an initial decaying of the surrounding structures and can be chronologically linked to

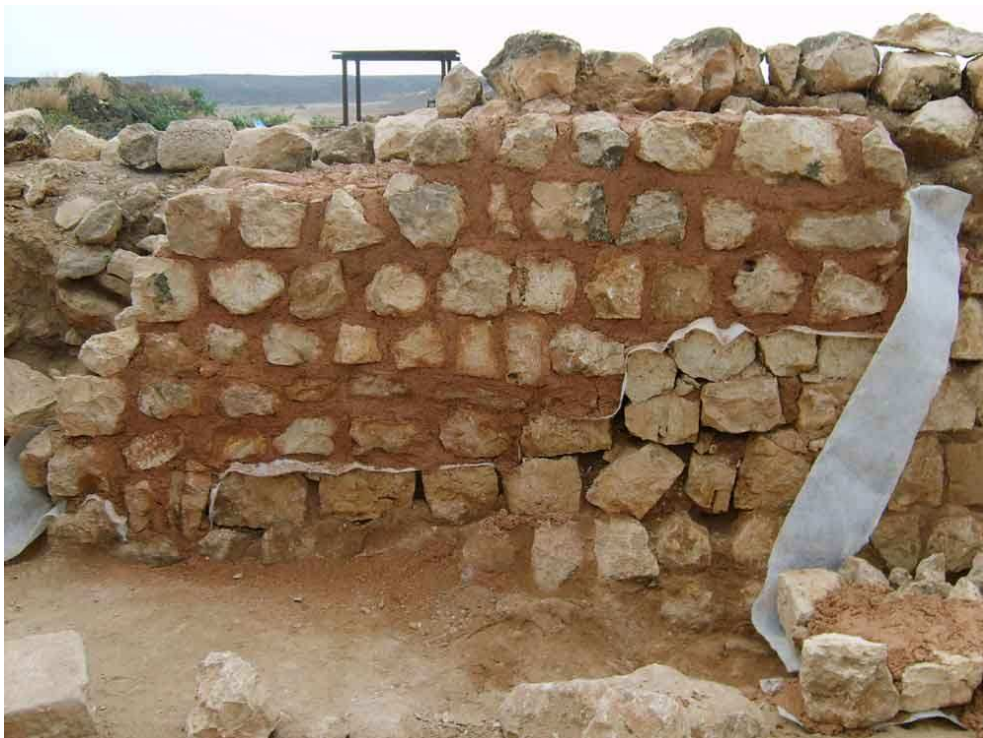
Fig. 6: Area A, wall M127 after rebuilding and wall M230 under construction: the almost collapsing north-western part of M127 is visible, supplying an explanation for M230 raising

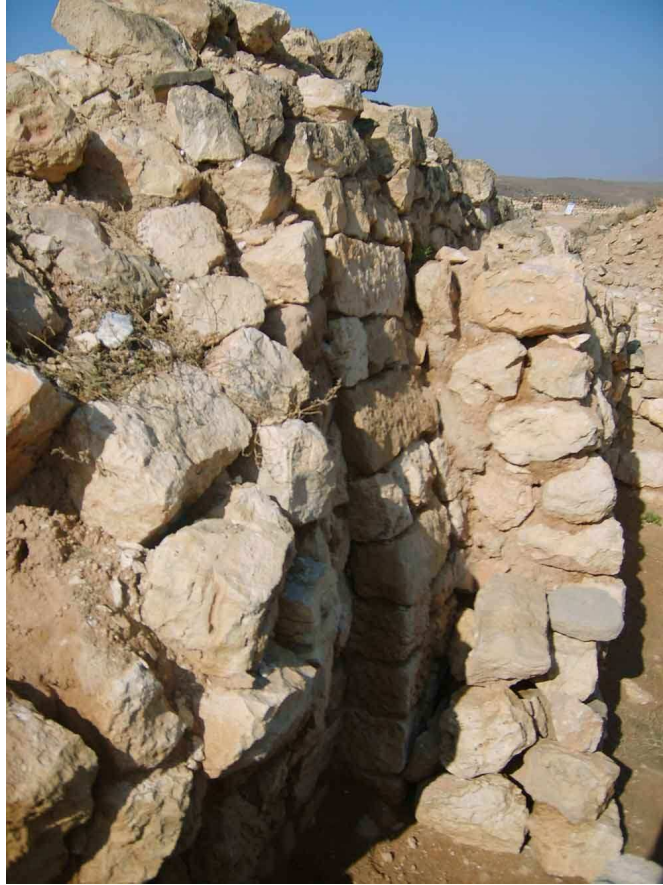
Fig. 7: Area A, wall M125 (right) leaning on wall M126 to prevent its collapse

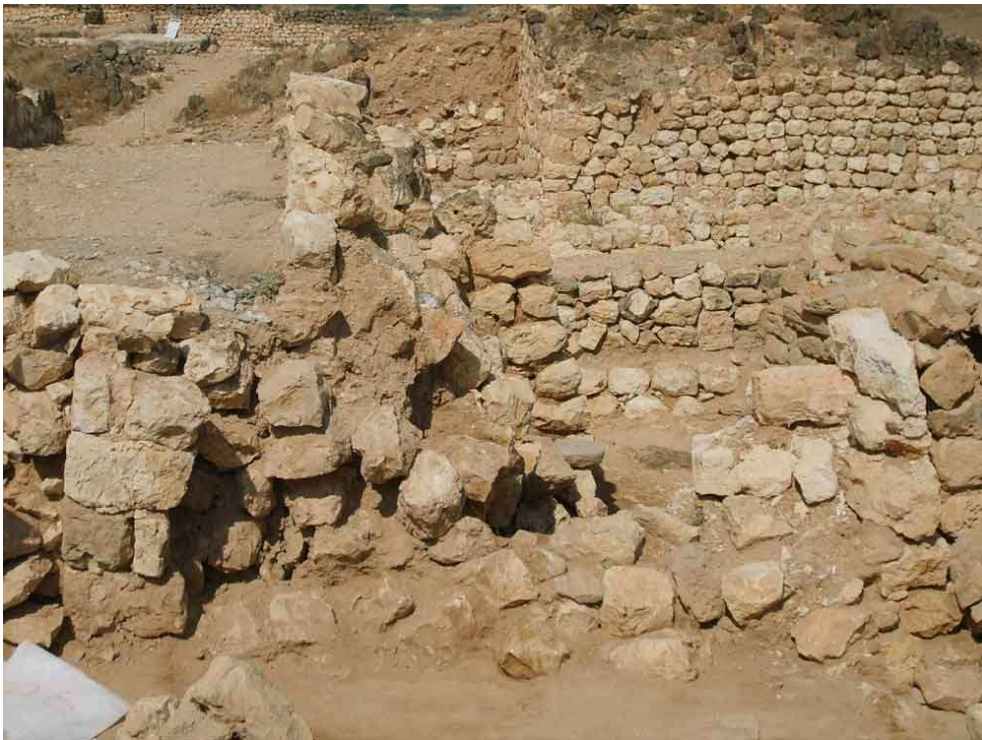
Fig. 8: Area A, the severely damaged structure of wall M148 seen from the east; only the southern end (previously defined as part of M170) and the northern corner with M147 are well visible

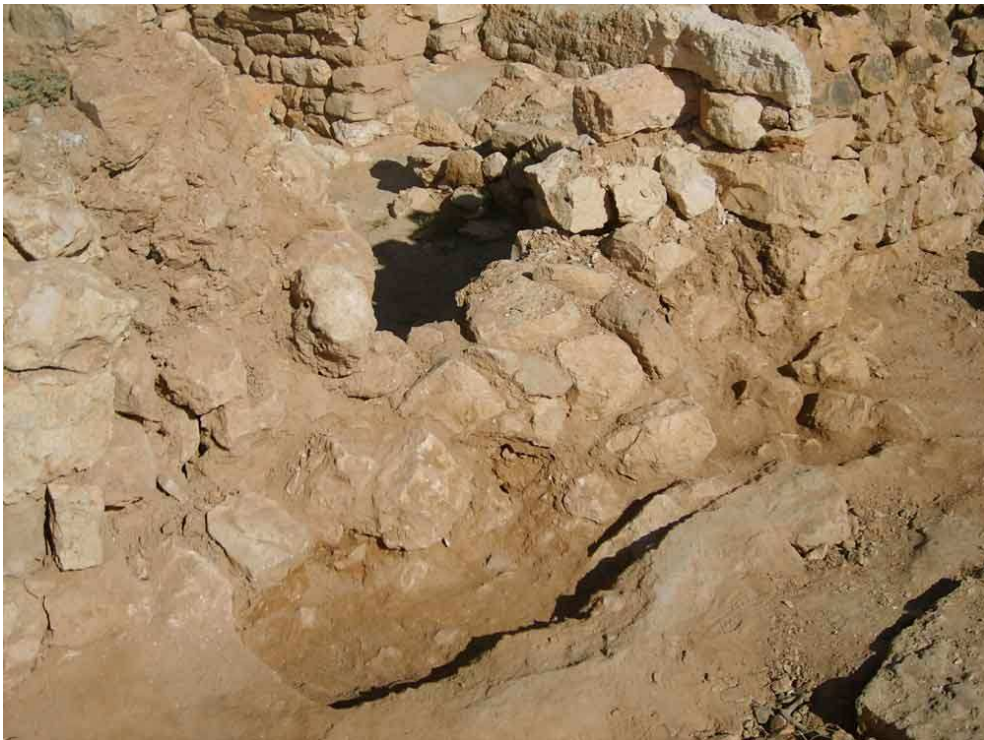
Fig. 10: Area A, the shallow sounding conducted near wall M148: stones coming from a collapsing event prior to the “late complex” phase are clearly visible under US192 floor level

Bearing in mind that many operation have taken place upon US192floor, involving the carrying (and actually throwing) of heavy loads (namely stone blocks), it cannot be dismissed the possibility that the looseness of the upper part of the loam removed during the new sounding only resulted different from the lower part just as a consequence of the abovementioned operations, actually belonging to the same US192floor.

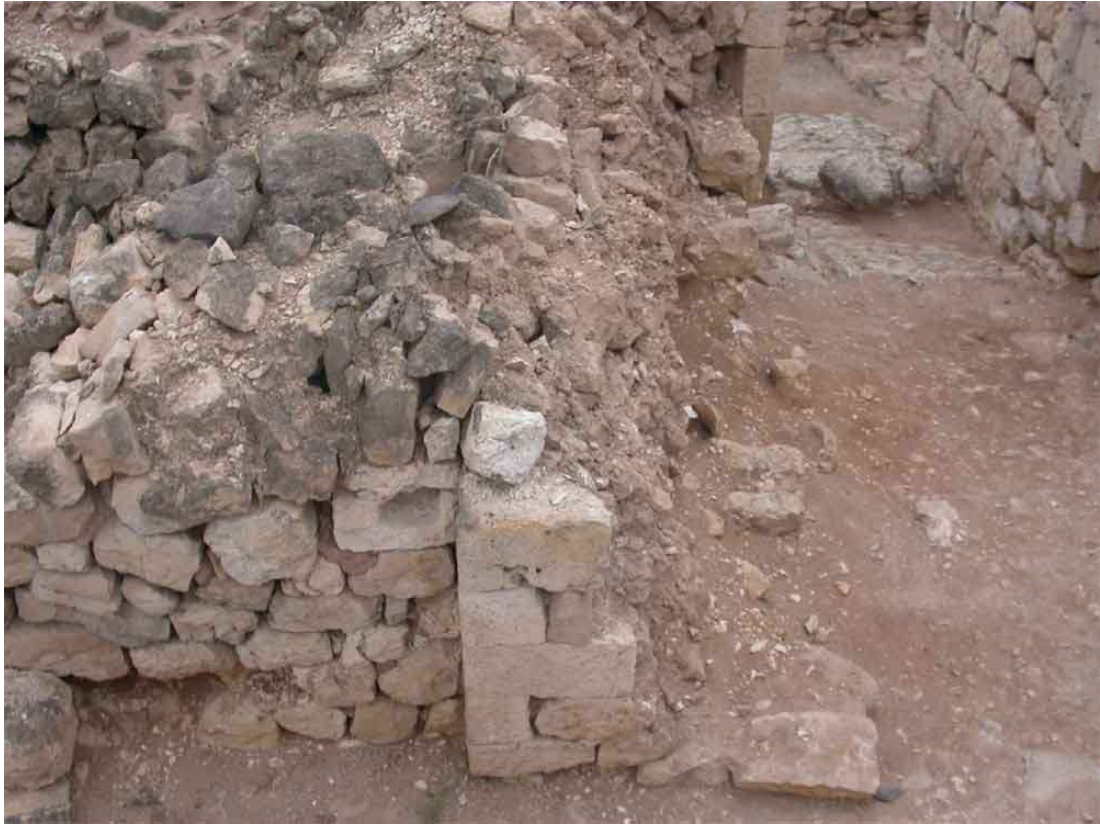
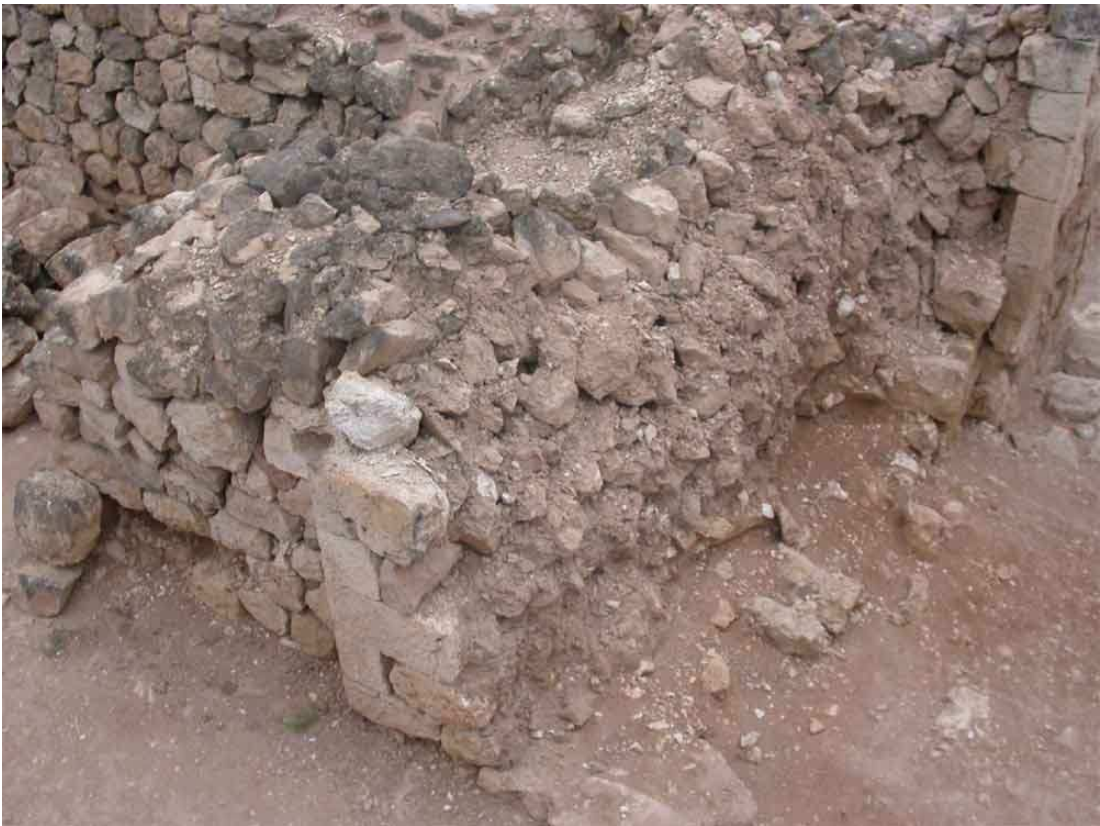
Eastern side of wall M6 before restoration

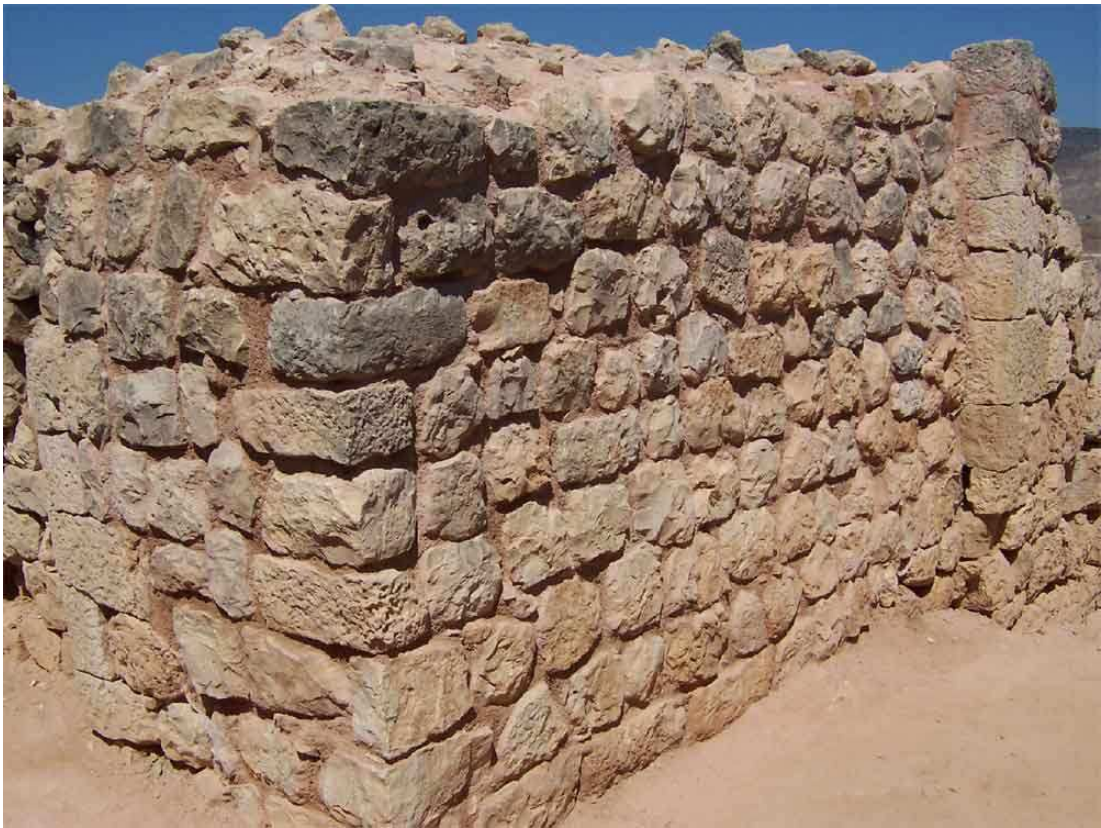
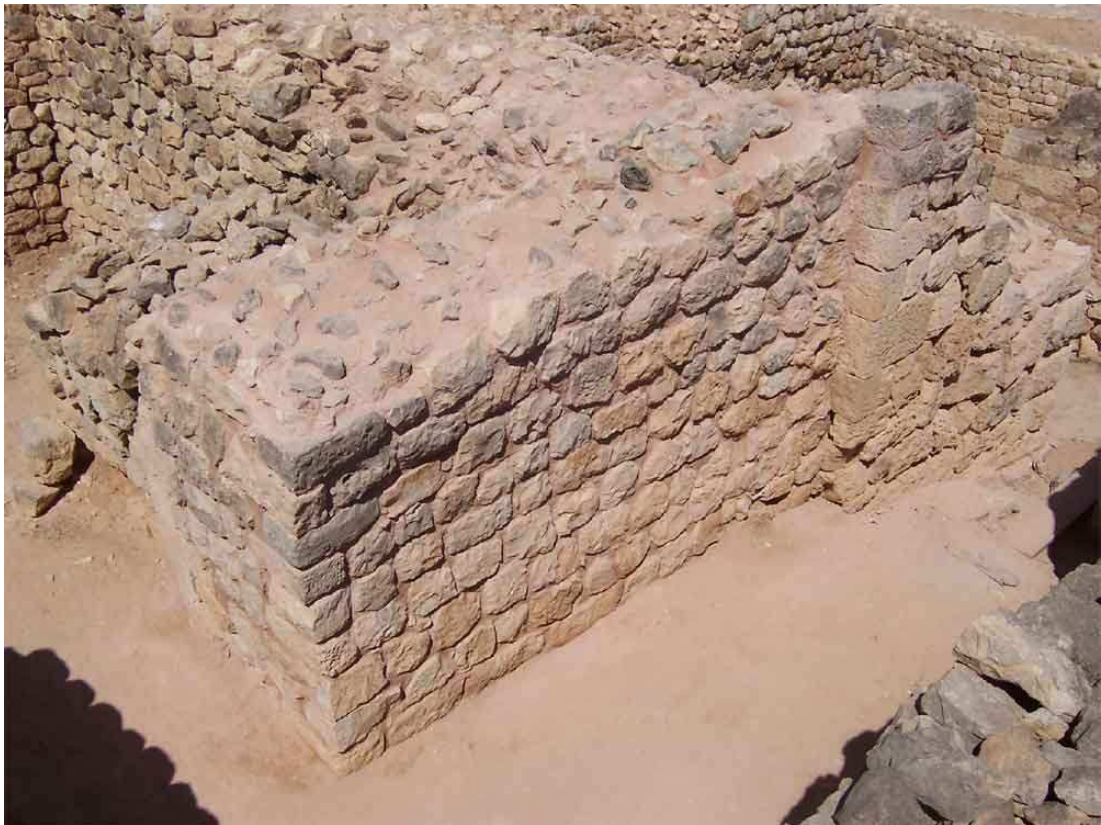
Eastern side of wall M6 after restoration

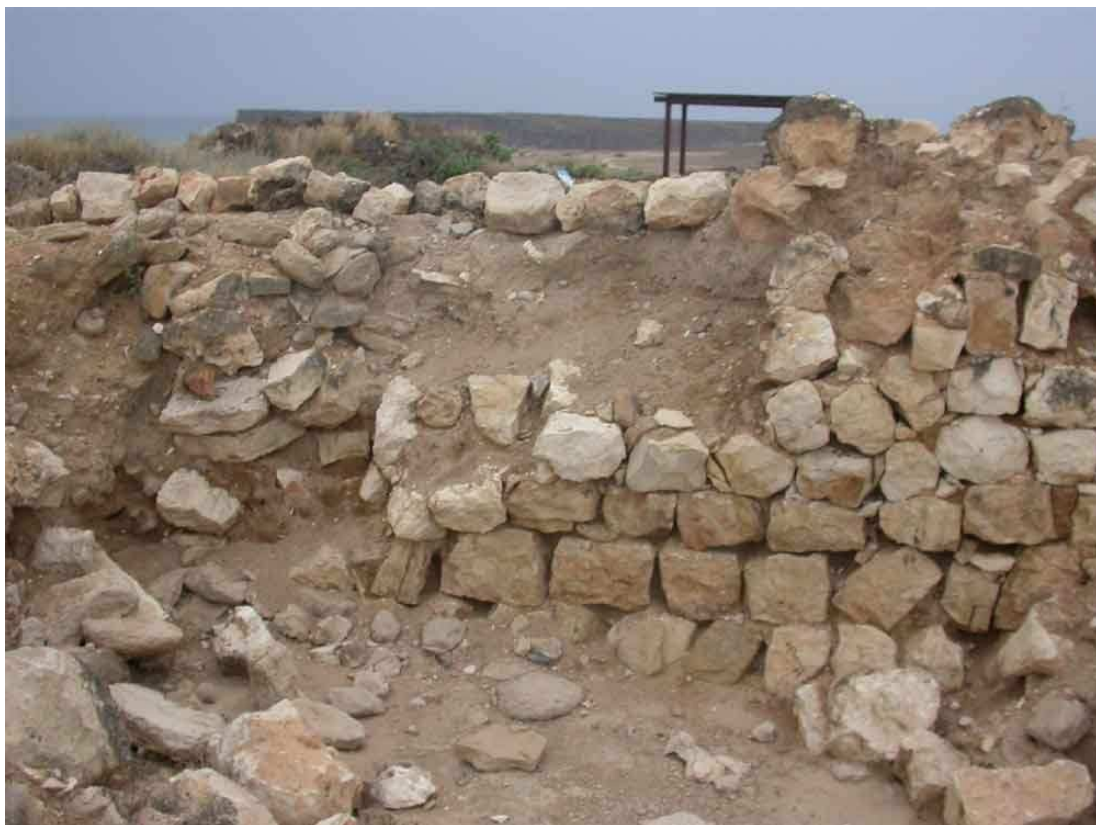
South-eastern part of wall M127 after the rains and before restoration

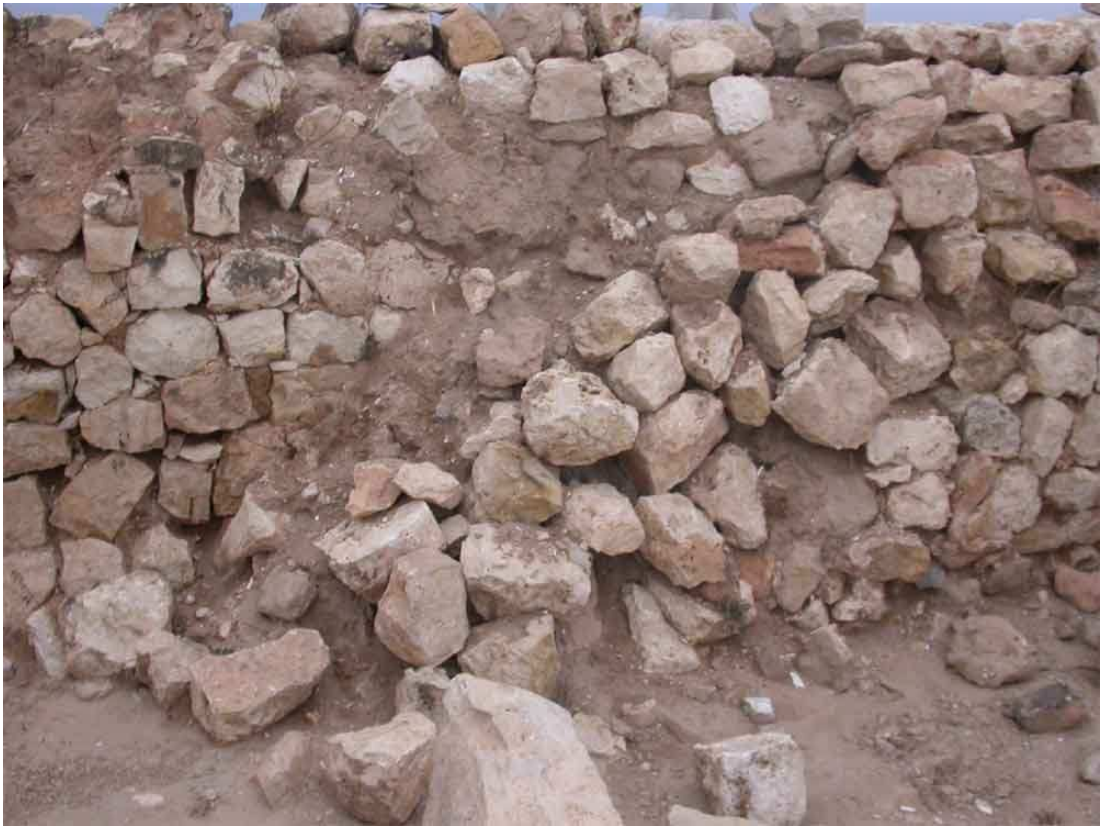
South-eastern parts of walls M127 and M230 after the rains and before restoration

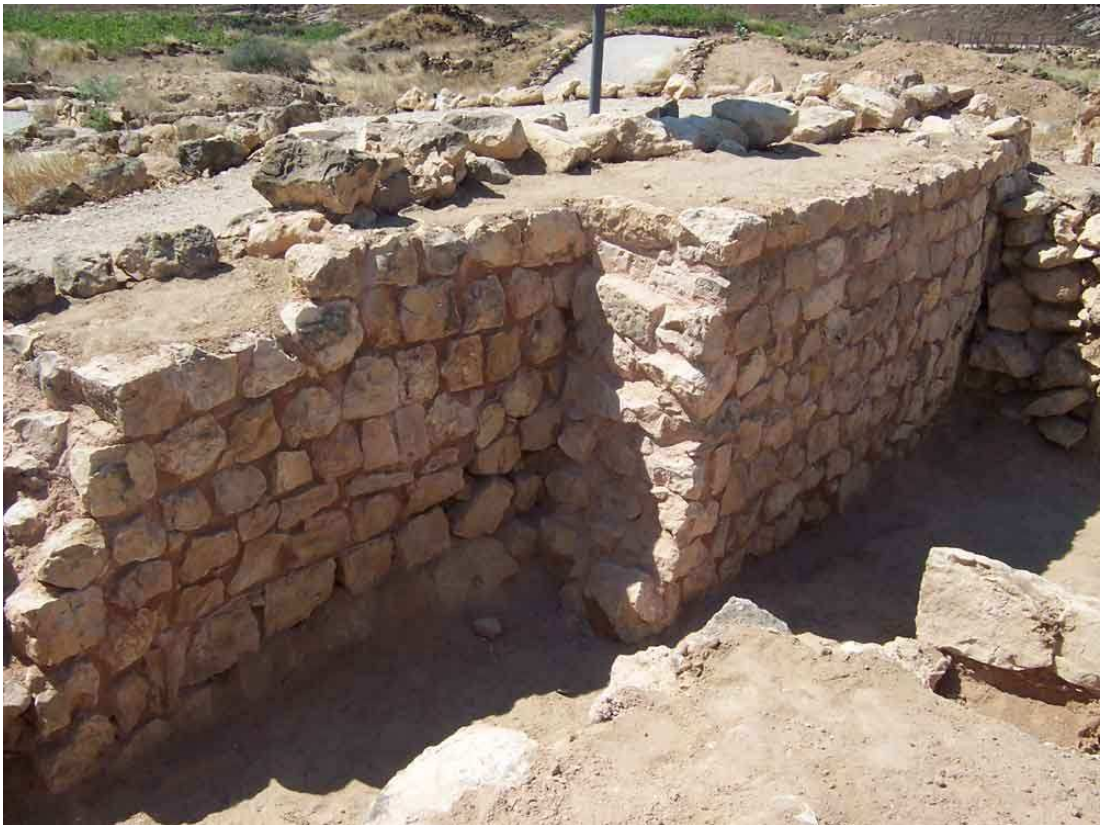
South-eastern part of walls M127 and M230 after restoration

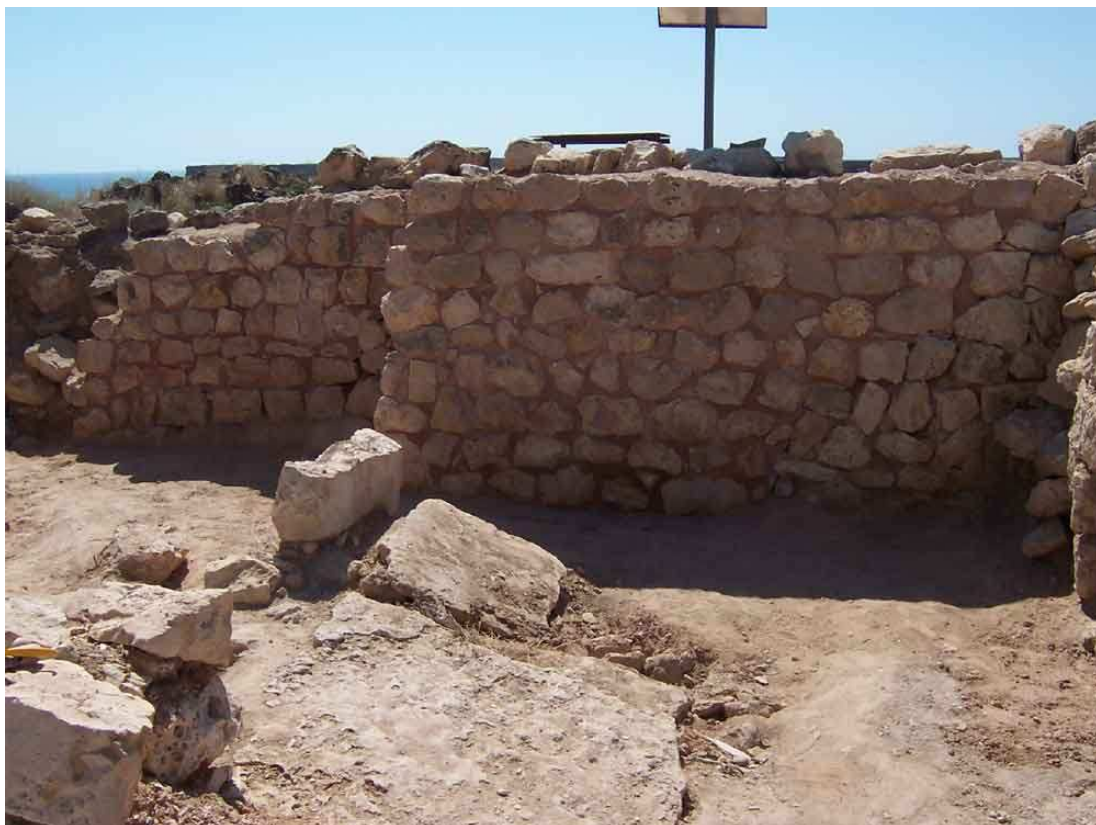
South-eastern parts of walls M127 and M230 after restoration

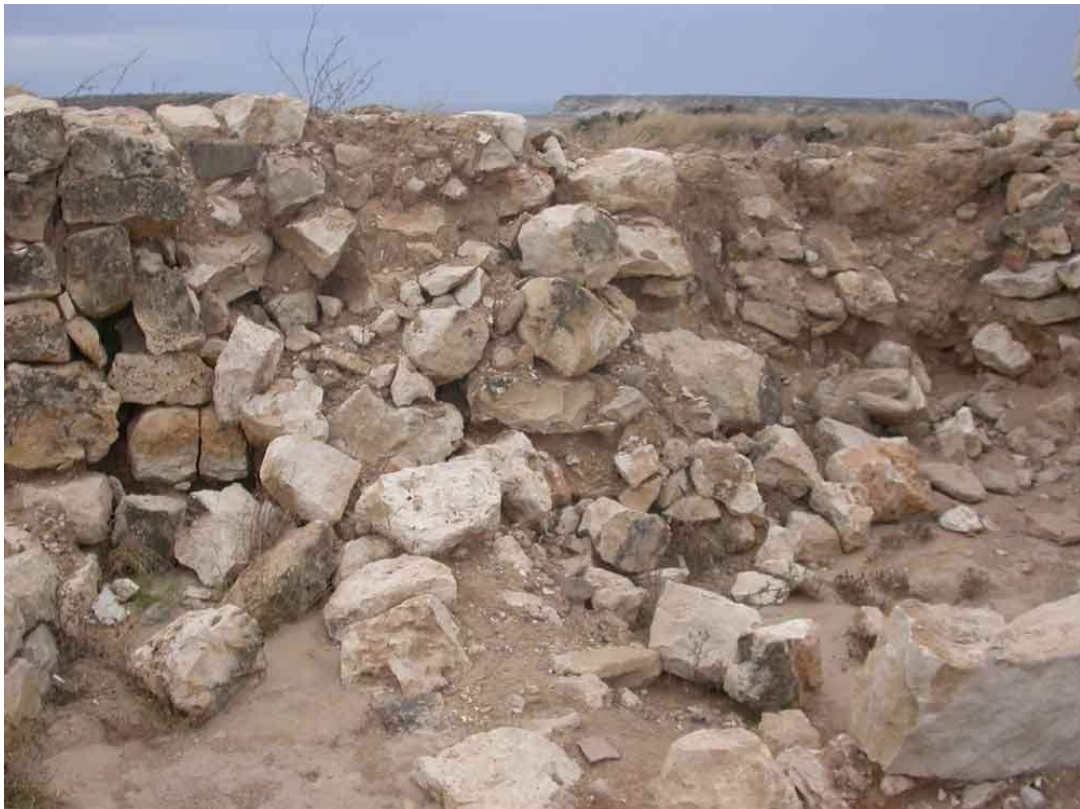
Southern part of wall M101 after the rains and before restoration

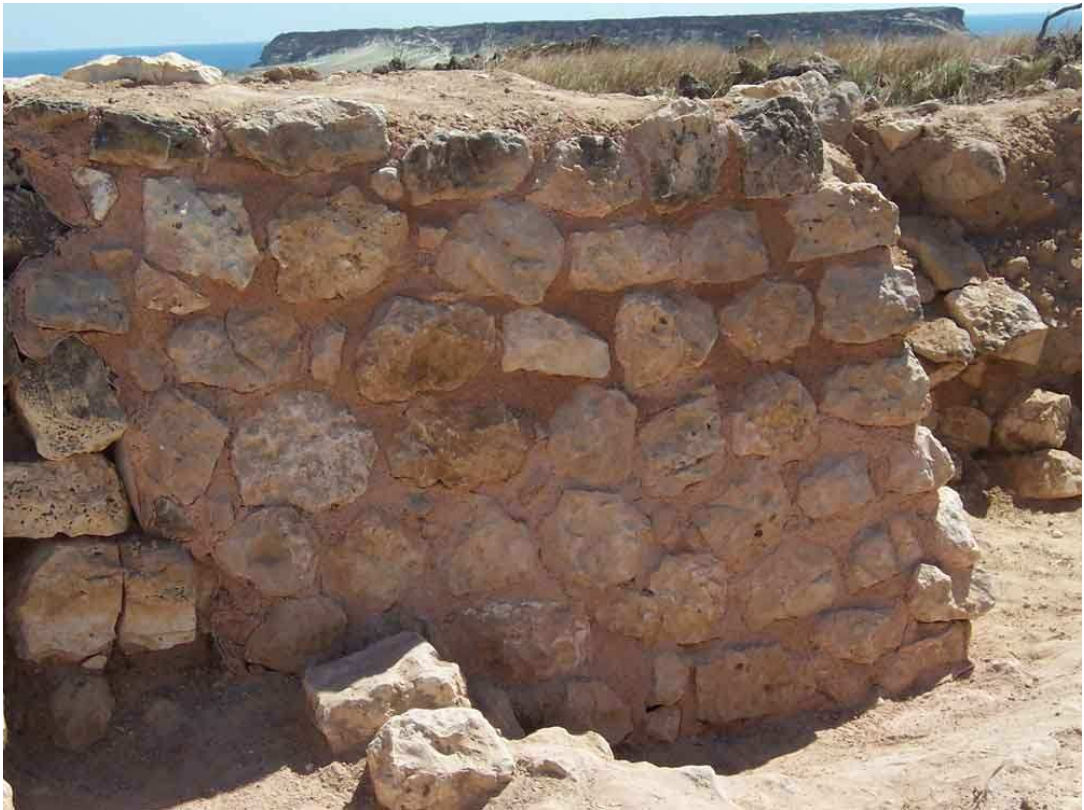
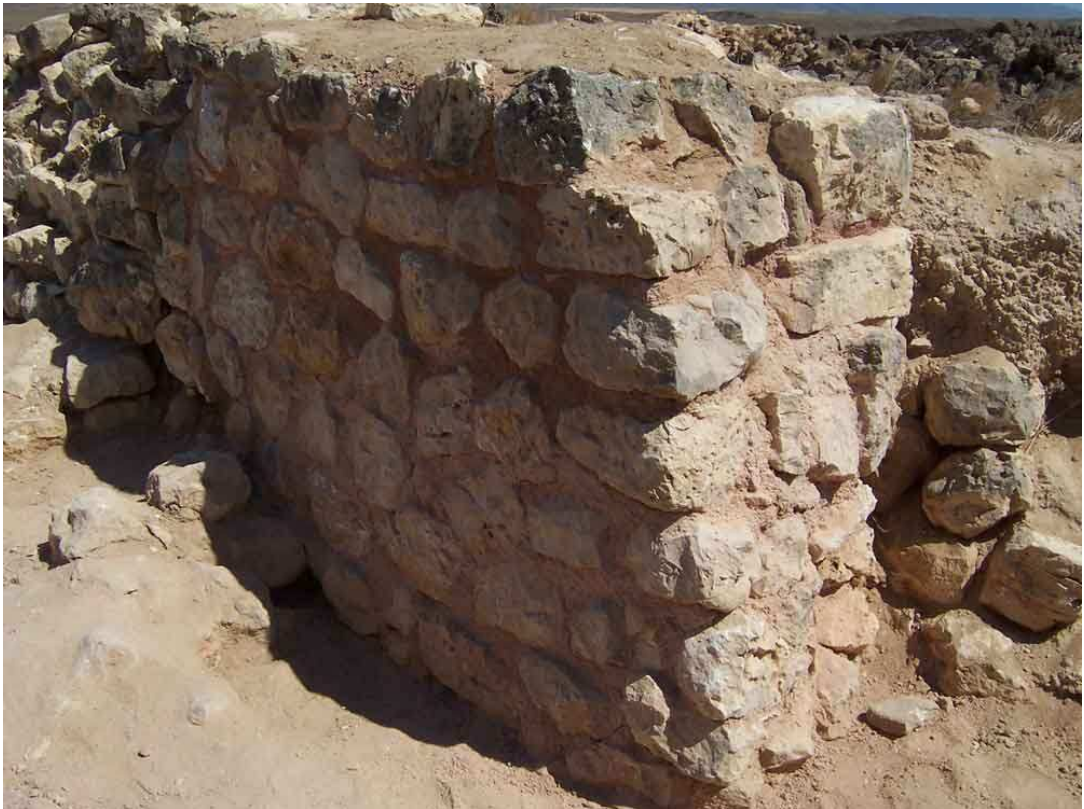
Southern part of wall M101 after restoration

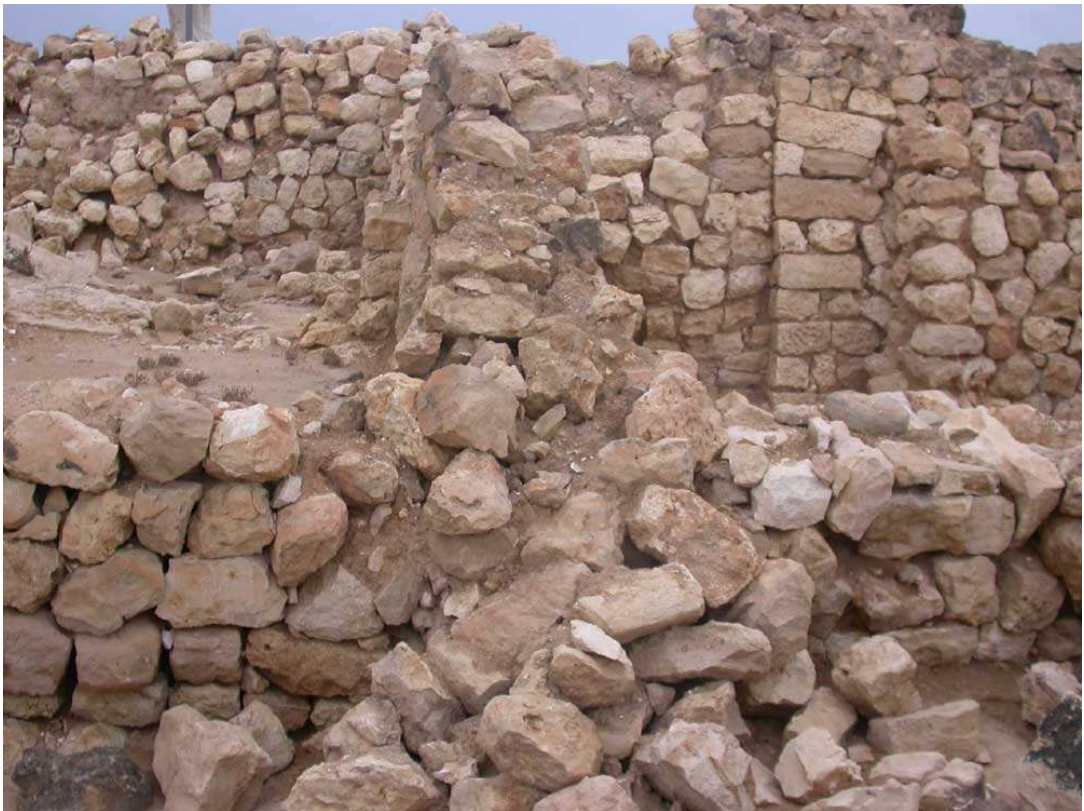
Wall M128 and northern part of wall M144 after the rains and before restoration

The same wall M144 underwent a small collapsing episode near the stair that, from corridor A60 level, leads to room A64a. Here, a short segment of the wall appears to have been built using mudbricks instead of stones. These bricks lay upon two lower rows of stone; this could indicate that mudbricks where utilized to repair an ancient collapse or to wall up a passage, in this case characterized by a raising step. The possibility that the preserved one was actually the original structure of the wall should not be discarded.

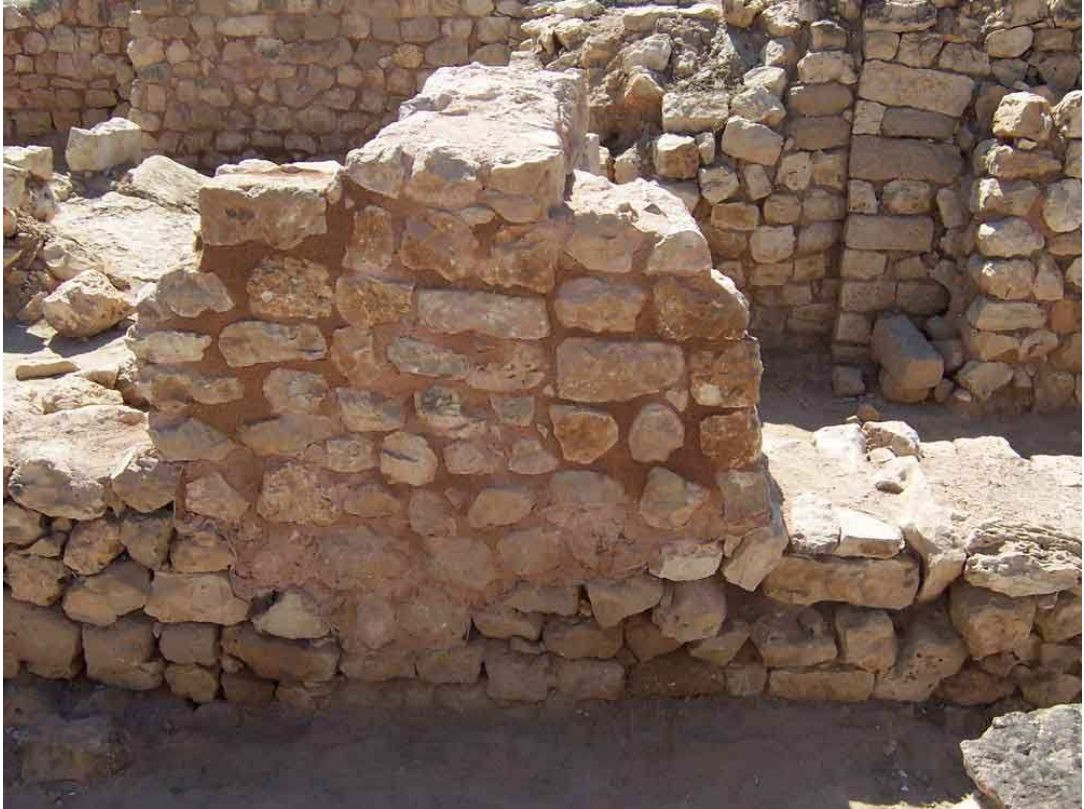
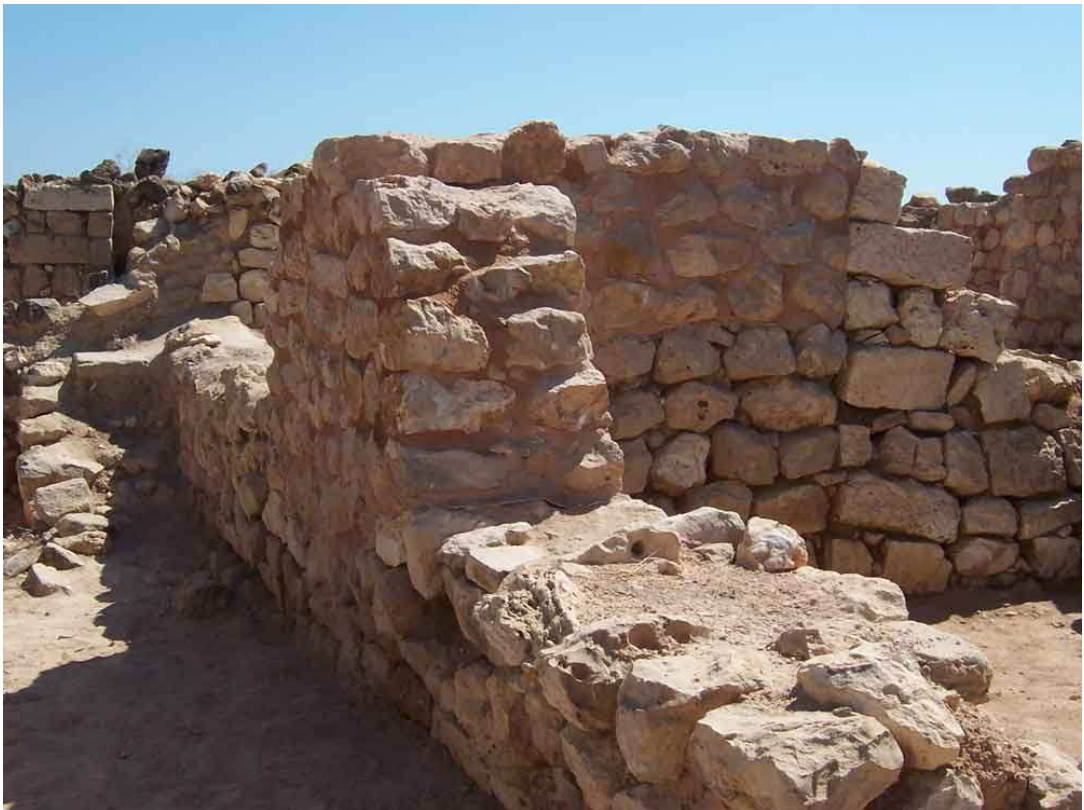
Wall M128 and northern part of wall M144 after restoration

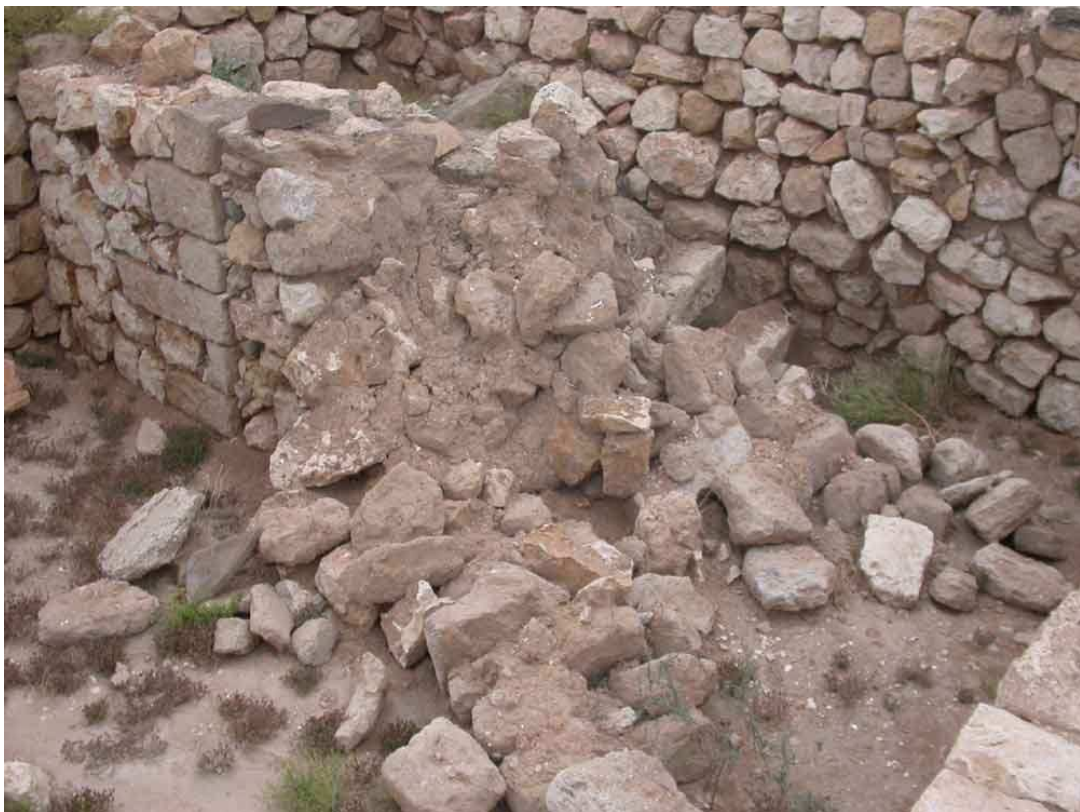
Wall M56 after the rains and before restoration

Otherwise, wall M56, delimiting the stair that leads from A28 level to A31, has been rebuilt using both its original stones and other good ones chosen from other points of the site. In search of a good base to start from, a little sounding has been excavated flanking the wall; no find came to light, but small bone fragments stand to testify that virgin soil have not been reached, or at least that the digging of a thin foundation trench could be hypothesised. This confirms what had already been found during SUM05B campaign, when a deep sounding was carried out along wall M57, in street A45. Here, two layers have been recognized, underlying the wall: a sort of foundation filling set upon mother bedrock, composed of limestone chips, and an upper brown compact loam layer (UU.SS. 168 and 165), a situation that seems to coincide with the one exposed with the sounding in room A28.

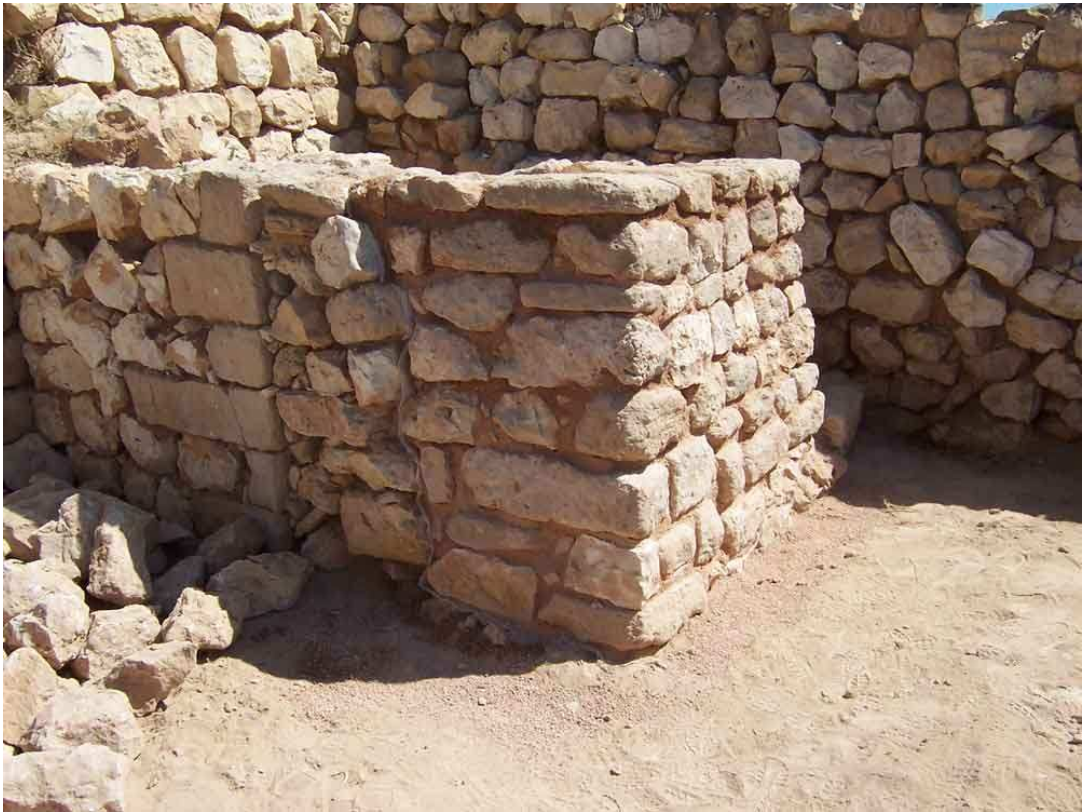
Wall M56 after restoration

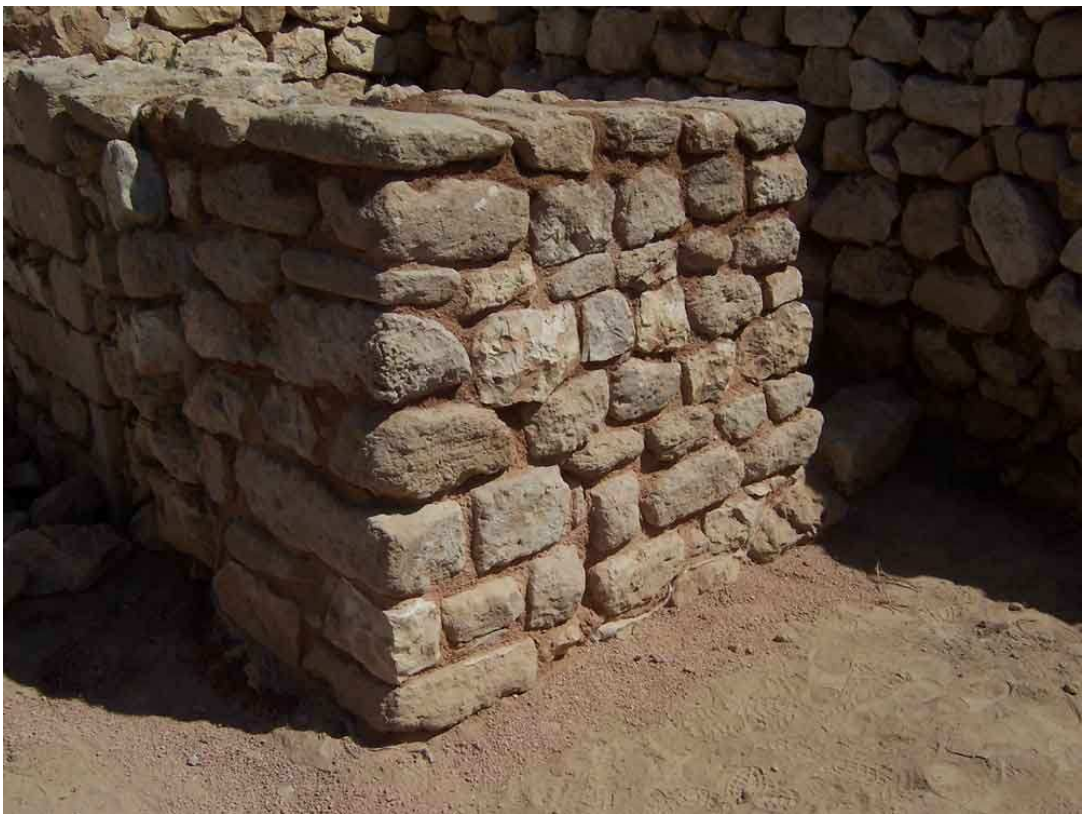
Wall M56 after restoration

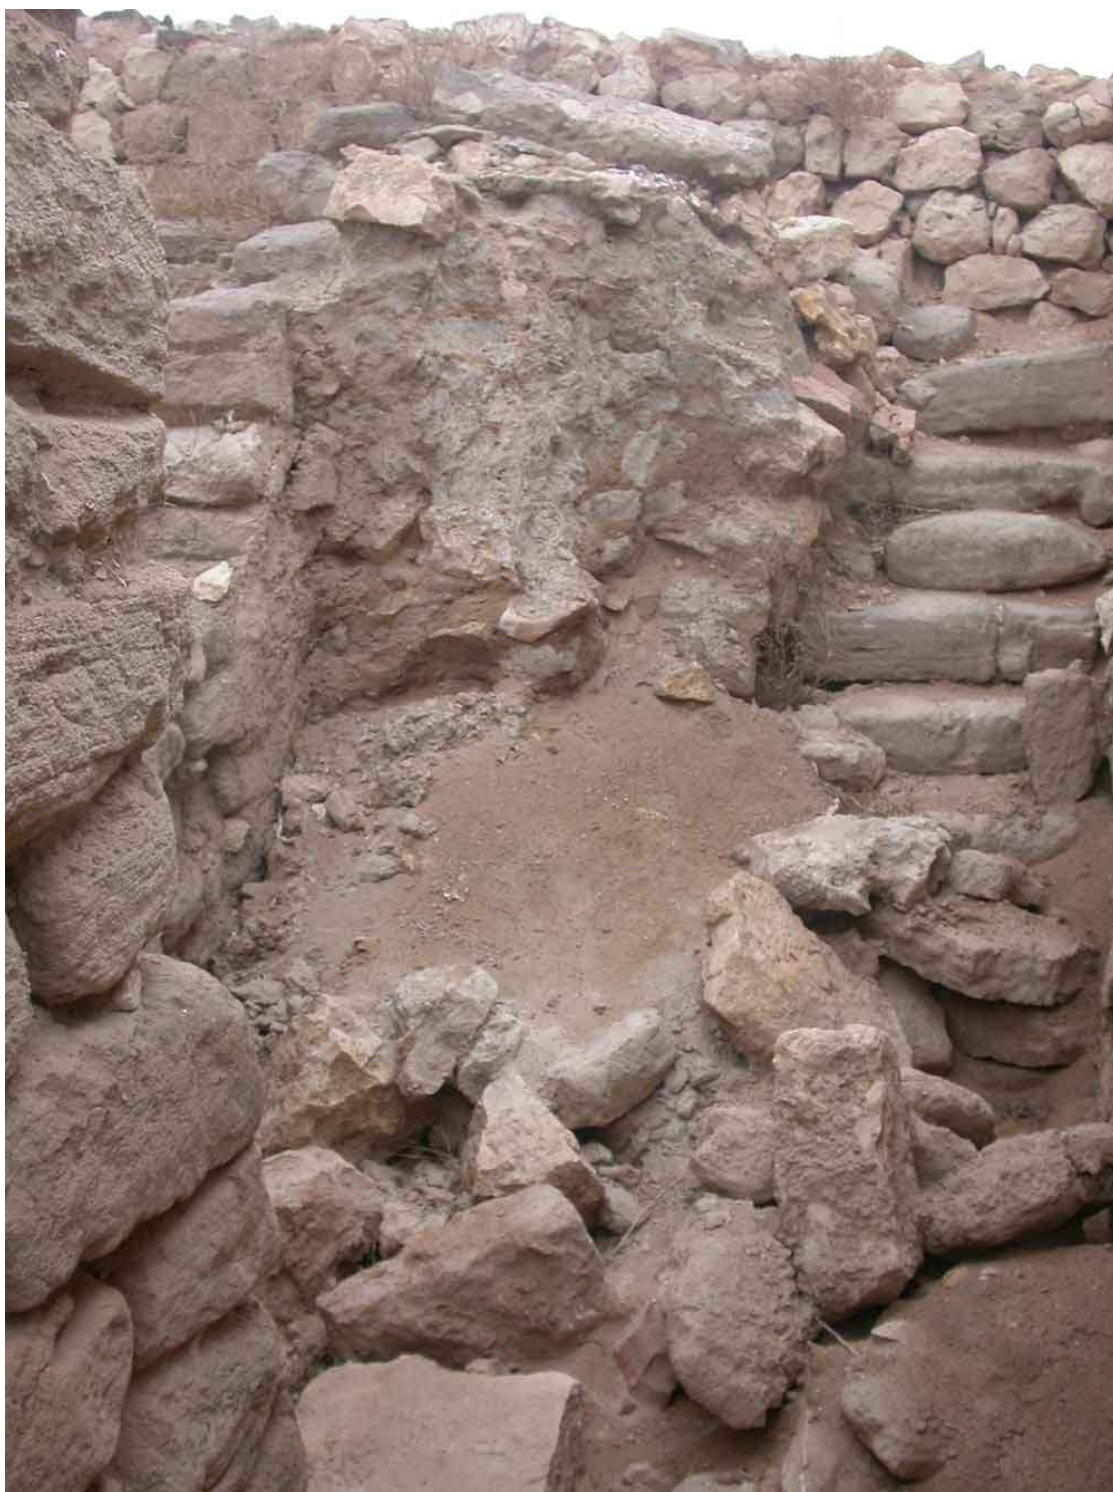
Wall M63 after the rains and before dismantling of collapsed part

The dismantling of wall M63 began on November the 10<sup>th</sup>. The stones and the earth forming the wall body were heaped nearby: no stone was removed from those parts of the wall featuring structural integrity and a proper masonry arrangement.
