**IMTO – Italian Mission to Oman**

**SUMHURAM**

**PRELIMINARY REPORT**

**(SUM07B)**

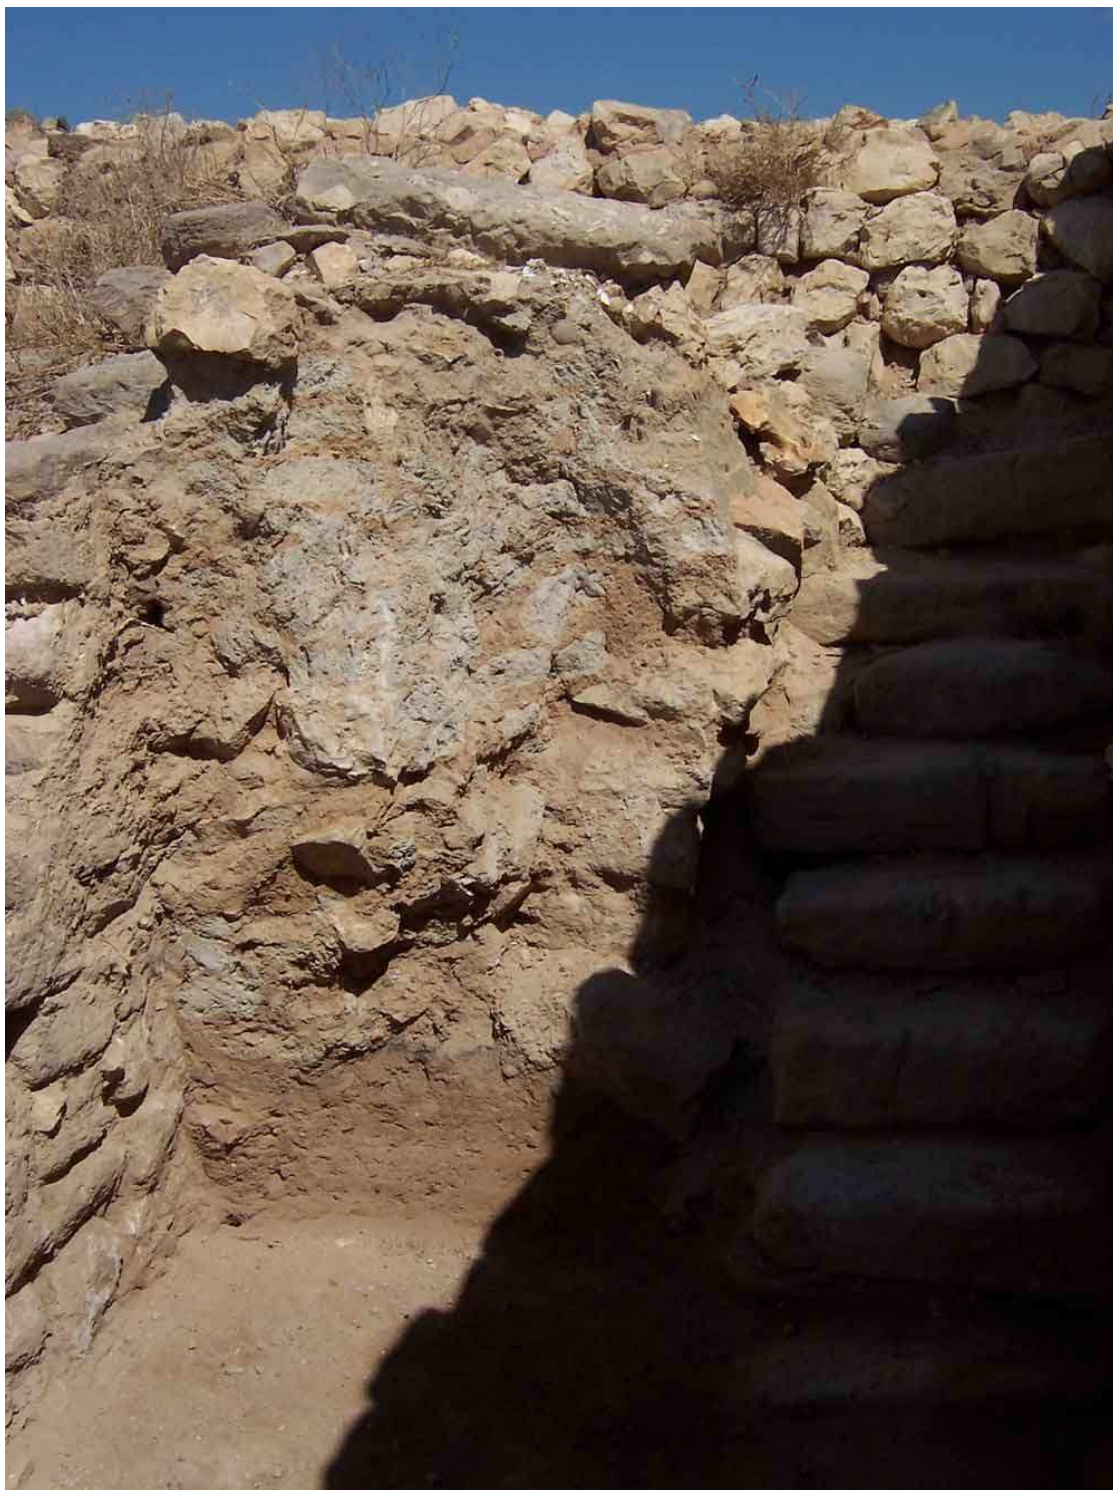
Wall M63 after dismantling of collapsed part

The dismantling of wall M63 began on November the 10<sup>th</sup>. The stones and the earth forming the wall body were heaped nearby: no stone was removed from those parts of the wall featuring structural integrity and a proper masonry arrangement.
