SUMHURAM

Preliminary Report

April – May 2012

**RESTORATION WORKS AT SUMHURAM
(ARCHAEOLOGICAL PARK OF KHOR RORI)
(Sultanate of Oman)
CAMPAIGN APRIL-MAY 2012**

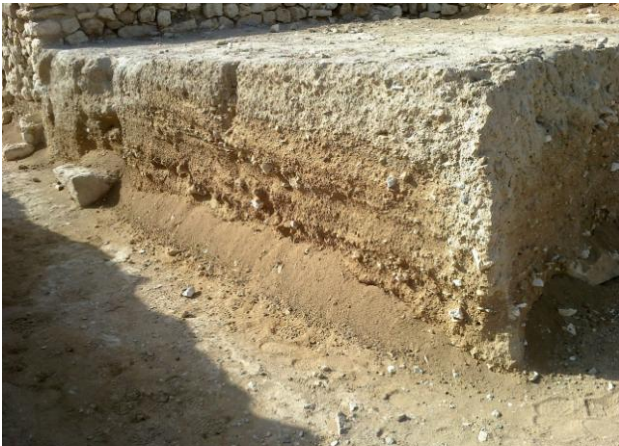
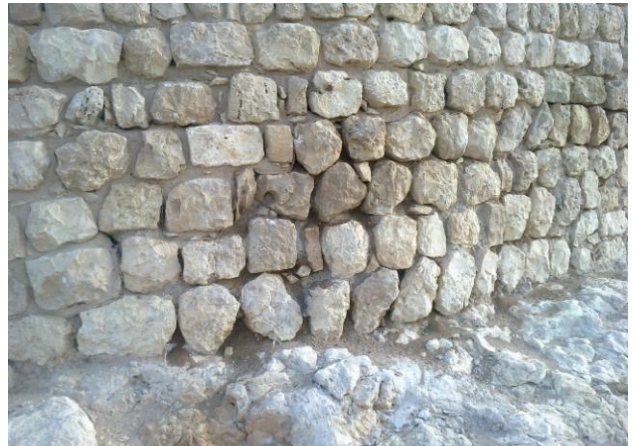
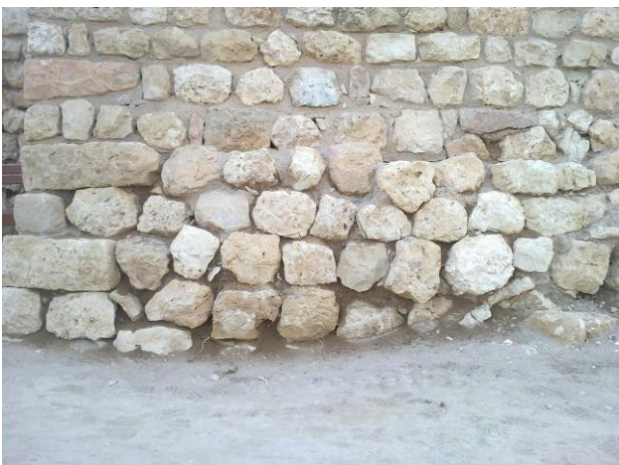
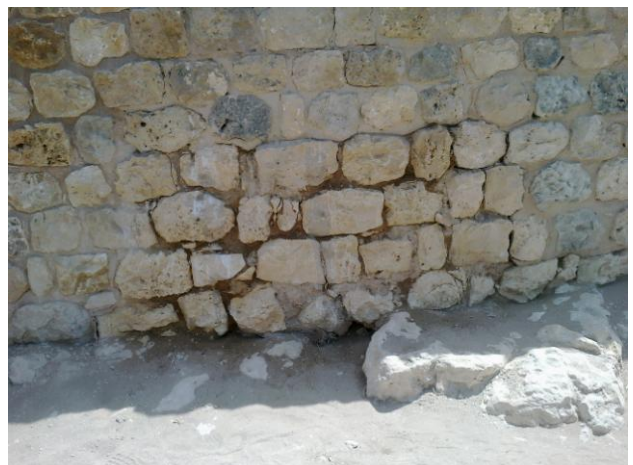
The first day on site we noted a condensation among several parts of the original walls. We took some pictures to show the phenomenon:

We tried to understand this phenomenon never seen during the previous campaign and at last we assumed the following:

- a) The condensation is due to the delta between the inside and outside temperature and to the humidity of the incoming raining season;
- b) The detachment of the ground from the external surface of the ground among the stones is due to the sun that dries the external film of ground and to the wind that dusts the ground in deep between the stones.

This fact day after day will leave a gap between the stones and will determine the collapse of the wall itself.

Our suggestion is to clean the gap between the stones and to put some mortar in deep between the stones in order to avoid the detachment of the superficial ground. This solution don't avoid the internal condensation but can block the erosion of the inner filling of the walls.

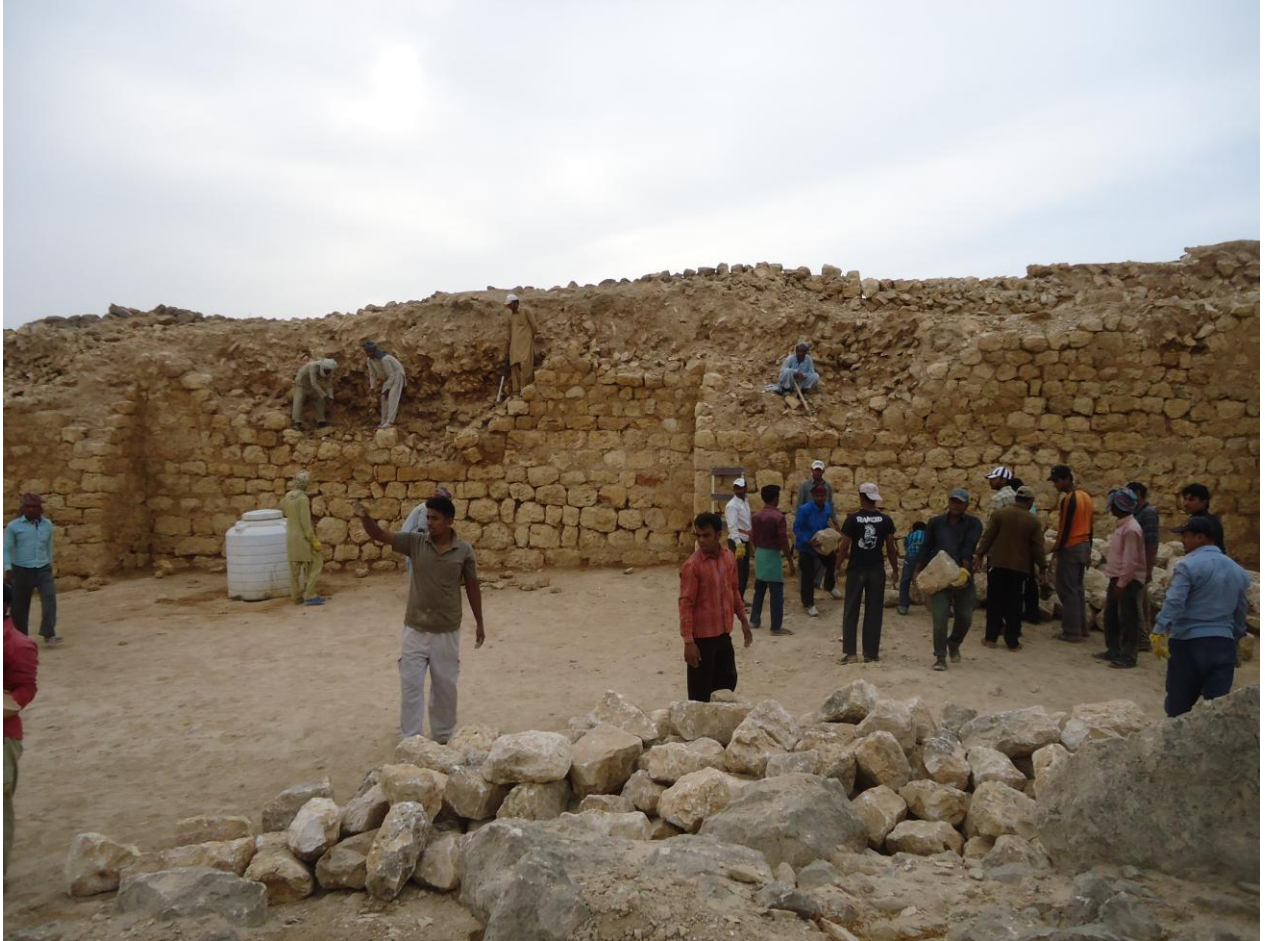
Rising up of the walls M75 – M117

The situation of the existing walls M75 – M117 were as you can see in the picture below, took on 14th April 2012.

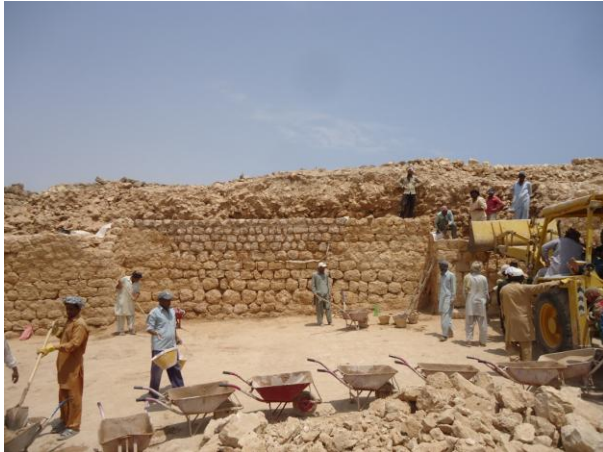
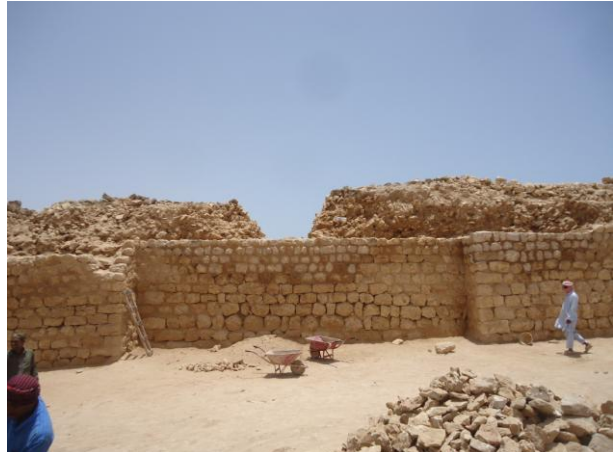
Sequence of photos on the walls M75 – M117 – up to 27th April 2012

After the cleaning of the above wall that faces to the temple, we decided to stop the works due to the fact that we have been asked to concentrate our efforts in finishing all the works at the southern side of the city walls because they want to construct the new paved path before the raining season. Therefore we moved the team to the wall M479 – M469 and M477. We will restart the works on these two walls, after the finishing of the above mentioned integration of missing walls.

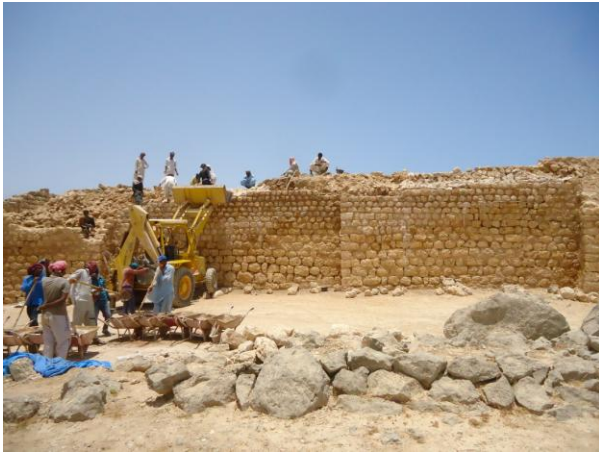
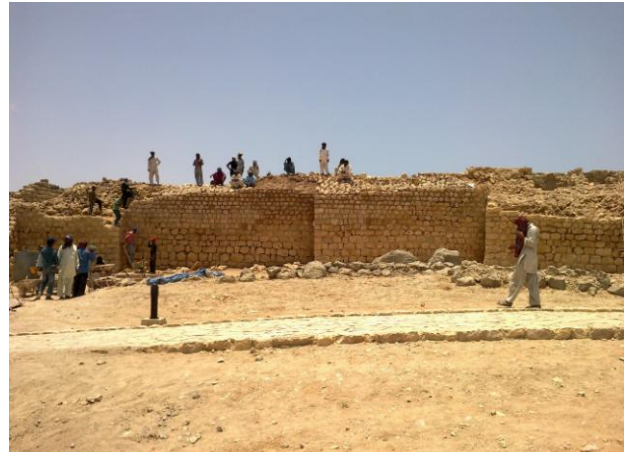
Sequence of photos on the walls M75 – M117 – up to 16th May 2012

This walls have been finished on 16th May 2012

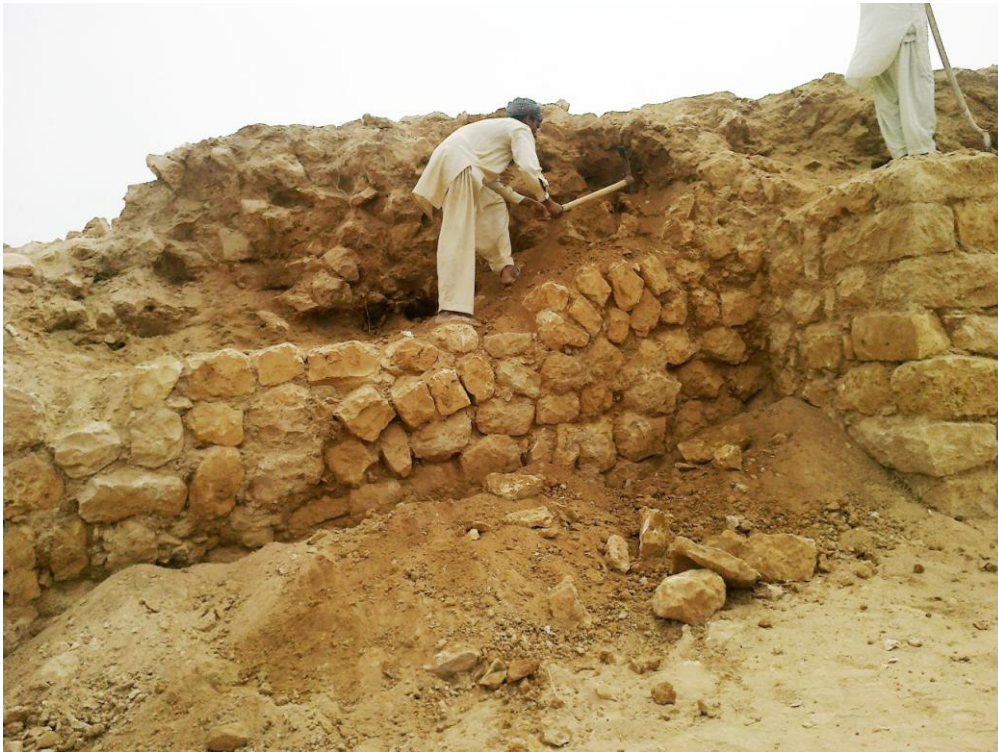
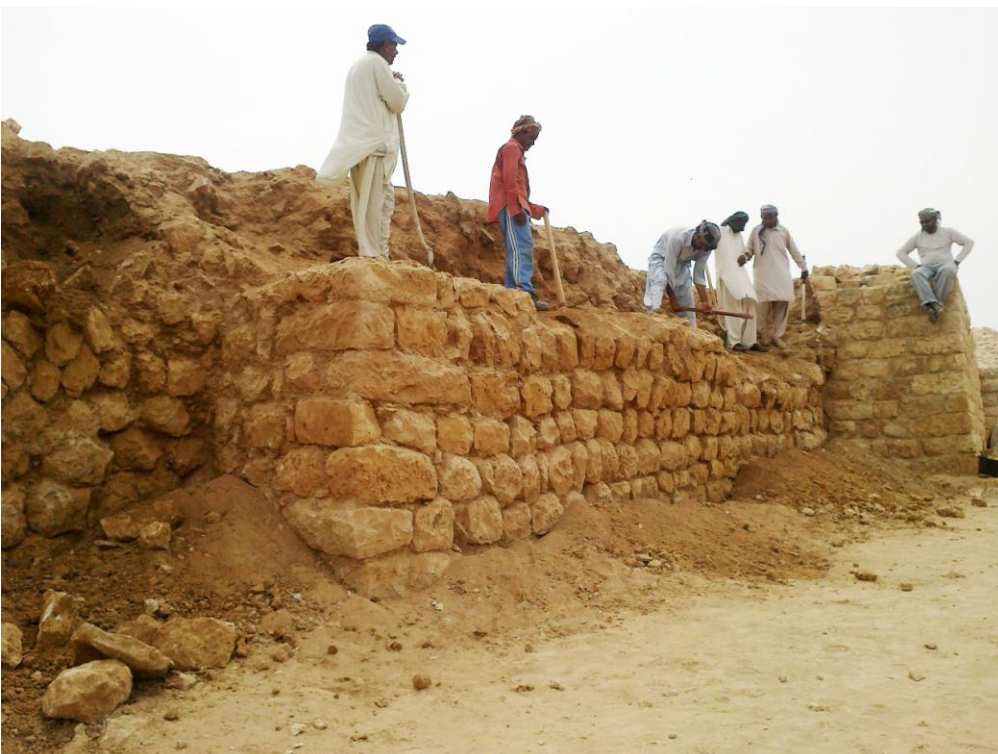
Restoration of the walls M545 – M505

The situation of the existing walls M545 – M505 were as you can see in the picture below, took on 15th April 2012. After the dismounting of the modern staircase, happened during last campaign SUM12A, the state of preservation was as shown below.

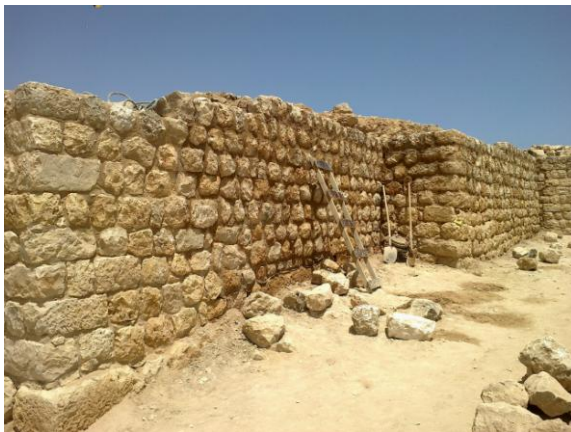
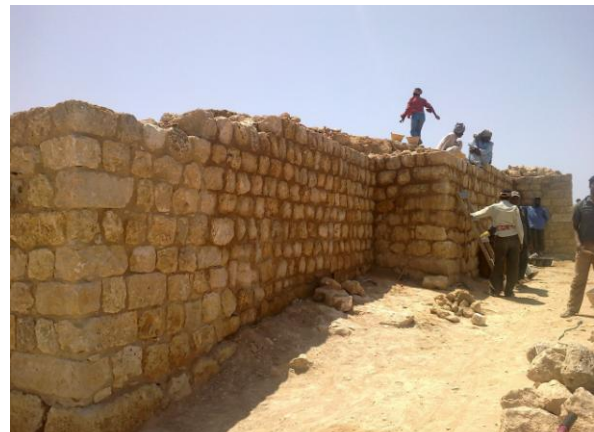
Sequence of photos on the walls M545 – M505 – up to 27th April 2012

These two city walls have been finished on 03rd May 2012.

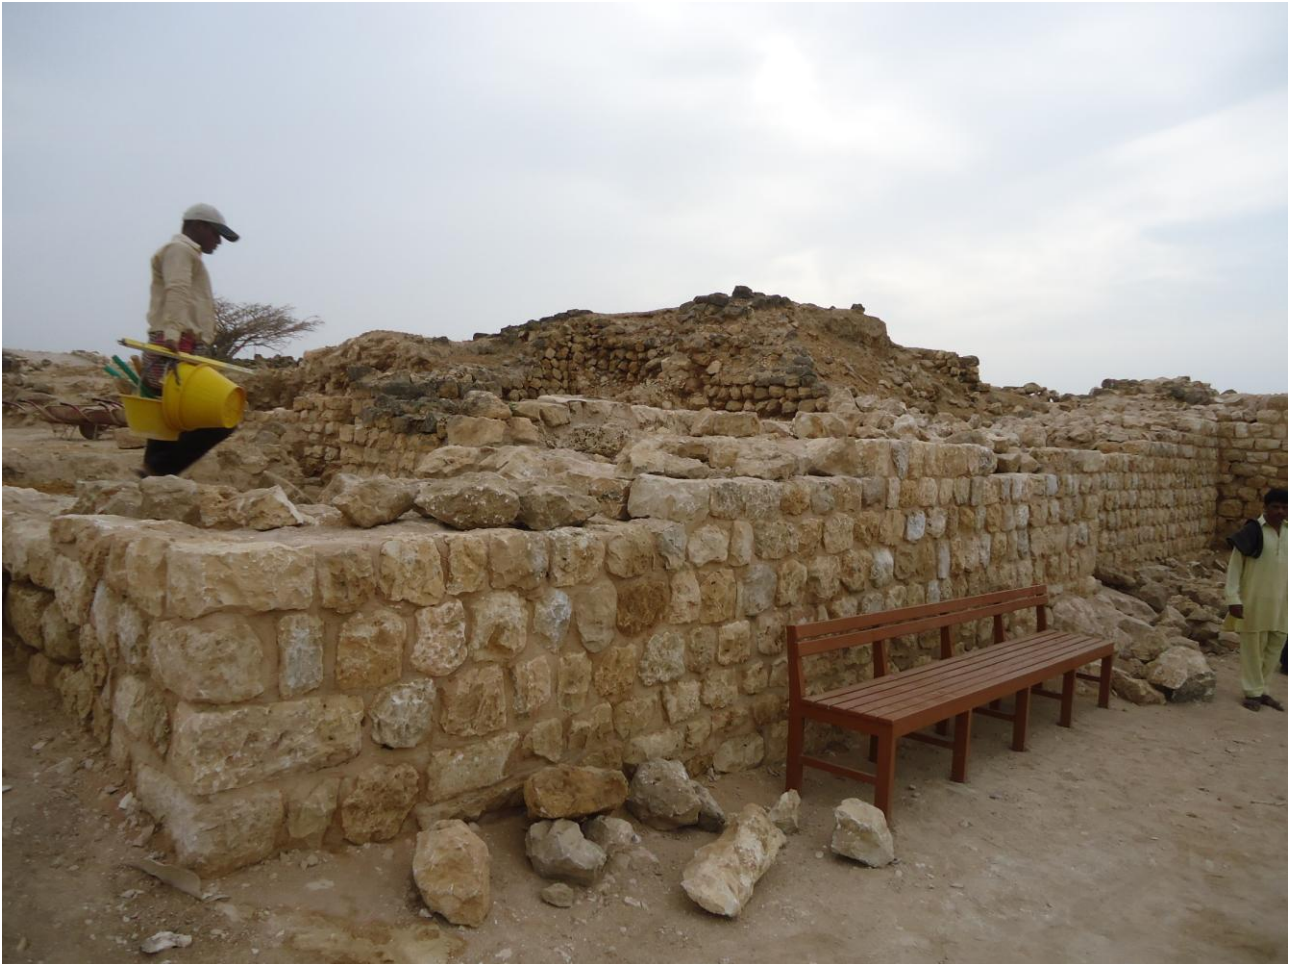
Rising up of the walls M350 – M351 – M477

The situation of the existing walls were as you can see in the following picture below, took on 15th April 2012.

The M350 – M351 and integration of M477 have been finished on 08th May 2012.

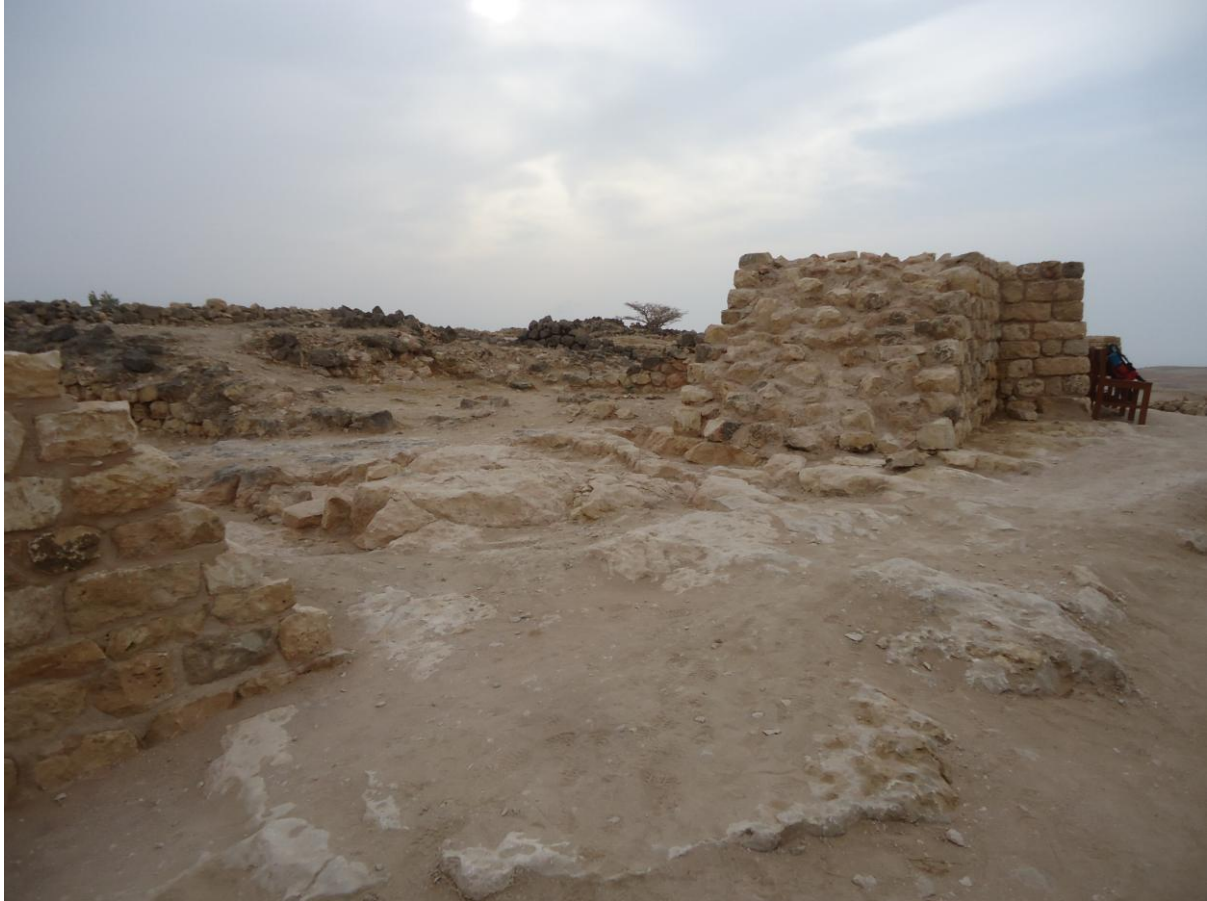
Integration of missing masonry of the walls M497 – M478

The situation of the existing walls were as you can see in the following picture below, took on 15th April 2012.

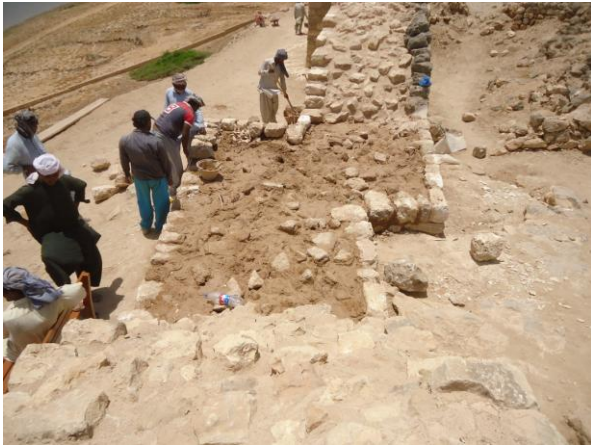
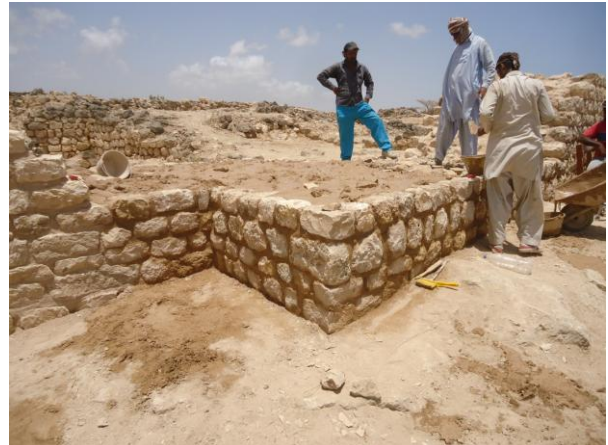
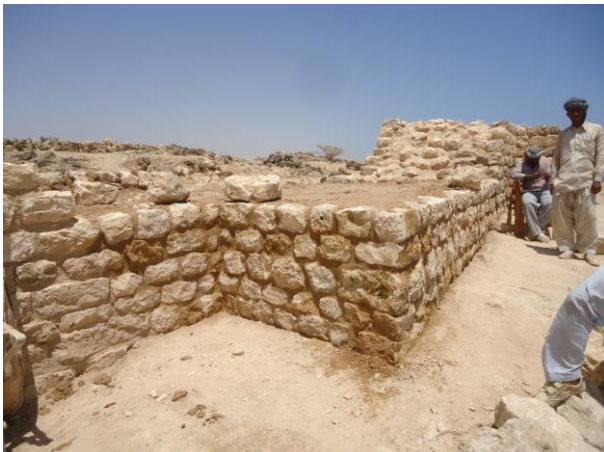
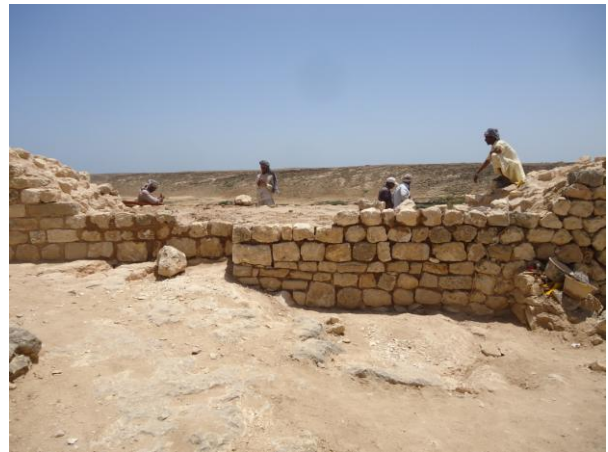
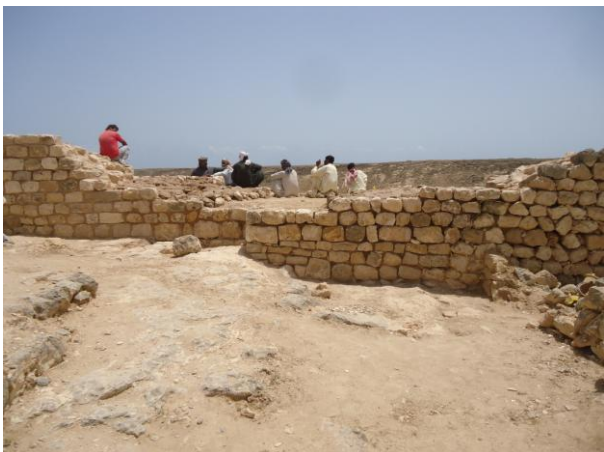
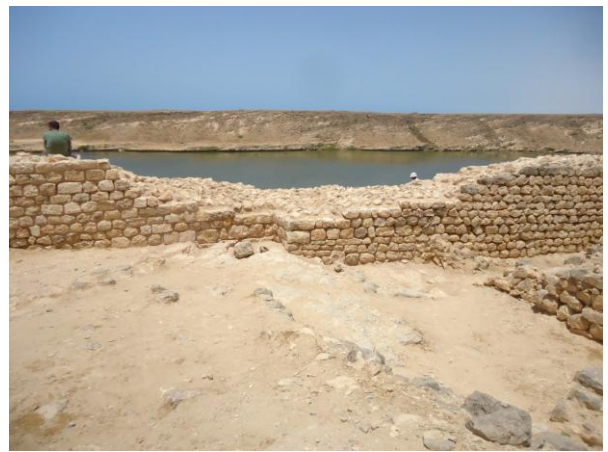
Sequence of photos on the walls M497 – M478 – up to 04th May 2012

These city walls have been finished on 08th May 2012.

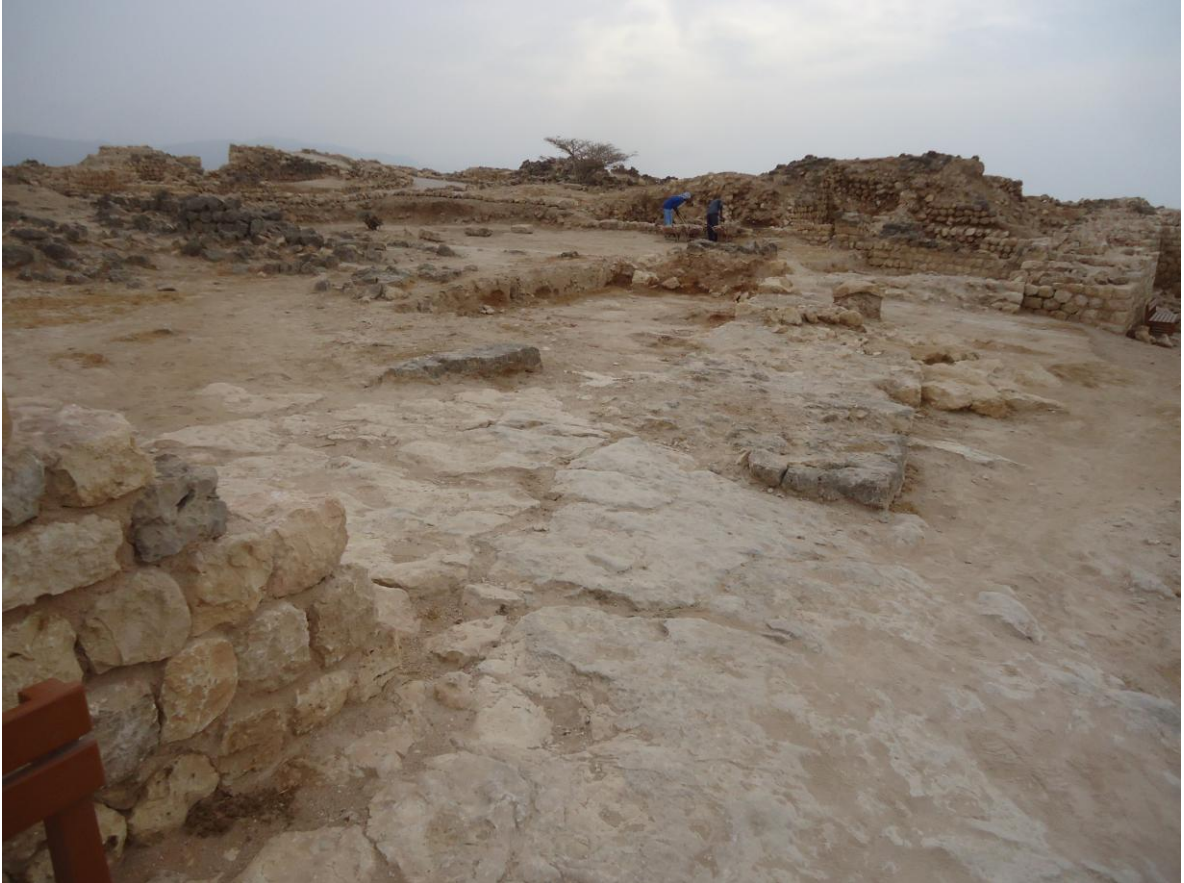
Integration of missing masonry of the walls M479 – M469

The situation of the existing walls were as you can see in the following picture below, took on 15th April 2012.

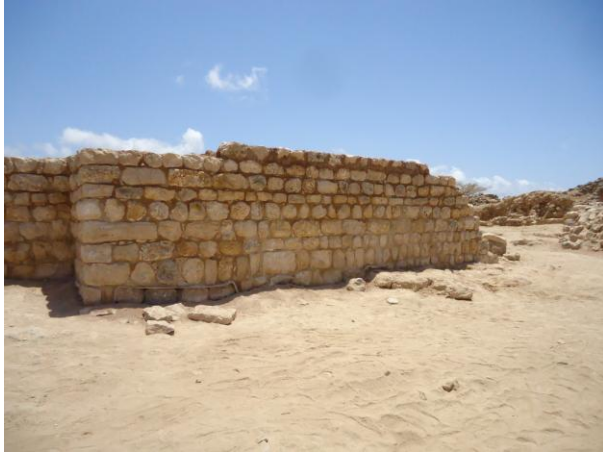
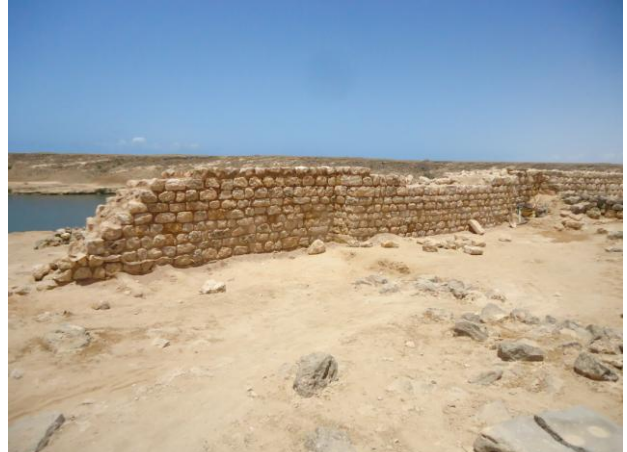
Sequence of photos on the walls M479 – M469 – up to 17th May 2012

This walls have been finished on 17th May 2012

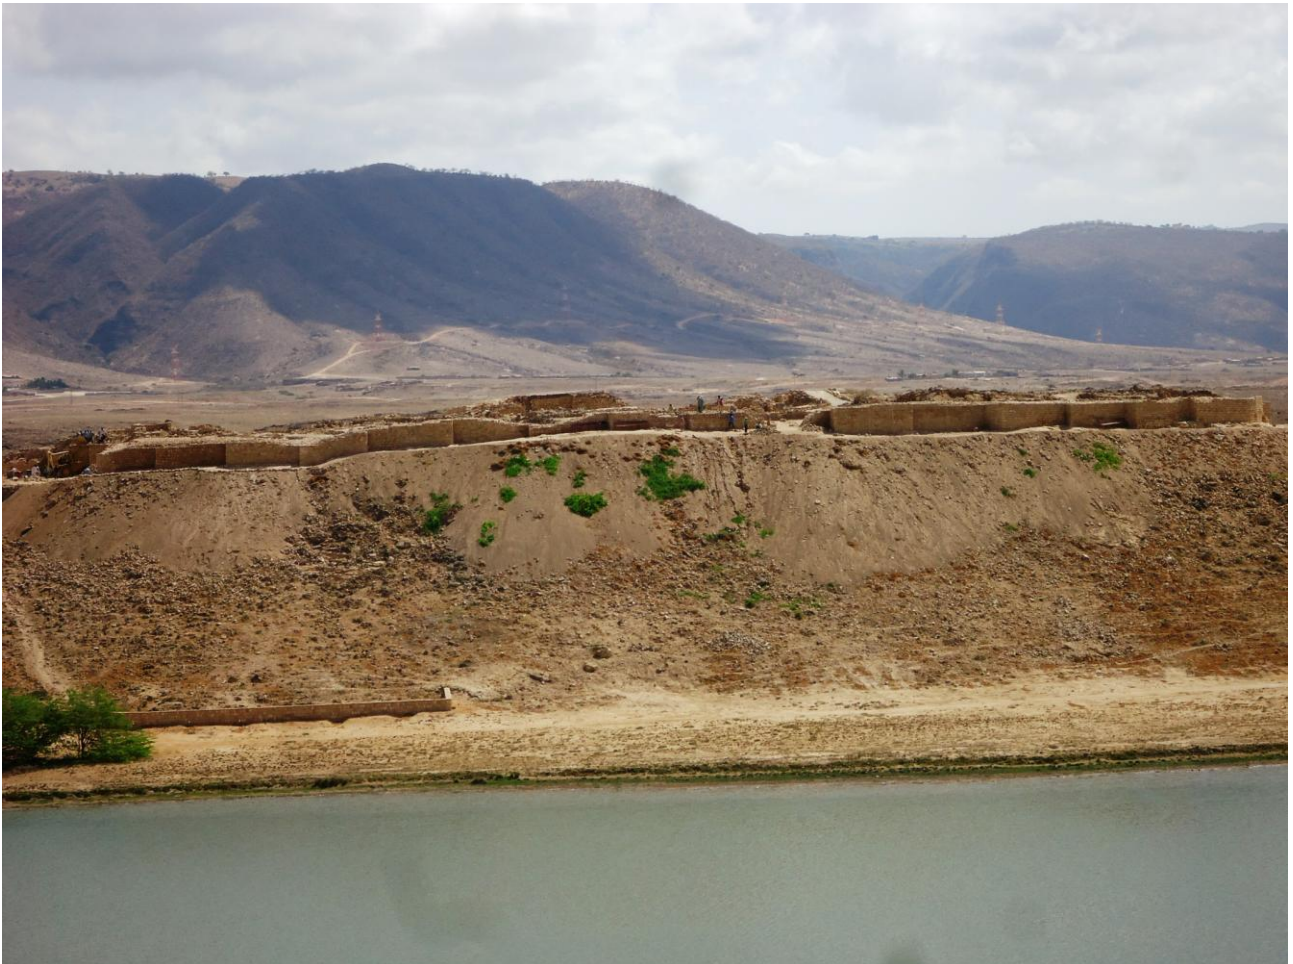
On the 14th May 2012, after the completion of the required works, we took a picture from the other side of the lagoon at the southern side of the city.

As you can see on the picture below, the right side of the city walls appear too horizontal:

Therefore we decided to rise up the wall M206 located in the middle part of that right side. We started the works keeping in mind that we had to finish before leaving on 18th May 2012. So only 3 days left, but enough to rise the wall with two rows of stones as shown on the pictures below.

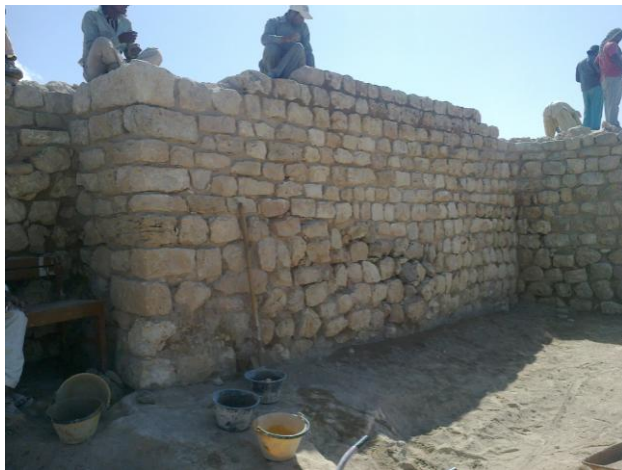
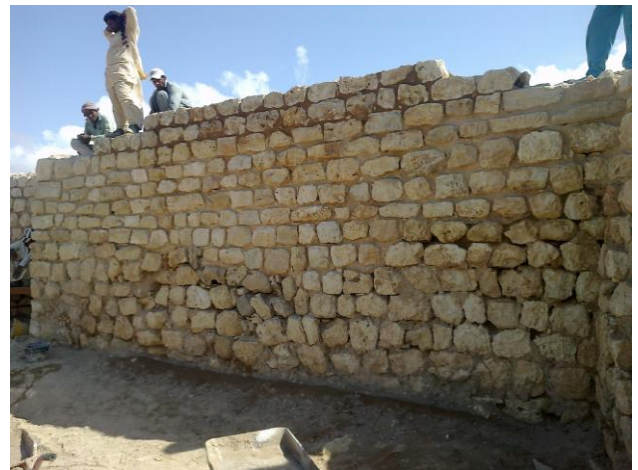
Sequence of photos on the walls M206 – up to 17th May 2012

This work has been finished on 17th May 2012.

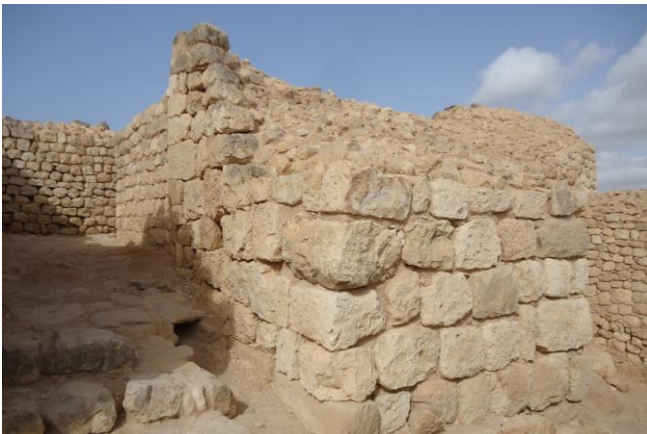
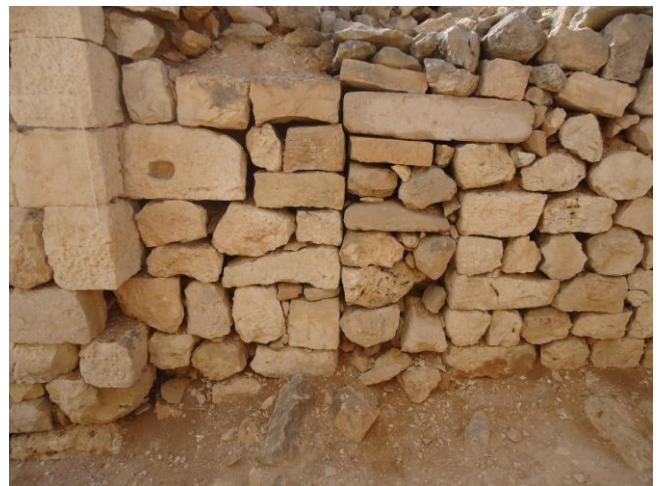
As you can see on the pictures below, the original portion of the wall, the lower part of the wall, is in bad state due to the erosion of the inner filling caused by the sun and the wind actions, as the other part of the walls we were talked about at

the beginning of this report. Due to this fact, some of the big stones, close to the corner, are broken but still in place.

Considering the reconstruction of this wall, it means that we need of an auto crane having 20 meter in wing and 1 ton at the end of the wing standing for all the time in front of the main entry. We need this auto crane for dismounting and replacing all the stones. The other problem is the dimension of the stones that we have to replace. These stones must have the same big dimension as those broken to replace. Therefore we suggest to keep the wall as it is, consolidating the lower part of the original stones by the means of mortar injection. We suggest to do the same for the wall M4, at the corner below the stone with the epigraph, and for the wall M14 on both sides of the entrance of the postern gate. You can have more details of what we are talking if you look on the below plan:

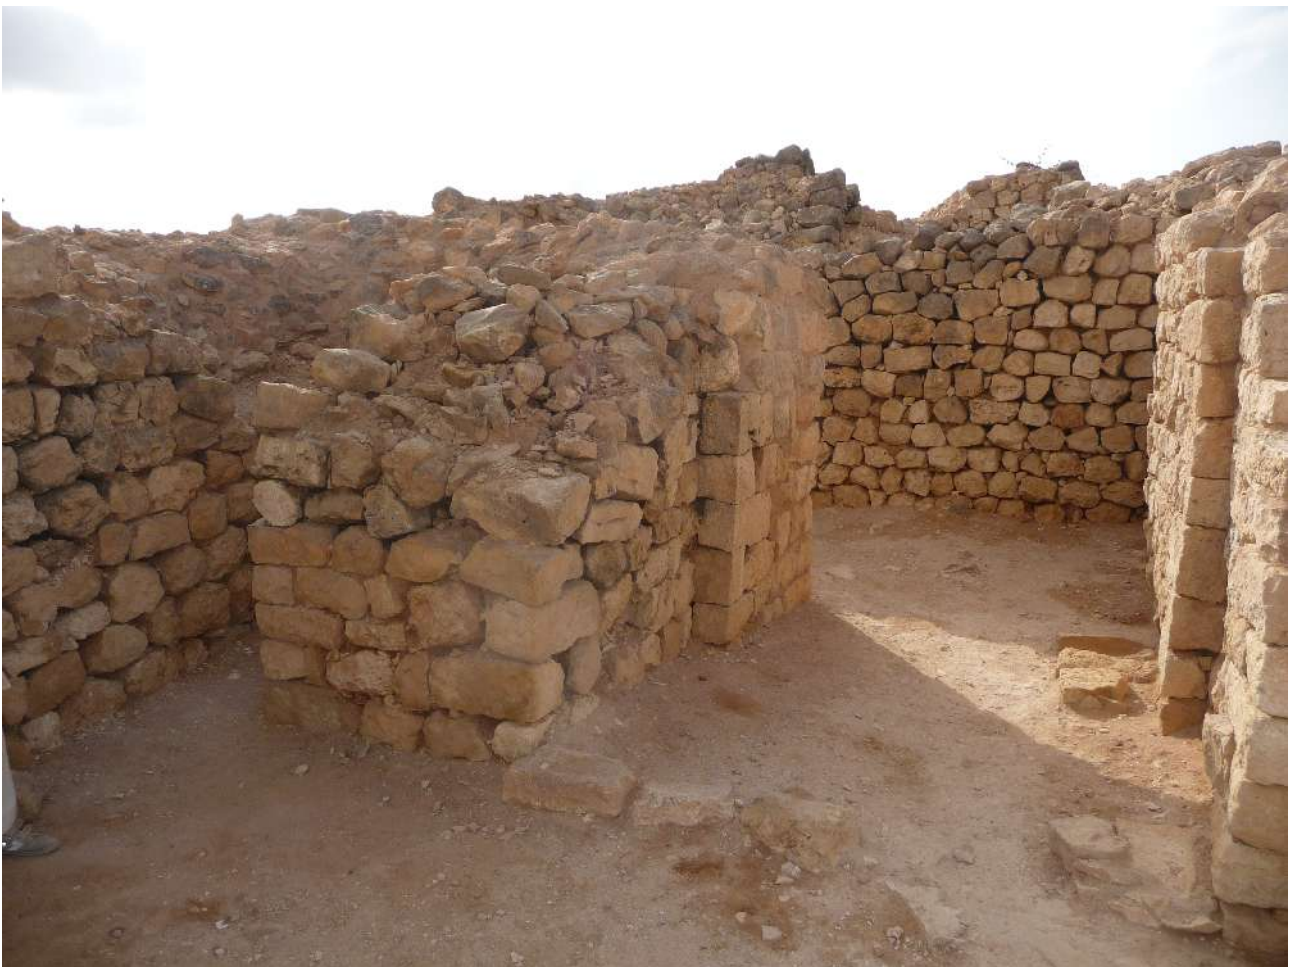
The restoration of M7 wall started the 5th of May with the check of the stones and the fractures. As usual I tried to keep in place more stones I can, in order to preserve the original shape and materials. The side of the wall close to the main entrance needed to be dismantled and reinforced. The removed stones were stored close to the area. To make the wall stable it was necessary to rebuild it on the existing solid lower row which is built on the original level and covered with geotex. The other side of the wall was in better state of preservation: only few stones needed to be replaced. The criteria for the composition of the mortar was the same of the last SUM12A campaign.

The 9th of May the wall M7 was completed.

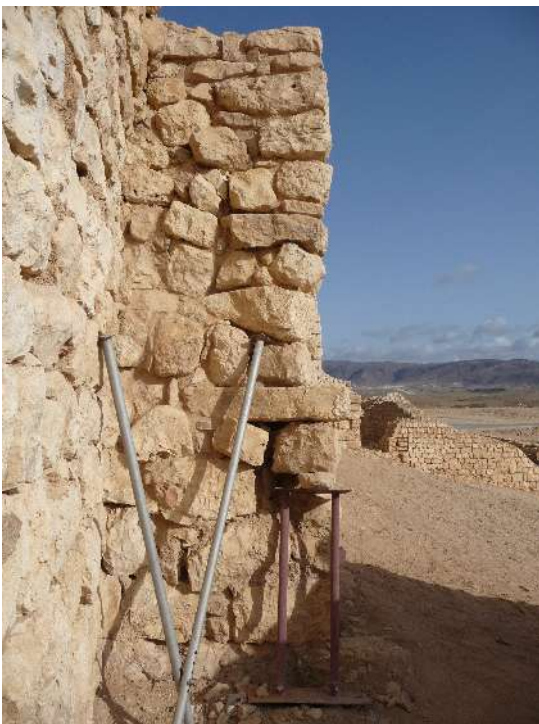
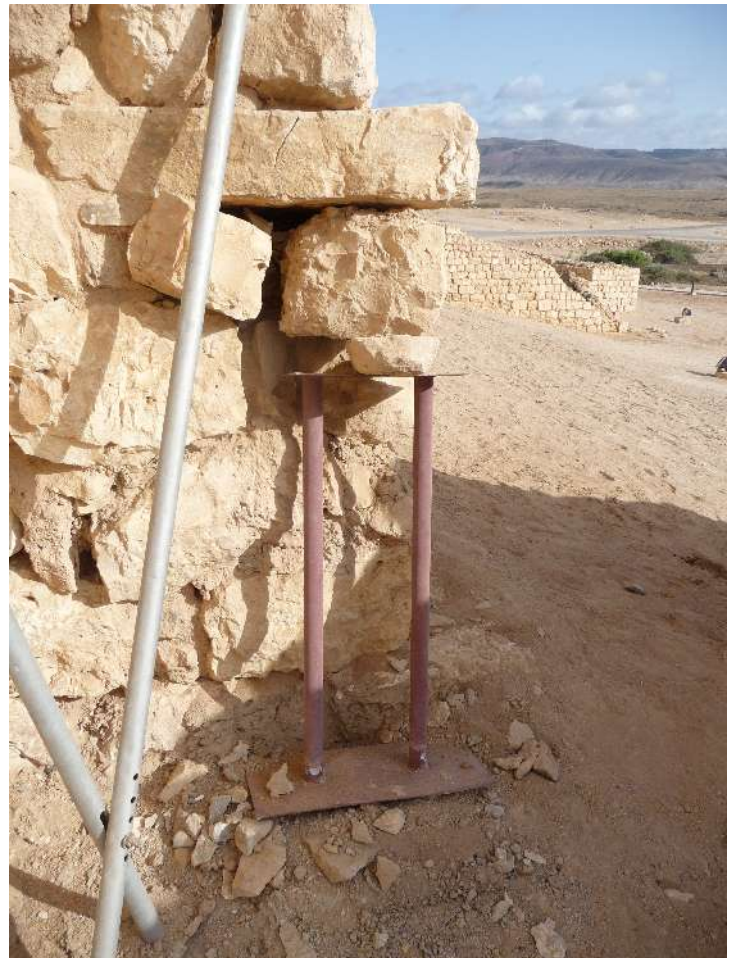
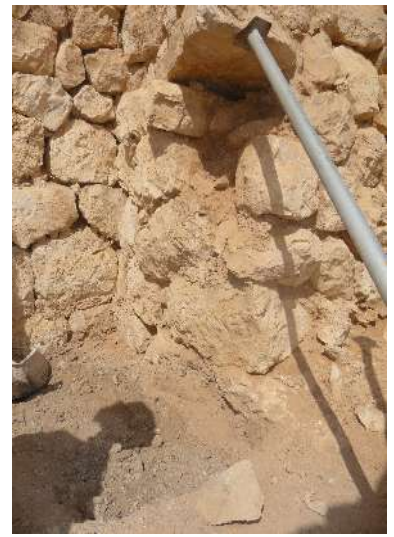
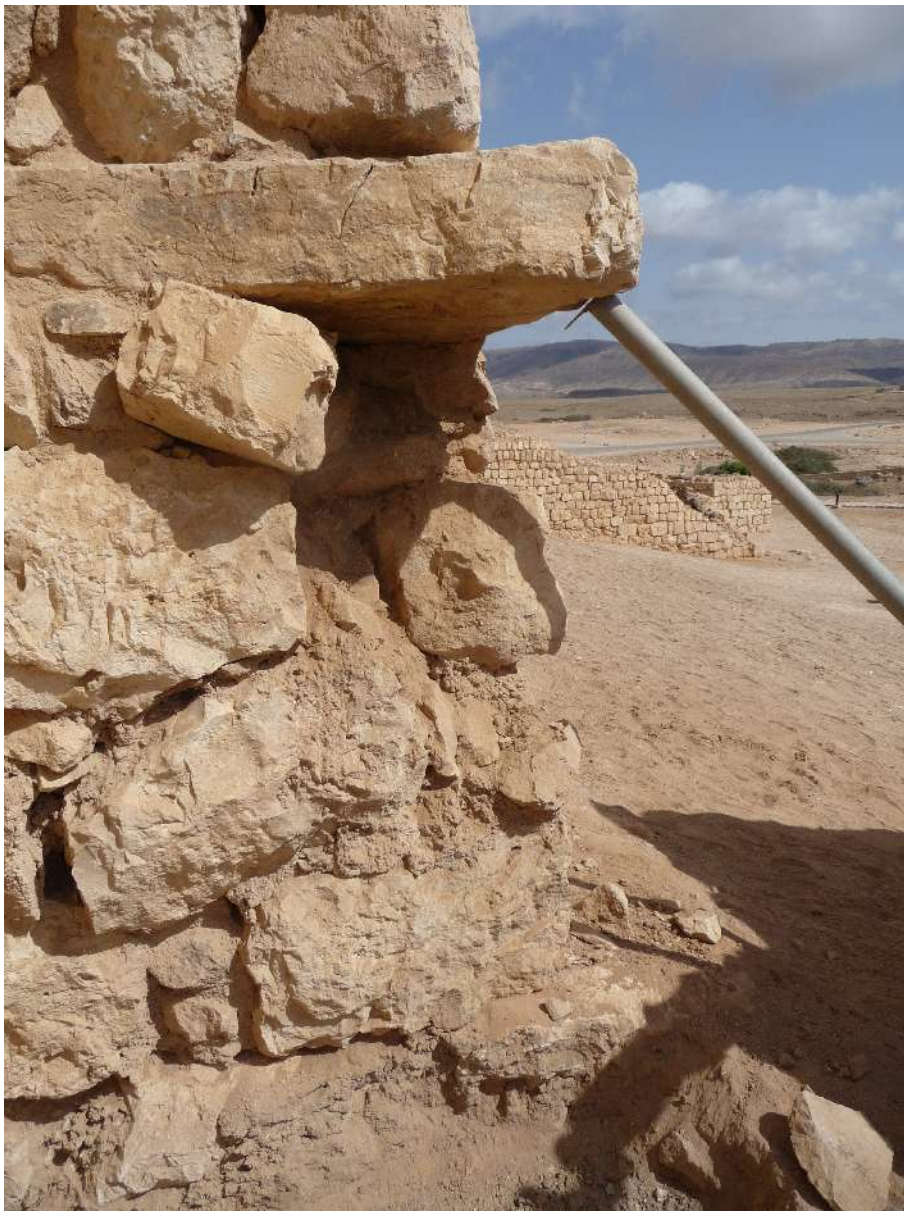
The corner on the left side on M221 wall, at the junction with M223, was in a poor state of preservation and the lower part was collapsed. I needed to remove the stones from that side up to the foundation, spreading then a layer of geotex following from the rebuild of a new part of wall using same stones from the collapsed area kept in place by mortar. At the beginning of the second week the part of the corner was entirely rebuilt.

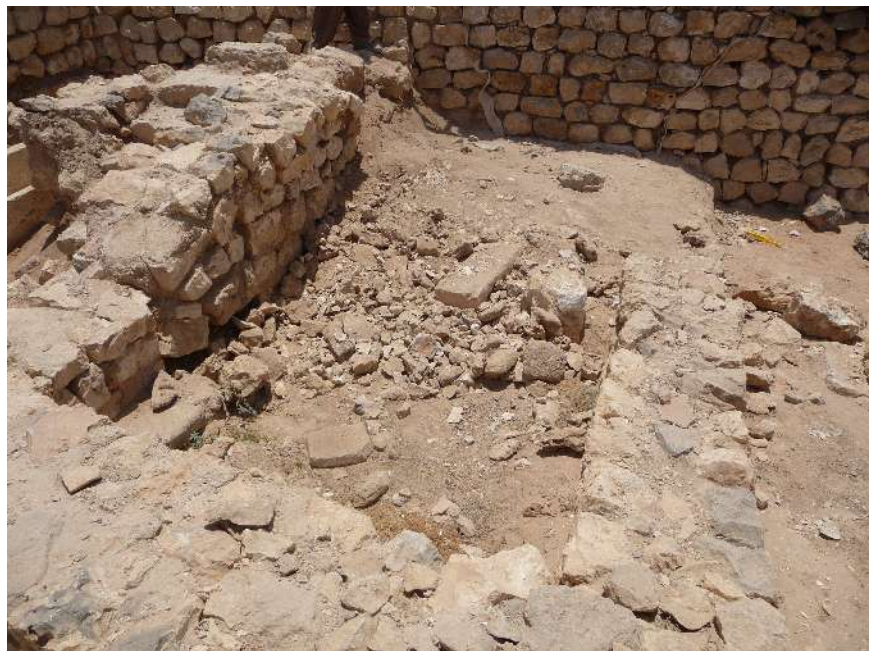
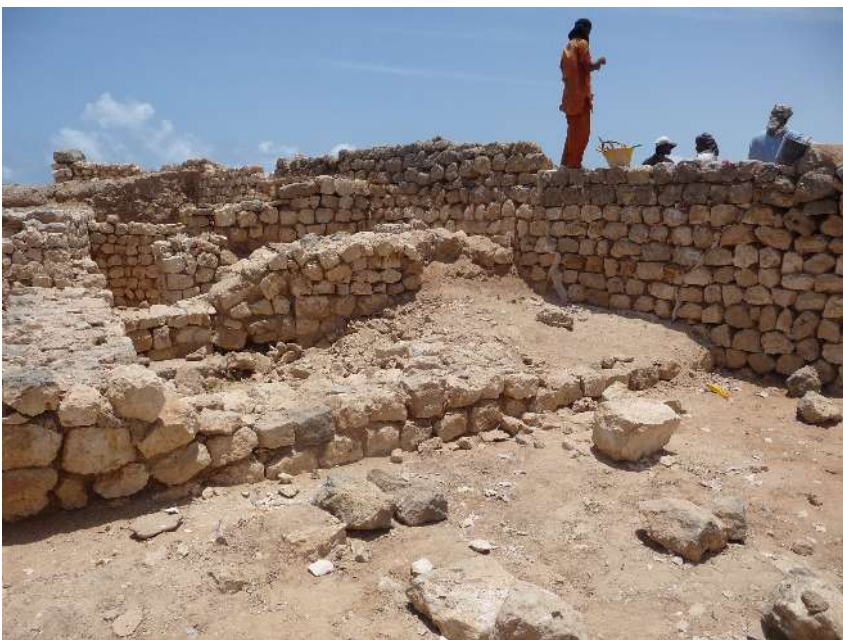
M39/M49

These walls belong to the Monumental Building area and needed to be preserved and reinforced putting in place two or three rows of new stones with mortar on a new geotex layer. I didn't find any problems with this couple of walls and in few days they are completely rebuilt and covered with a little quantity of mortar and finished with dry-stones.

M39 and M49 walls were restored and partially rebuilt at the end of the second week.
