IMTO – Italian Mission to Oman

SUMHURAM

Preliminary Report

February – March 2016 (SUM16A)

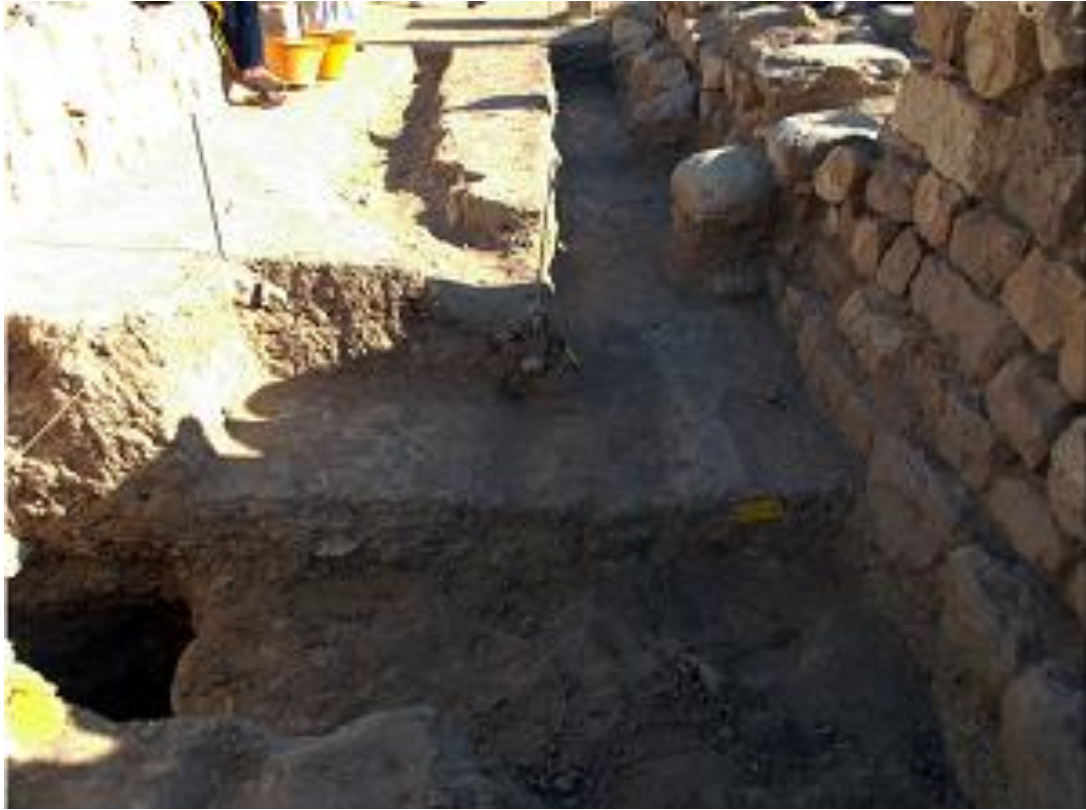
It is the first living surface in street A75. US846 floor consists of an earth packed soil, very compact in consistence and greyish brown in colour. US846 floor had an almost even elevation of about 28.40 m in all the trench. A drain channel running from South to North and cutting the floor was detected. It is 0.26 m wide and 0.10 m deep. Its lower surface reached the foundation filling.

US846 floor

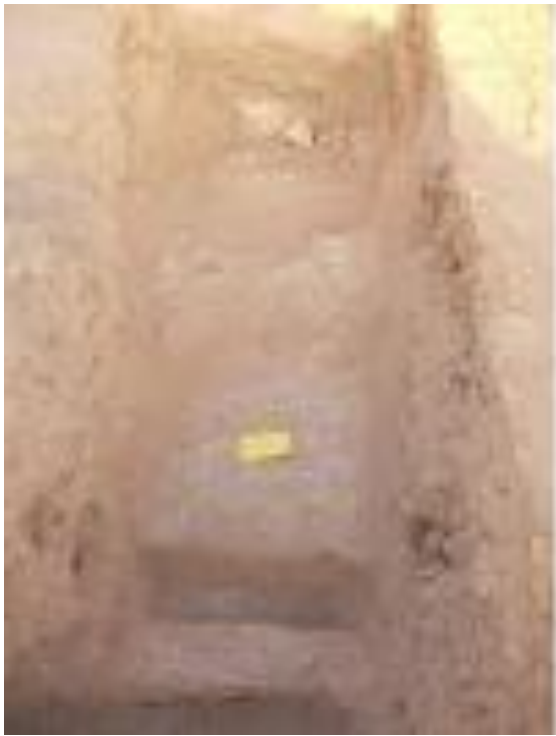
Below US770 floor in US846 we noticed the presence of some stones and limestone slabs medium in size. They were only near the wall M66 and probably are linked with its construction. The floor of this layer, found at an elevation of 28.42 m, is grey and very compact and it returned animal bones. The foundation of M66 is set at the level of US846 floor. Between the last row of stones of the wall and the floor there is a row of mudbricks. The mudbricks can be put in relation with the levelling of the bedrock in order to build the wall M66.

US846 floor with drain channel

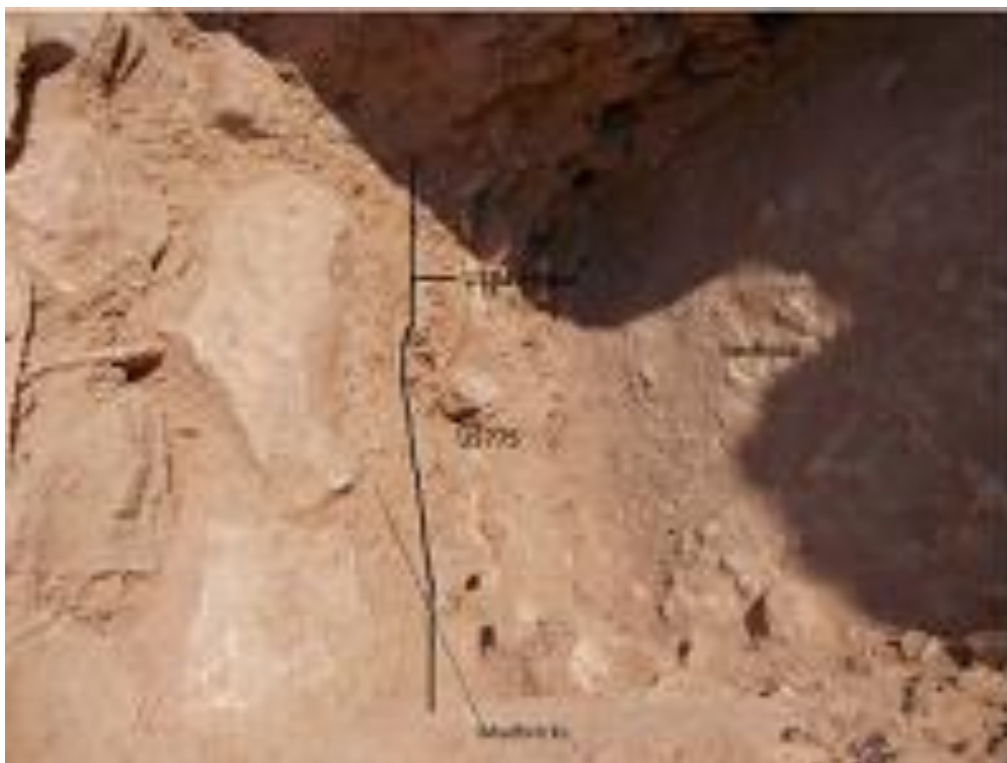
Particular of the foundation of M66

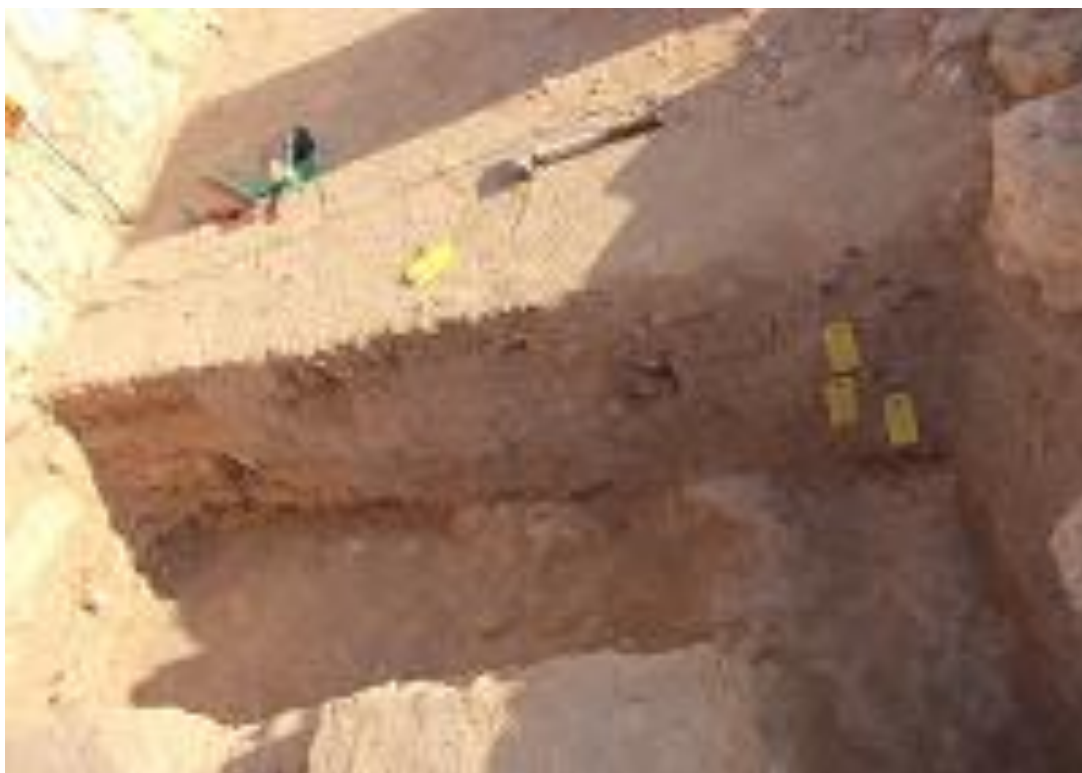
East-West section (North)

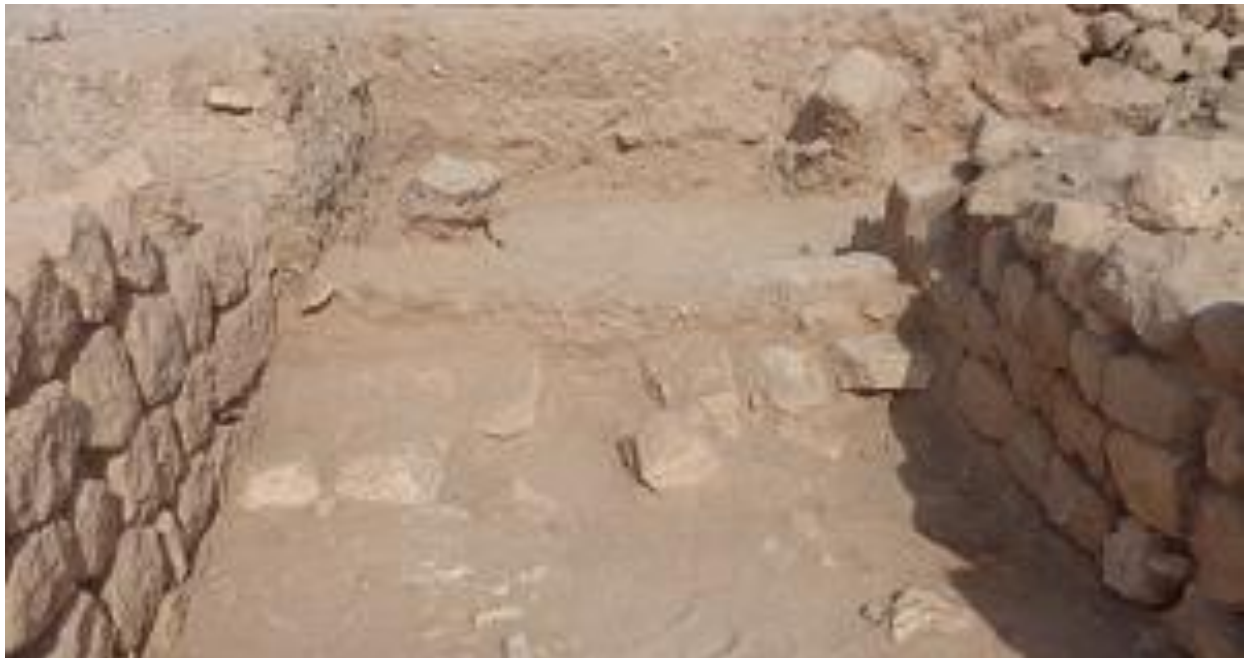
After the removal of the US774, the trench was enlarged southwards. After the removal of the natural surface, US862 was excavated. It was brown in color. The consistence of this layer is not homogeneous. It is medium compact near the southern wall of A231, while it becomes more loose going southwards. US862 rests on a compact level interpreted as floor, found at an elevation of 29.42 m. Below this layer we found another time the US774. The excavations stops at an elevation of 29.02 m. In the southern part of the trench the US774 floor is not preserved. From this level near the southern wall of A231, there are some stones going down to the floor in A204, forming a kind of staircase.

Probable staircase in A204

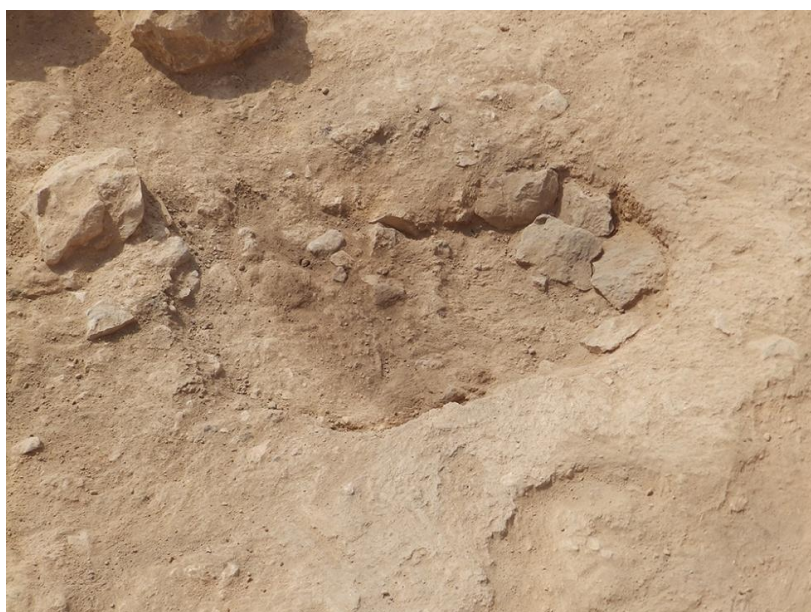
Fire-place in room A227 (South-West)

It was the pit of an oval form ($0.90 \times 0.54\text{-}0.61$ m, the depth is 0.14 m). The bottom of this construction was covered with small stones; part of this cover survived in the western part of the pit. It was filled with ash with small pieces of charcoal. Two small fragments of burned animal bones were found in this filling.

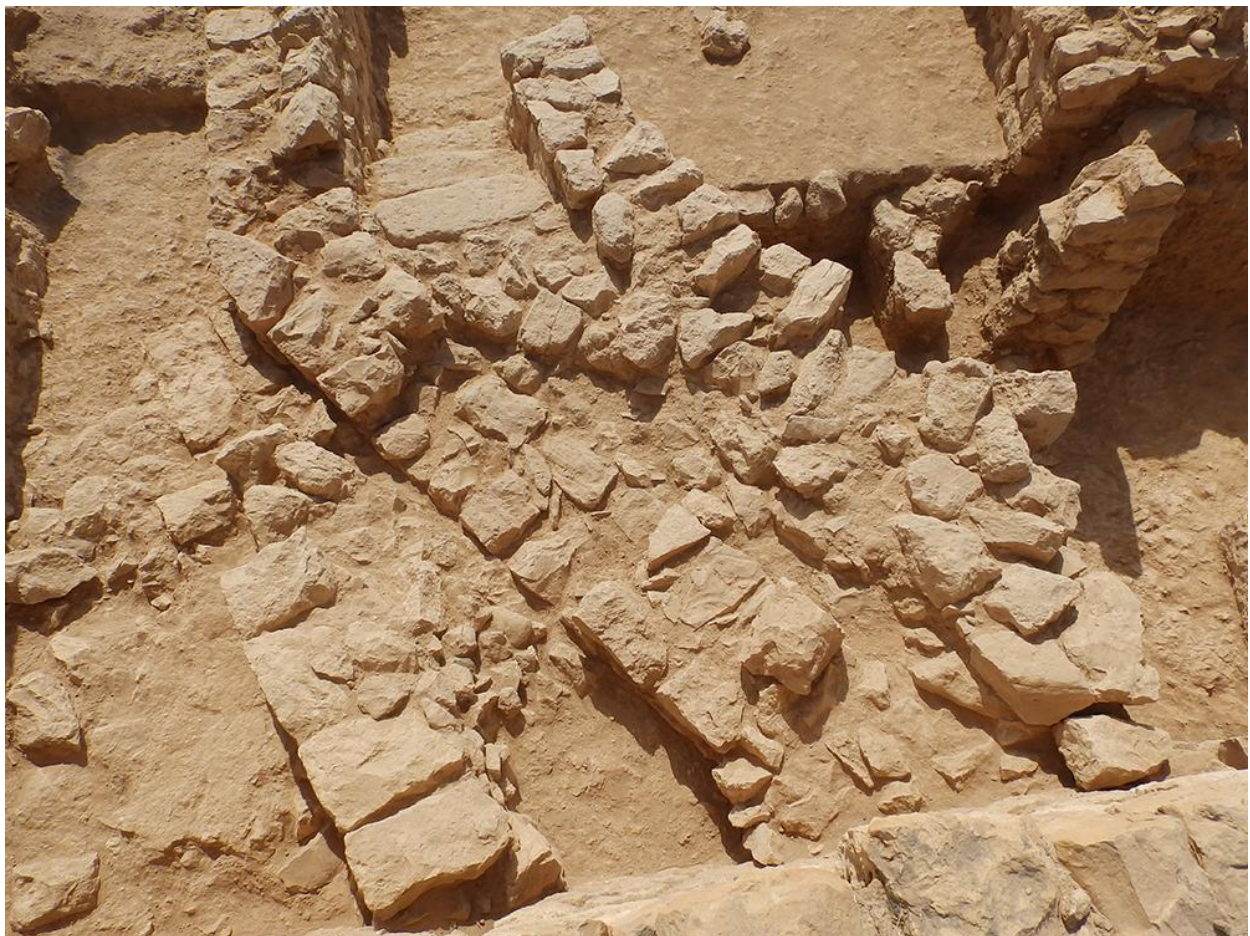
Part of the platform of the Early Temple survived in the angle of the walls M36 and M40. It's clear now that all walls and staircase M768, discovered during SUM15C, belong to the construction of the platform of the Early Temple, which was covered by the platform of the Later Temple.

Platform of the Earlier Temple. View from the north-west

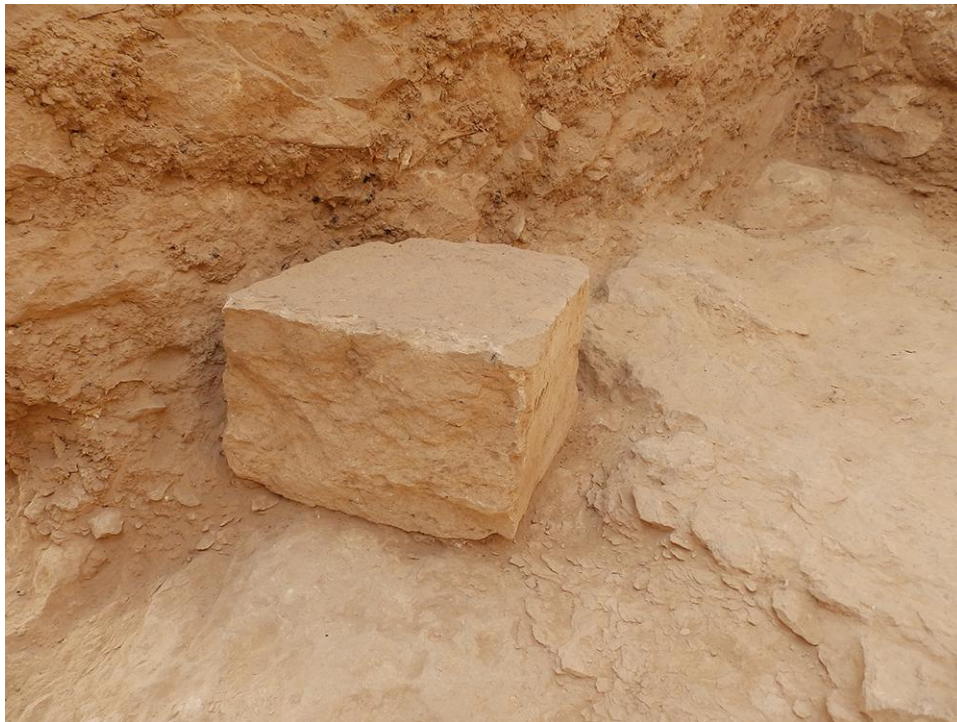
Base of column, view from the north

It was put in the place, specially cut in the rock. The second is the fragment of stone slab, that could be the base of column (0.33×0.31 , height – 0.12 m).

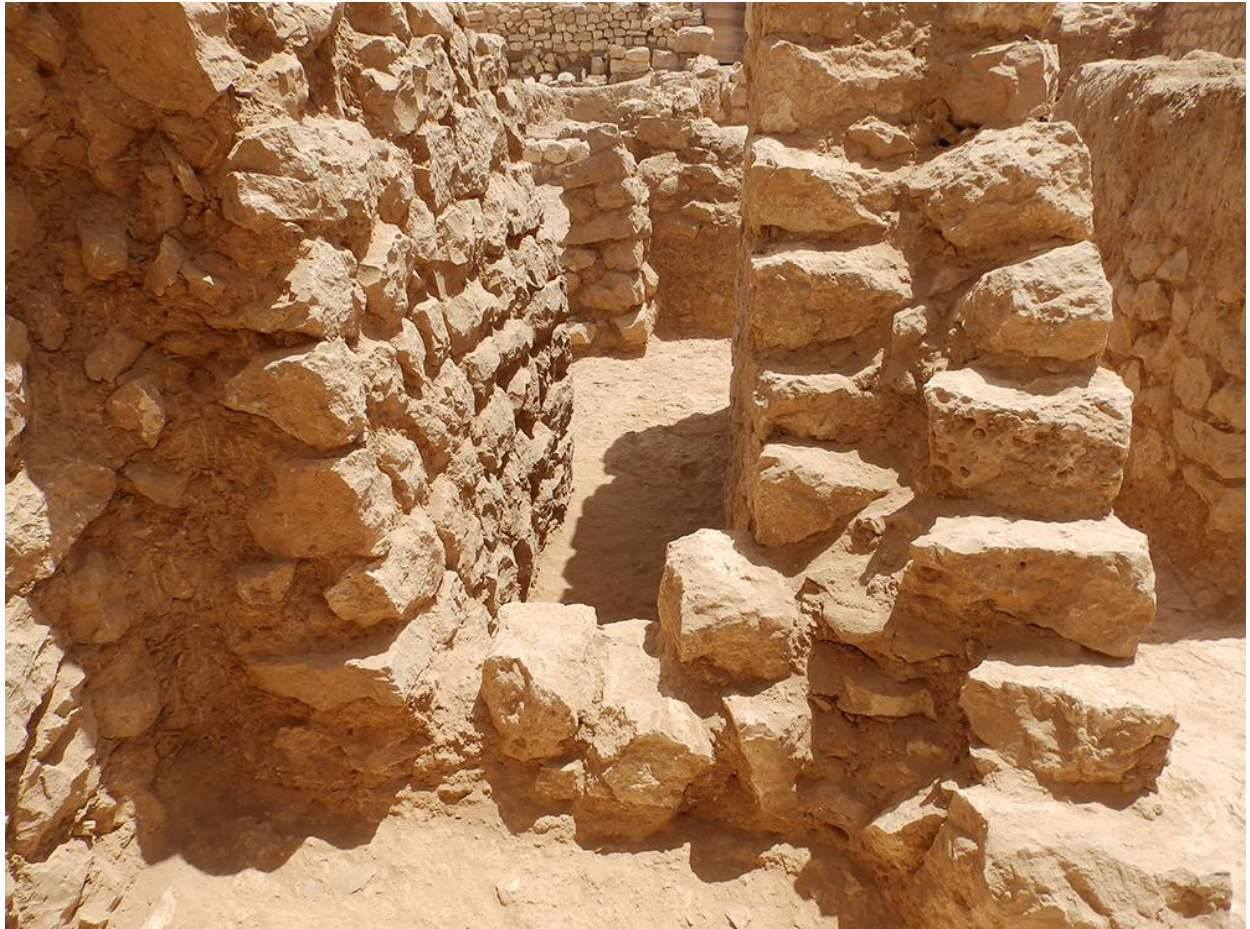
Angle of the walls M784 and M100. View from north-west

The length of this wall is 0.64 m, the width – 0.40 m, the height – 0.61 m. The foundation of M784 partly lays on the strata US869.

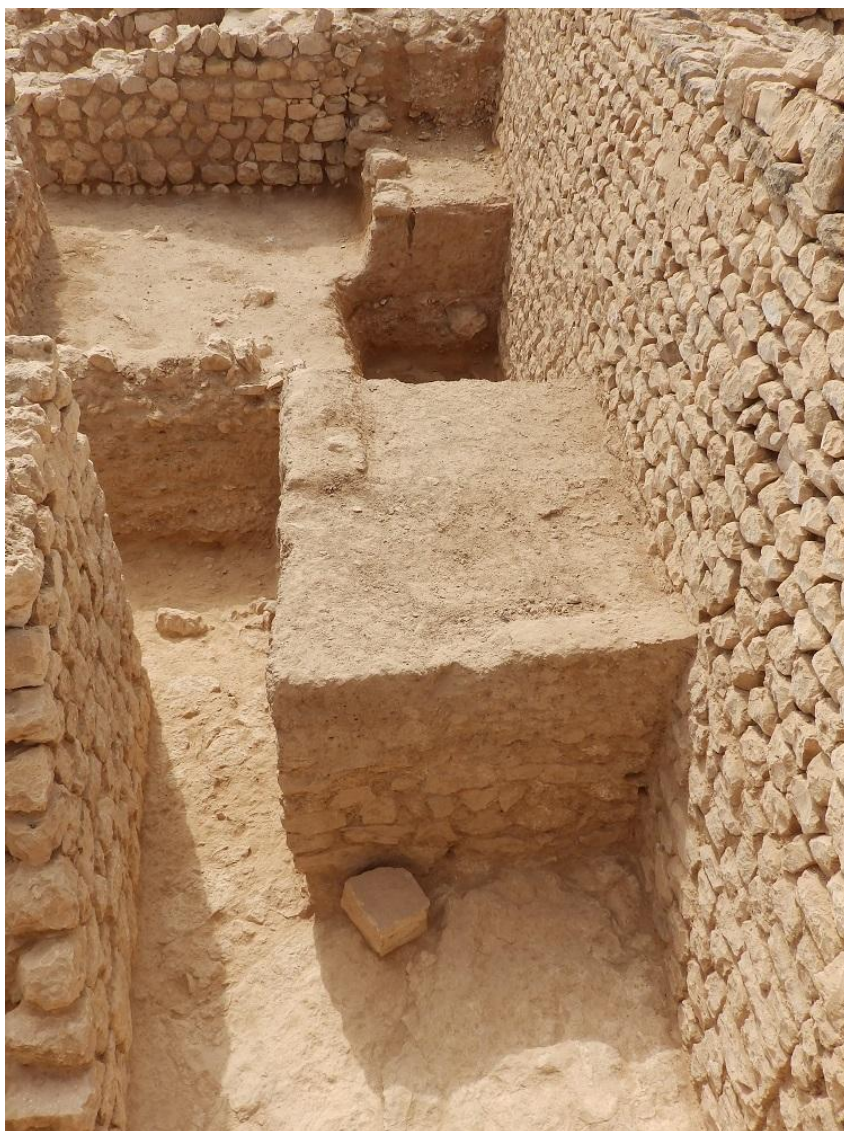
Construction near the wall M93 of the Monumental Building–2. View from the north-west

Two walls of it survived – the northern **M785** and the western **M786**. The foundations of both walls were built of roughly dressed stones (width – 0.40 m, height – 1.10 m). In spite of bad quality of this masonry, maybe, firstly it was designed like an ordinary room, because it has an entrance in the central part of M785 (the width – 0.66 m). But later the walls of mudbrick and loam were erected over this foundation (the width of these walls are about 0.30-0.35 m), and all inner space of the construction was filled with loam with stones. This filling we left unexcavated. In all probability, this construction had continuation to the east till the similar structure M634, which was investigated during previous archaeological seasons. The function of these unordinary structures is unclear.

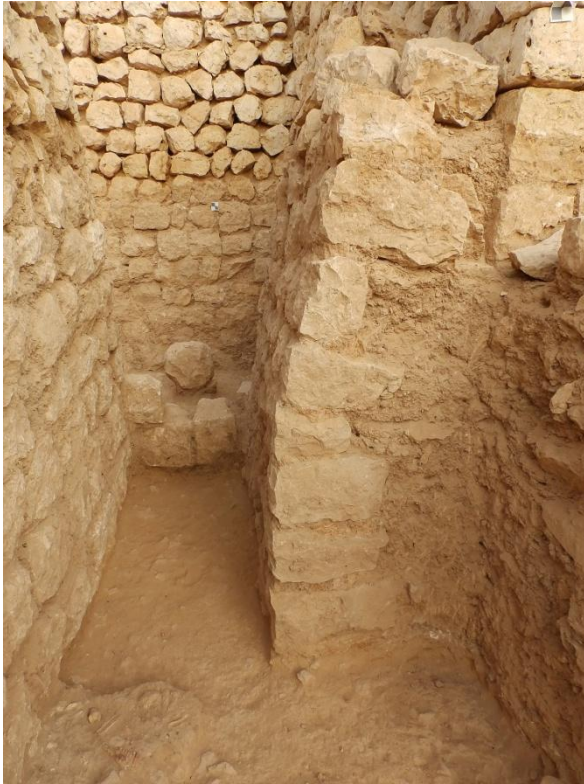
The wall M48 of the Later Temple in its eastern part was supported with a special construction, it was the **wall M90**, which was partly opened in the season of SUM15C and fully investigated this year. **This supporting wall**, bent to M48, was made of roughly dressed stones in one course.

Wall M90, view from the east

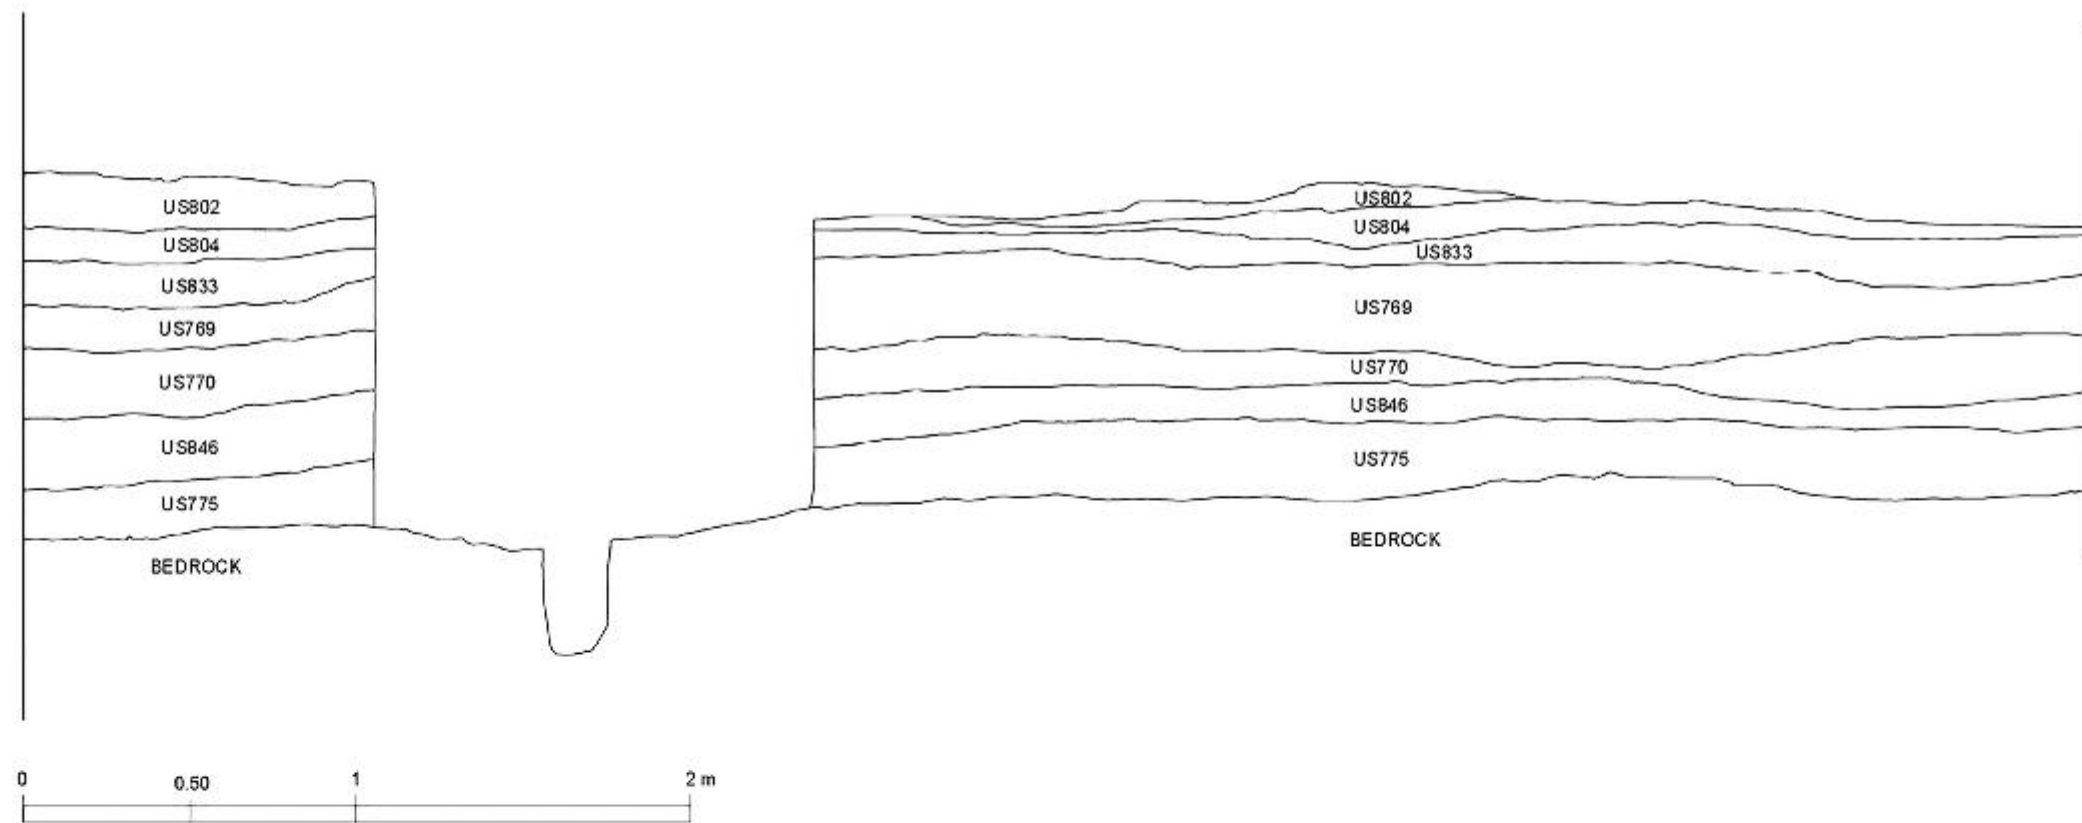
A75 - section N-S (South)

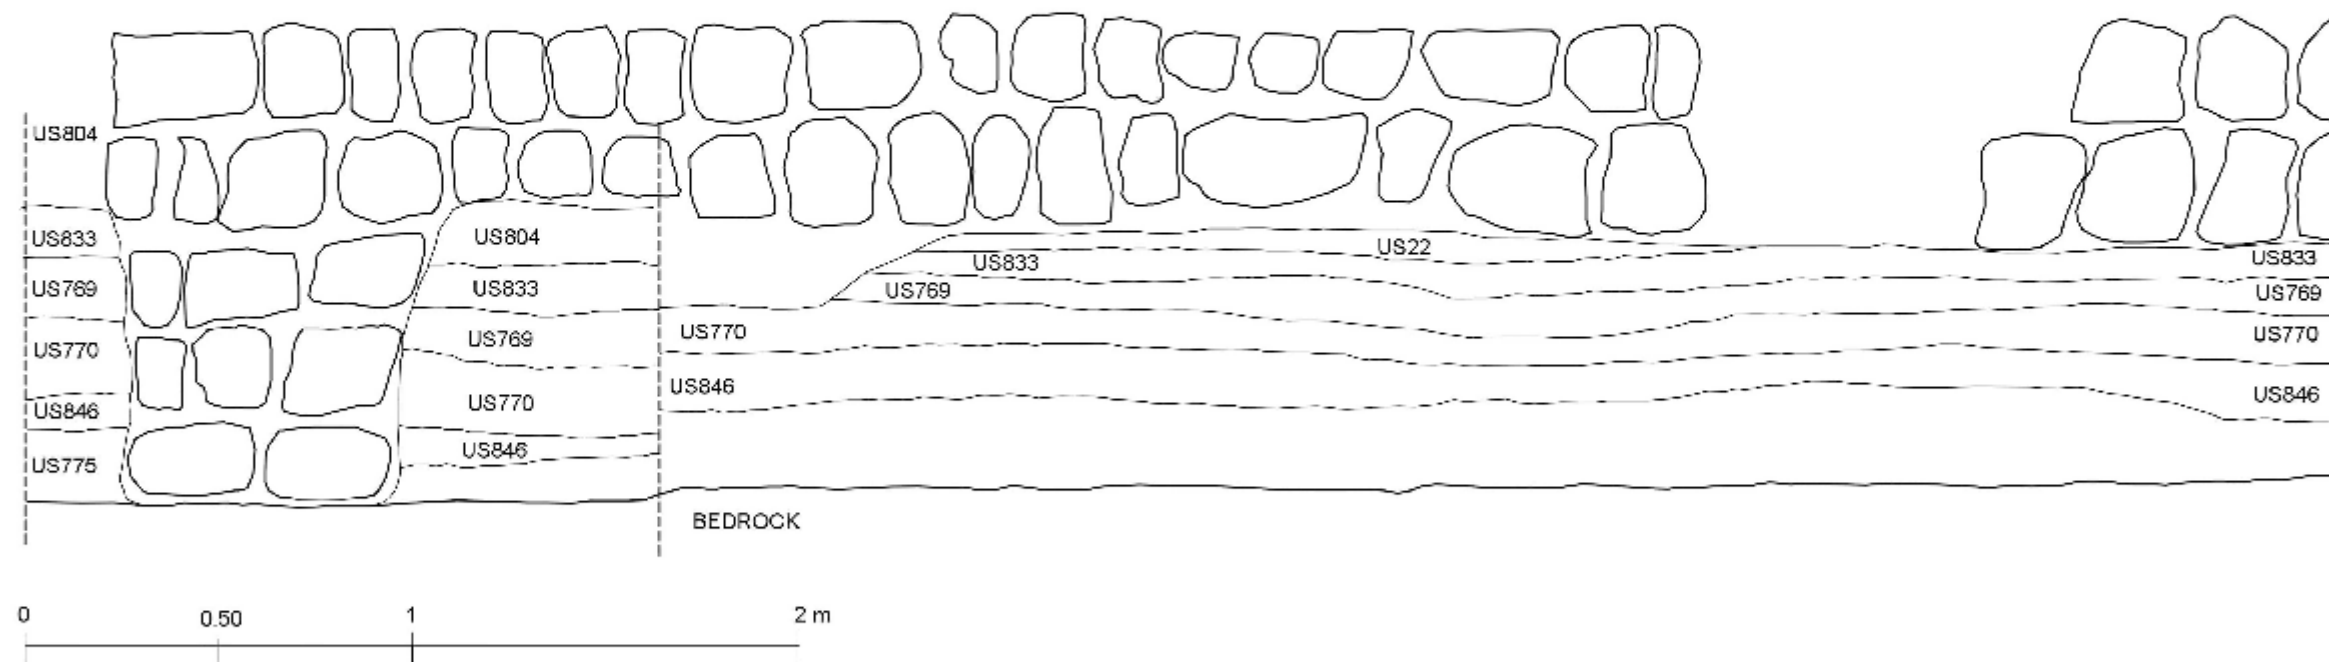
A75 - section N-S (North)

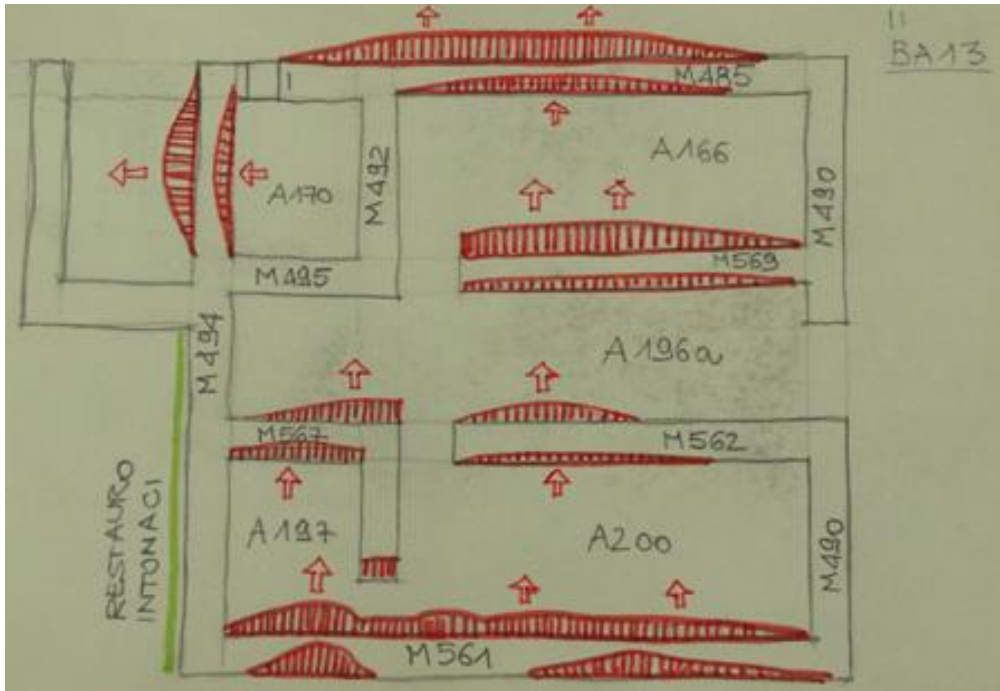
The building had a large part of the walls collapsed. The restoration was done by giving the priority to the walls on the tourist route and then those inside. The work is proceeded with the disassembly of some parts of the masonry, the cleaning and the replacement with the same stones as not to alter the original shape.

Sketch area BA13. Plan with collapsing walls

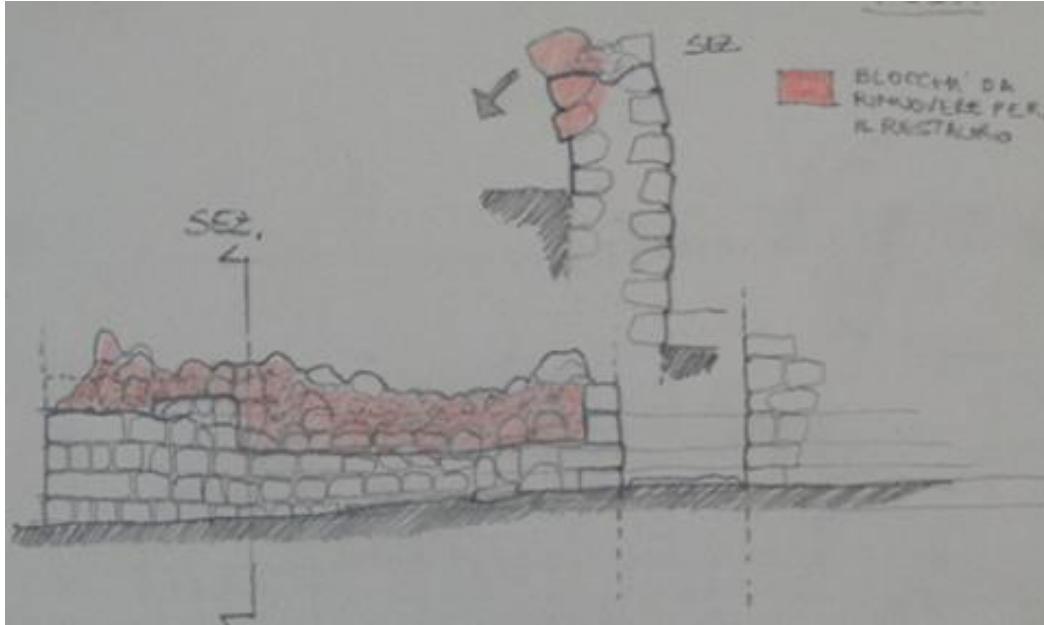
The restoration was done by giving the priority to the walls on the tourist route. The work is proceeded with the disassembly of some parts of the masonry, the cleaning and the replacement with the same stones as not to alter the original shape.

M635, south facing wall. Stones to remove highlighted with hatch

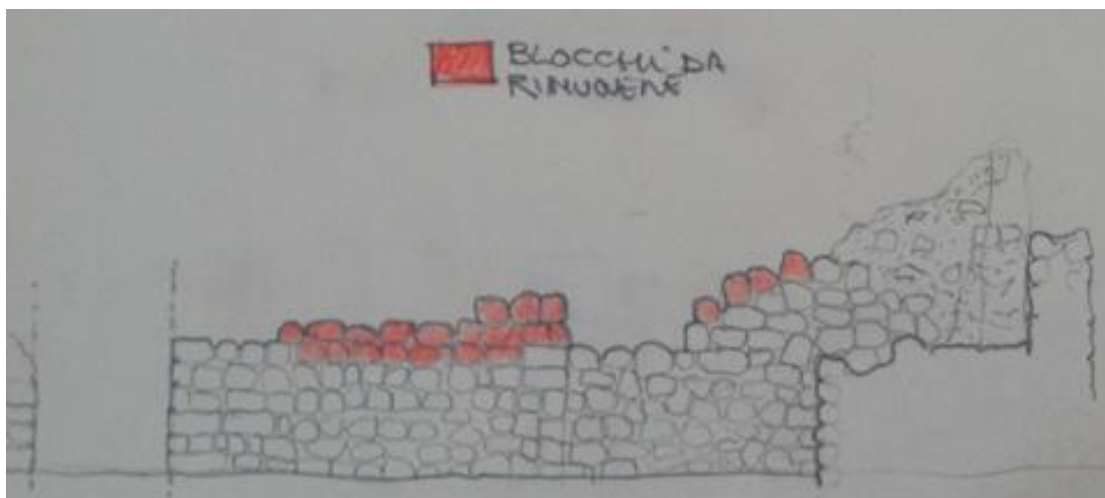
Restoration of the wall M581

The restoration was done by giving the priority to the walls on the tourist route. The work is proceeded with the disassembly of some parts of the masonry, the cleaning and the replacement with the same stones as not to alter the original shape.

M581, south front wall. Stones to remove highlighted with hatch

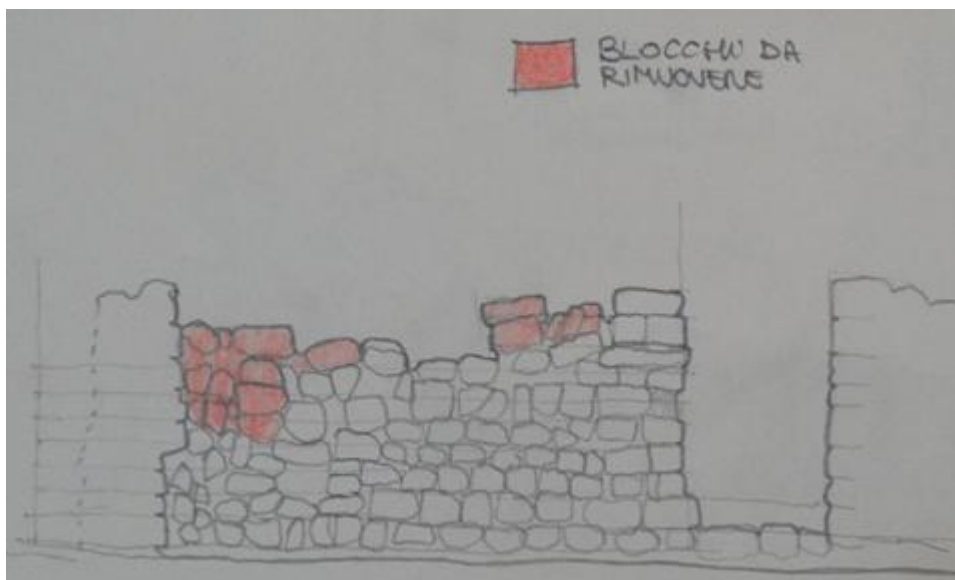
Restoration of the wall M70

The restoration was done by giving the priority to the walls on the tourist route. The work is proceeded with the disassembly of some parts of the masonry, the cleaning and the replacement with the same stones as not to alter the original shape.

M70, south front wall. Stones to remove highlighted with hatch

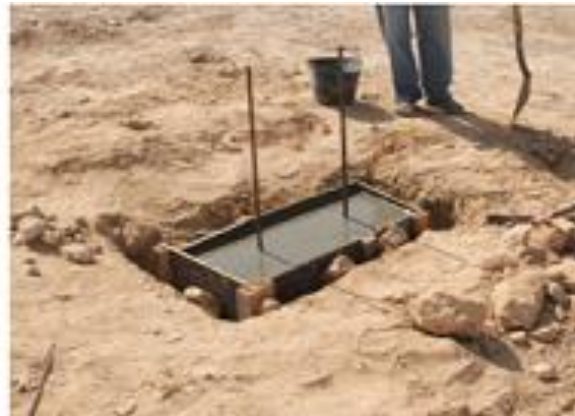
New foundation

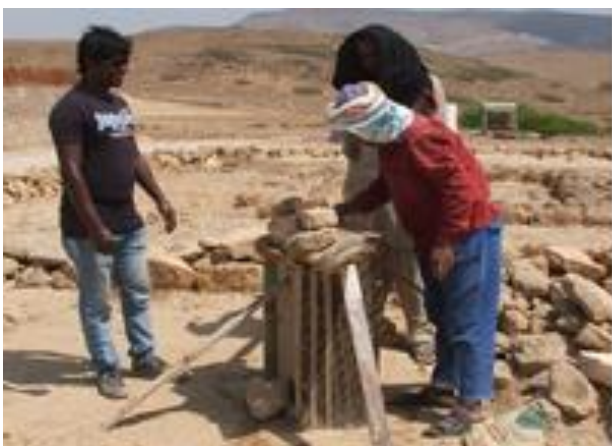
Formwork

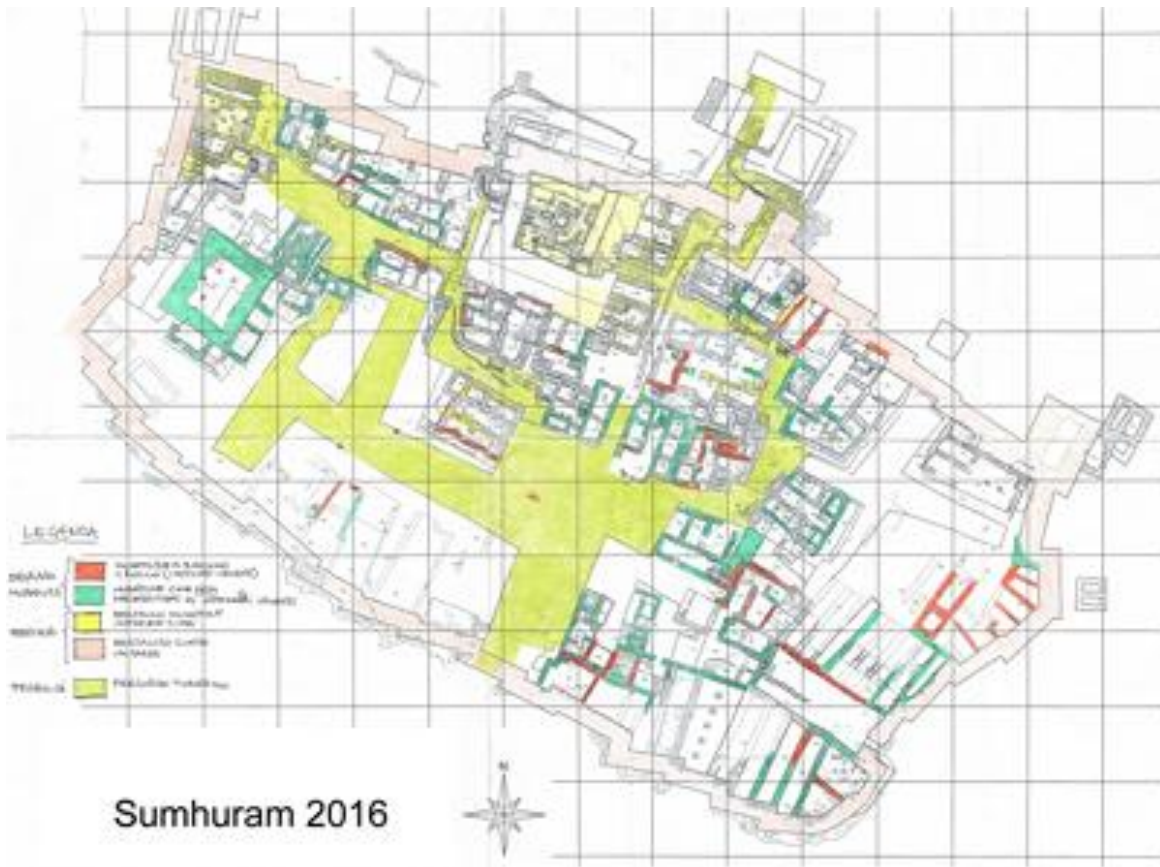
Plan with a risk collapse highlighted walls

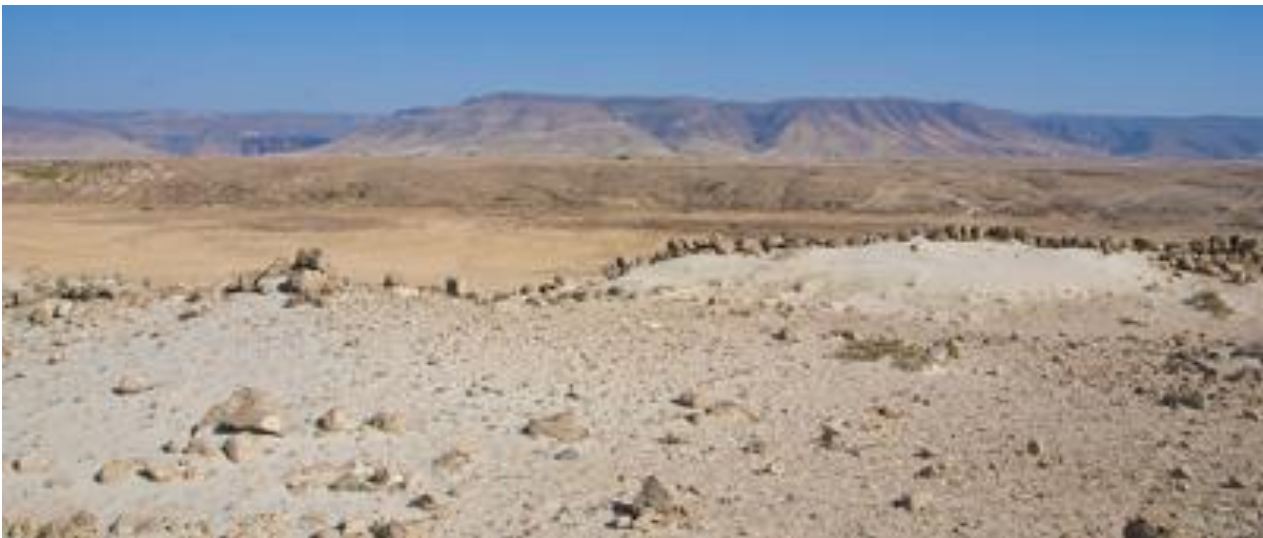
East wall in bad condition

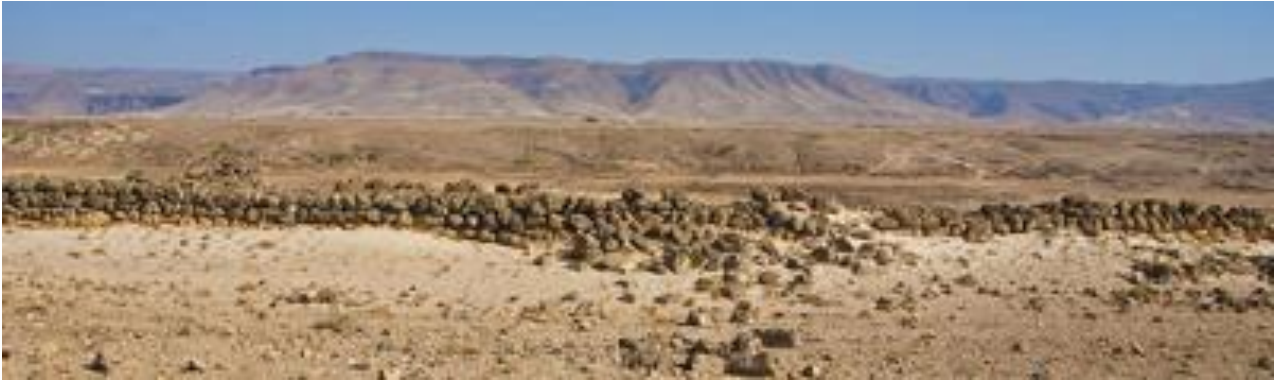
West wall in bad condition
