IMTO -Italian Mission To Oman-

SUMHURAM

PRELIMINARY REPORT

November – December 2006

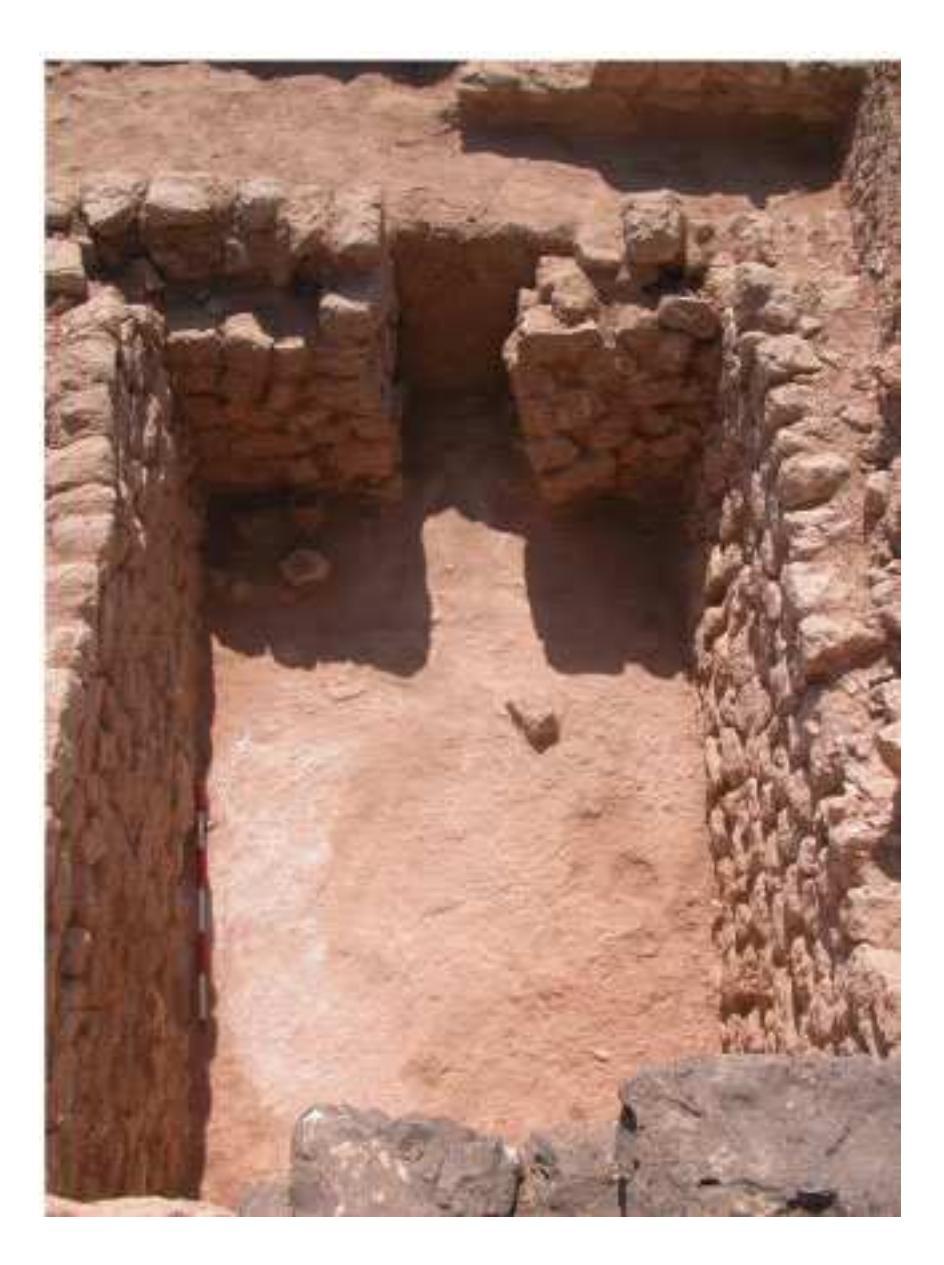
Fig. 1: Area A, room A85, view from north east

The room, rectangular in layout and 3.25x2.50 m in size, was located west of the 'tower' M174 of the Building BA5 (fig.1). Its perimetral walls are the wall M17 of the Monumental Building 1 to the NE, wall M192 to the NW, wall M191 to the SE and wall M193 to the SW. The entrance to the room, 0.70 m wide, was located in the center of wall M193. The floor of the room, US214floor, was reached at the elevation of 28.07 m. The floor was well plastered. On the floor one bronze coin (Co397) and two large fragment of vessels were found. A complete whale vertebra was also present. The filling above the floor (US214), only 0.15 m deep, consisted in grayish loam mixed with few small stones, charcoals and animal bones. The following objects were recovered from US214: two complete upper stones of hands mills and a fragmentary one laid on the floor (S1039, S1040, S1038), together with several stone tools, two pestles (S1032, S1041), two polisher (S1035, S1036), two whetstones (S1033, S1034) and four oil lamps made from *Chlamys townsendi* shells (Sh282, Sh283, Sh284, Sh285). Just above US214 a charcoal sample has been taken for analysis.

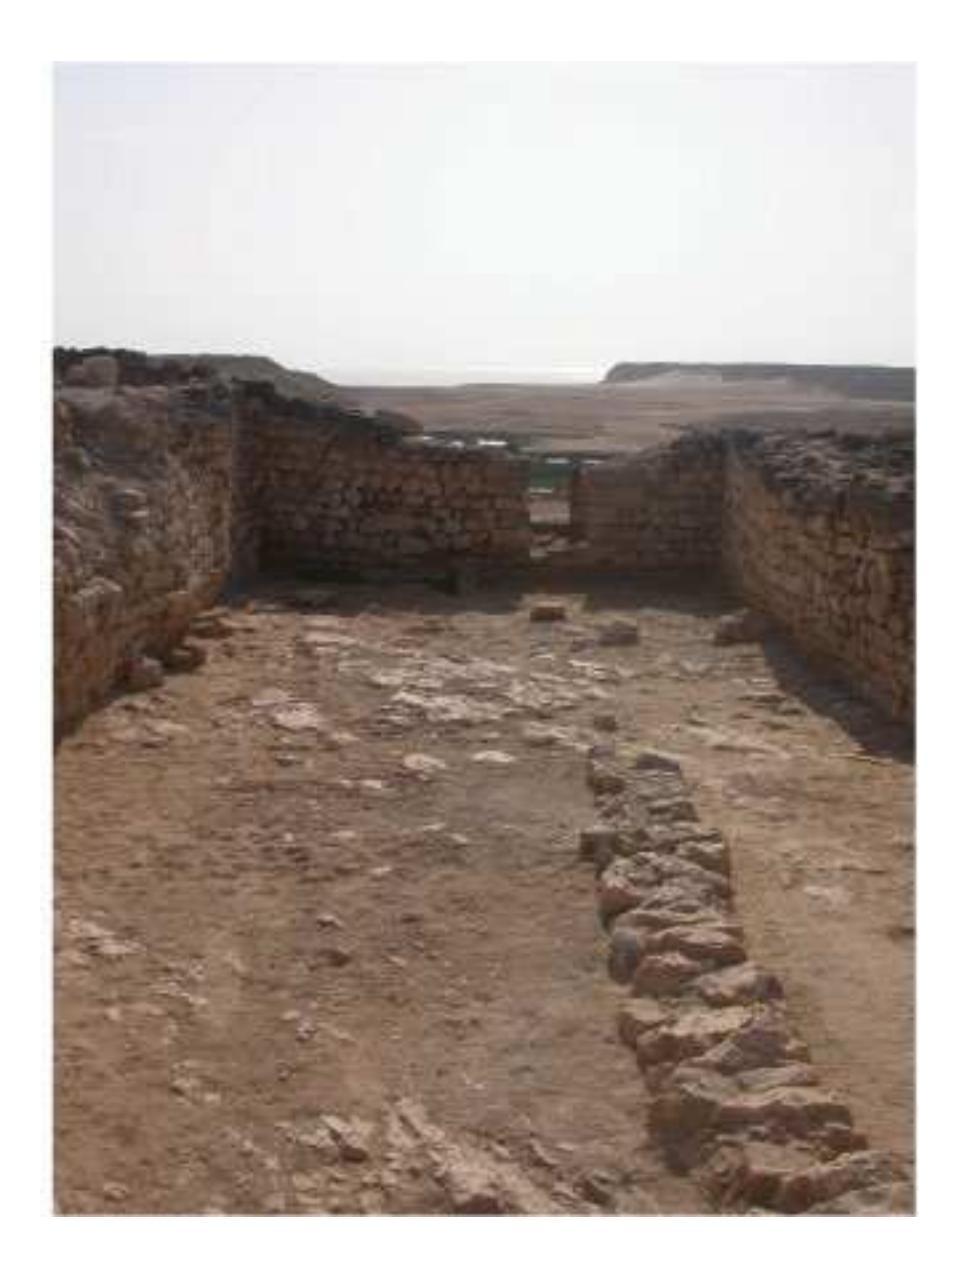
Fig. 2: Area B, room A77, view from north west

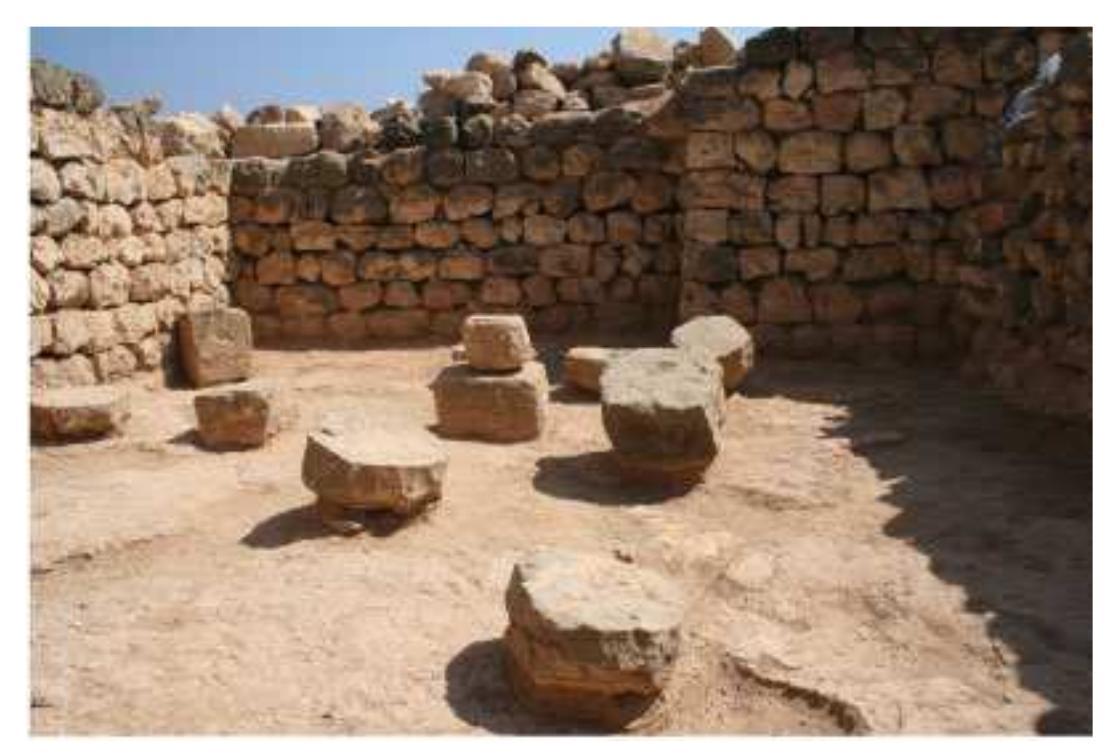
Fig. 3: Area B, room A81, view from south east

The room, roughly trapezoidal in layout and 4.1x5.1-6.5 m in size, was situated immediately south of the SE corner of the square A77 (fig.3). Walls M197, M198 and city-walls M140 and M199 delimited the room. F.P. Albright interpreted it, together with adjacent room located southwards, as 'mint'. The floor of the room as well as lower parts of the walls was plastered. Number of limestone blocks, nine of them rounded and five – rectangular, were found scattered on the floor of the room. Only four rectangular blocks were *in situ* while the rest of blocks were definitely from a collapsed structure. Shallow round pit or better to say 'imprint' in the floor was discovered roughly in the centre of the room. We may suggest that a pillar to support the ceiling was once stood here. In this case the round blocks could be considered as trunks of this collapsed pillar. The rectangular blocks found *in situ* may have been, as Albright suggested, "tool stands or bases for the craftsmen to work on". An 'imprint' of low ledges 10 cm high and 60 cm wide was traced along the city-walls M140 and M199.

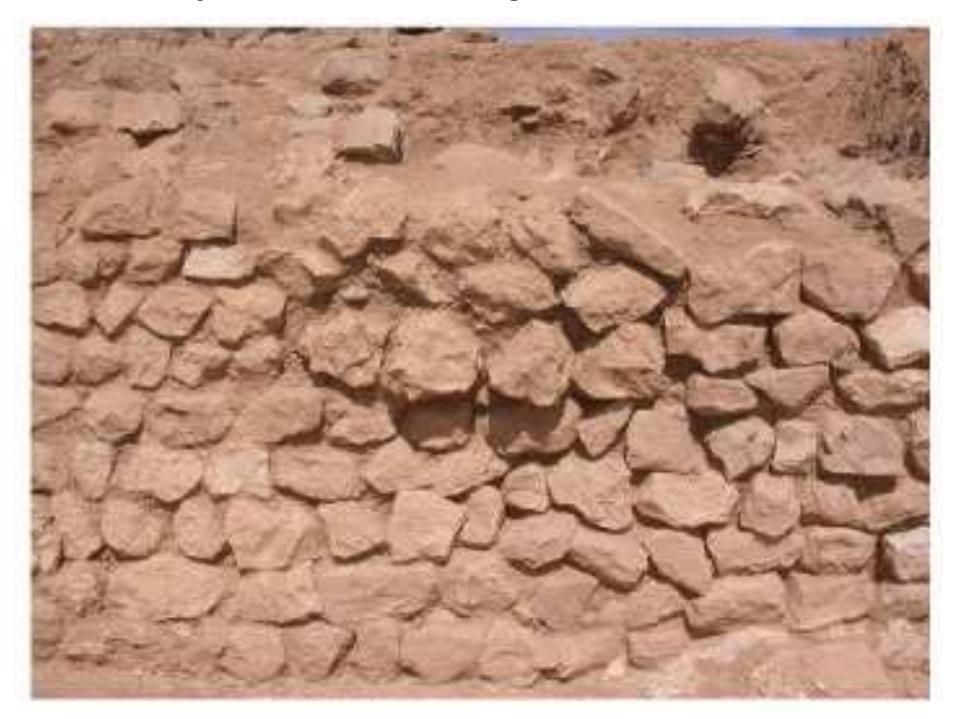
Fig. 7: Area B, entrance to room A94 from square A77 blocked with masonry

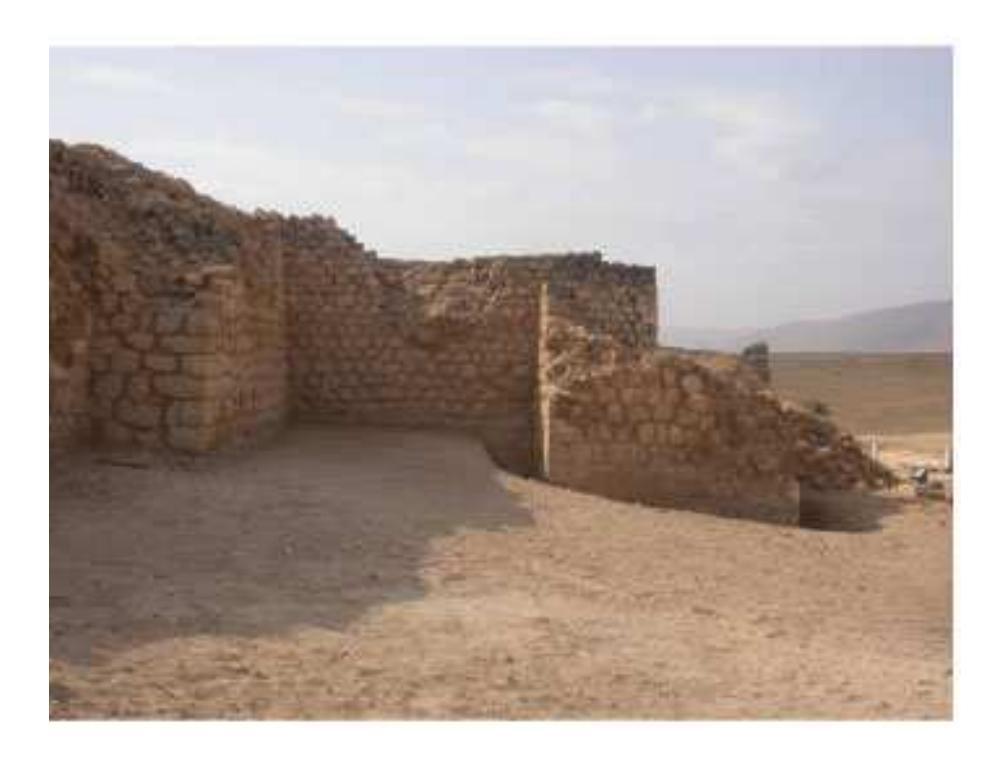
Fig. 9: Area E, corner tower A 62

The foundation of the SE corner of extension of the tower was reached at the point 22.58. The foundation of the corner between extension and the SE wall of the corner-tower A62 was reached at the point 23.22. It means that the outer walls of extension were built on the slope, and in spite of significant efforts of its consolidation (see below) the elevation was quite significant and caused the forthcoming destruction, especially in the SE corner of extension.

Before the construction of the corner-tower and its extension, the natural slope was consolidated with a thick (8-10 cm) layer of cement-like lime plaster. The lowest rows of the masonry of the corner-tower and its extension were placed on this layer. A sort of lime pavement was constructed also on the slope started from the lowest row of masonry.

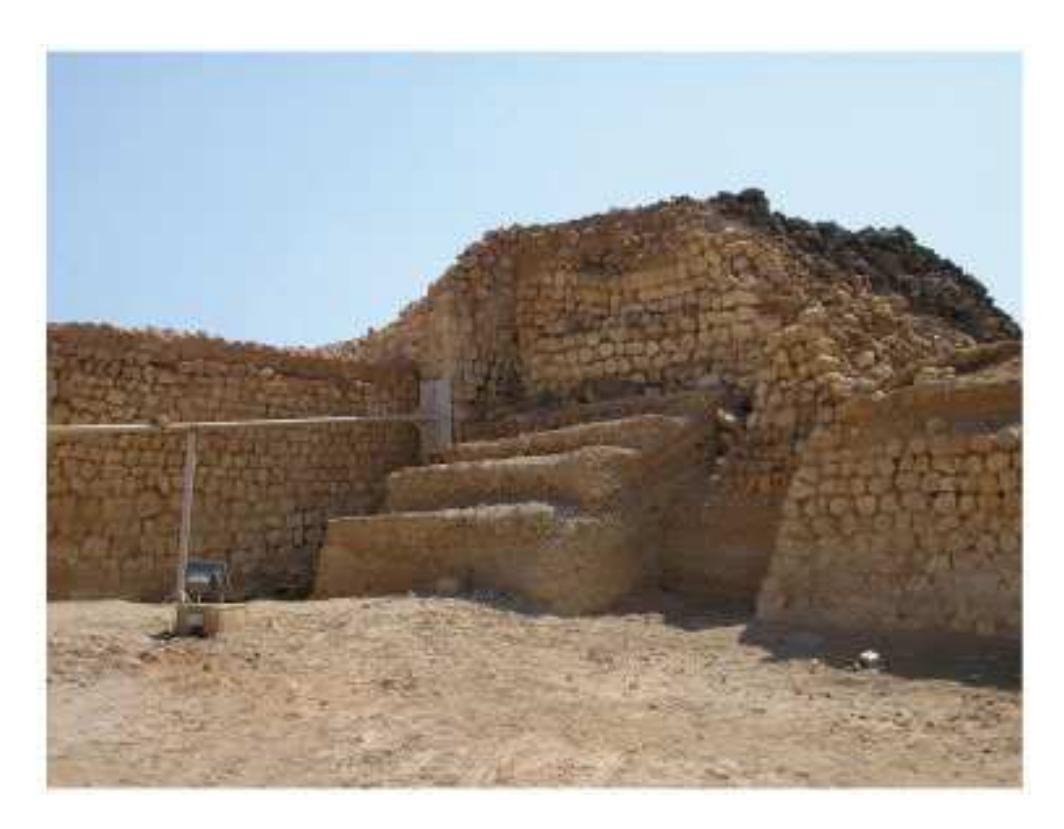
M15 before restoration

In front of M15, on its very western side, it has been found another smaller and less tall wall, built in a second phase, with the aim of retaining the collapsing original one. Both walls were in a very bad state of preservation, showing high rotation, and leaned on the big embankment in front of them. In the outlook of following excavation and removing of the embankment, it has been decided to remove also the higher step of the embankment, up until reaching a reasonable high. The crumbled material has always been removed starting from the top of the wall, by means of hand instruments. Ten rows of stones of the wall M15 have so been removed but no stones of the retaining wall in front of it have been removed. Certain amounts of the earth of the filling have also been removed, with the aim of both lightening the pushing body of the wall and creating enough space for a later easier reconstruction. The stones forming the wall body were heaped nearby, in the outlook of a following usage during the wall reconstruction.

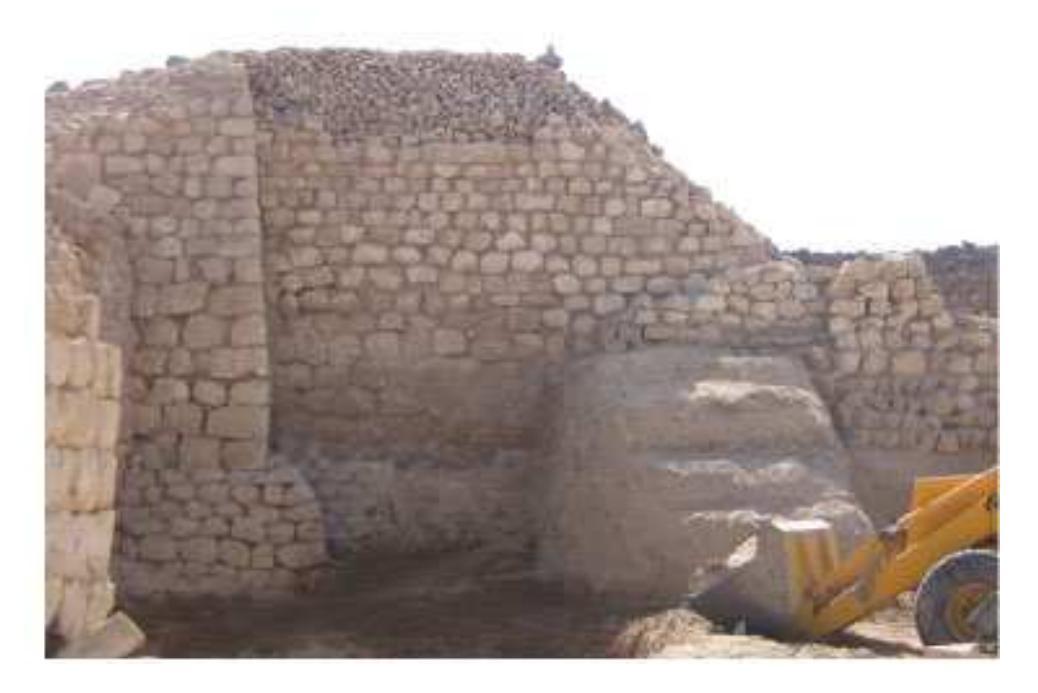
M15 after restoration

- *Surface refinement*. After rebuilding the wall for a certain length, the external surface was adjusted filling carefully the leaks between the stones with mortar, and then, as soon as the mortar had became enough consistent, smoothing the joints with soft brushes. Finally, the stones external faces have been cleaned with sponges and clear water.

A film of geotextile has been posed in the first mortar joint to separate the new rebuilt part of the wall from the old one. Some of the stones used to rebuild the wall were the same ones which had been removed from the outer side and heaped nearby, and some others were found in the environment around. In order to give to the small gate its most probable original appearance, the angular stones found nearby have been used, paying particular attention to their positioning.

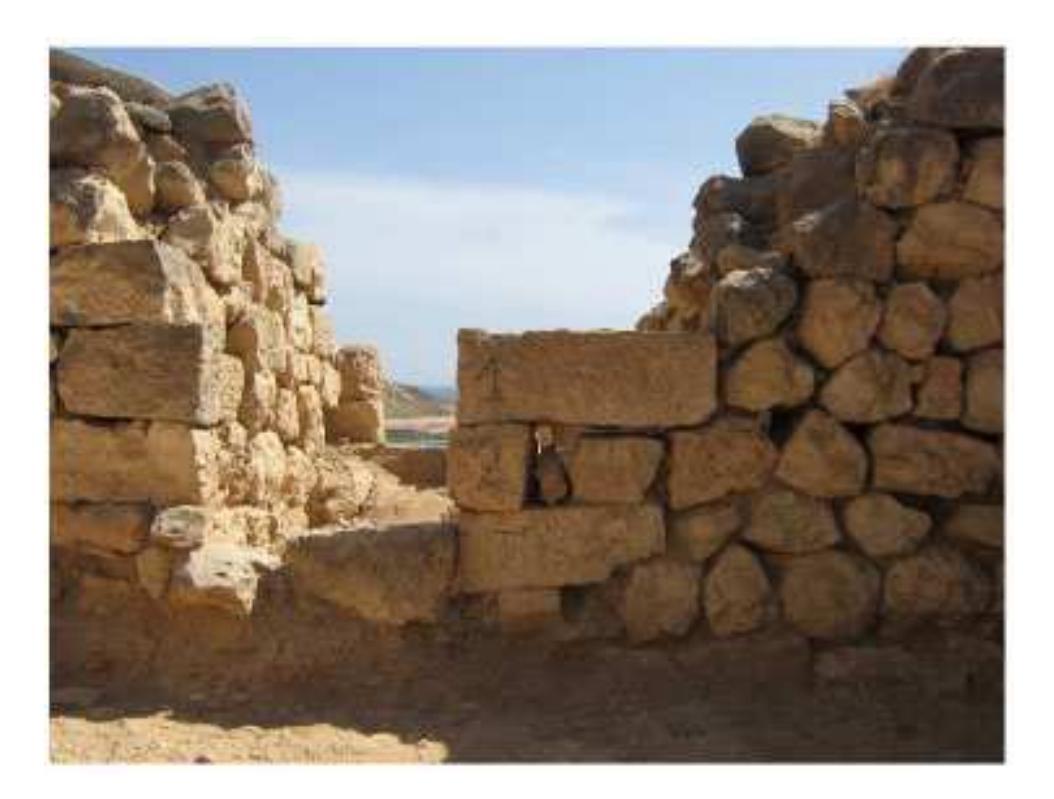
SMALL GATE before restoration

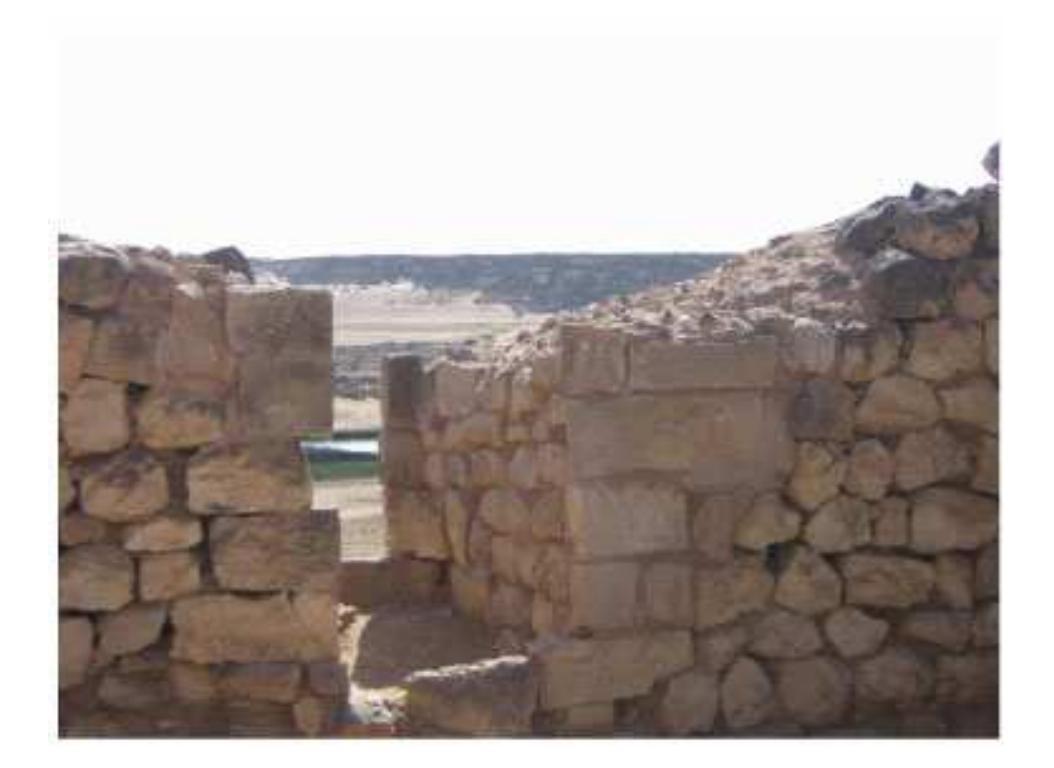
SMALL GATE after restoration

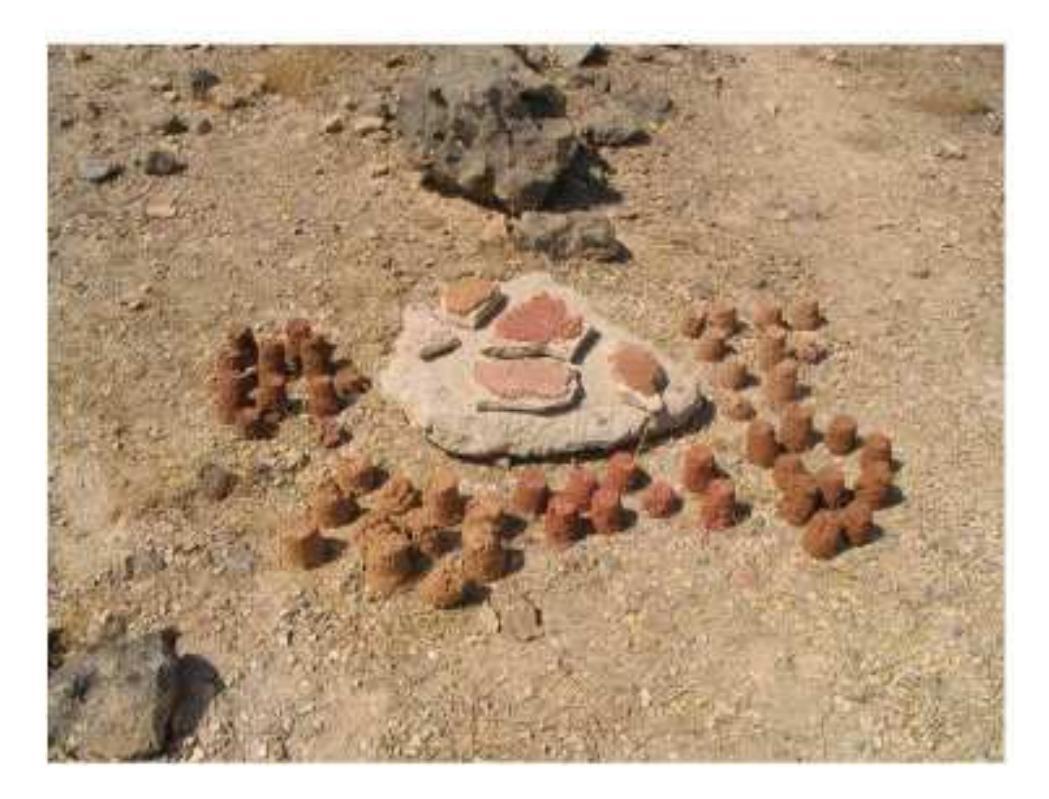
Mortar test

In this outlook, the earth used in the past to link adjacent stones has been replaced by lime mortar in the lateral surface region, to realise a more stiff and resistant structural system. A proper mix has been chosen to reproduce as closest as possible the colour of the old stones. The rebuilt part has been separated by the old undamaged one by using a geotextile film inserted in the first mortar joint.

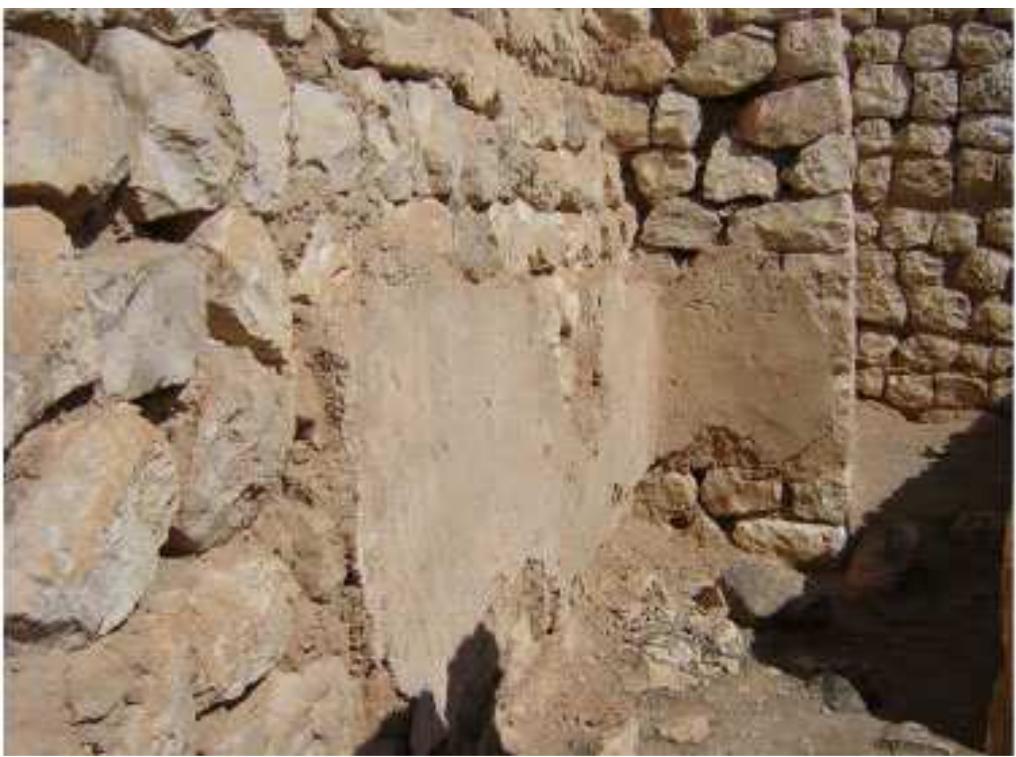
Fig 6. Wall made of roughly worked stones assembled dry and plaster.

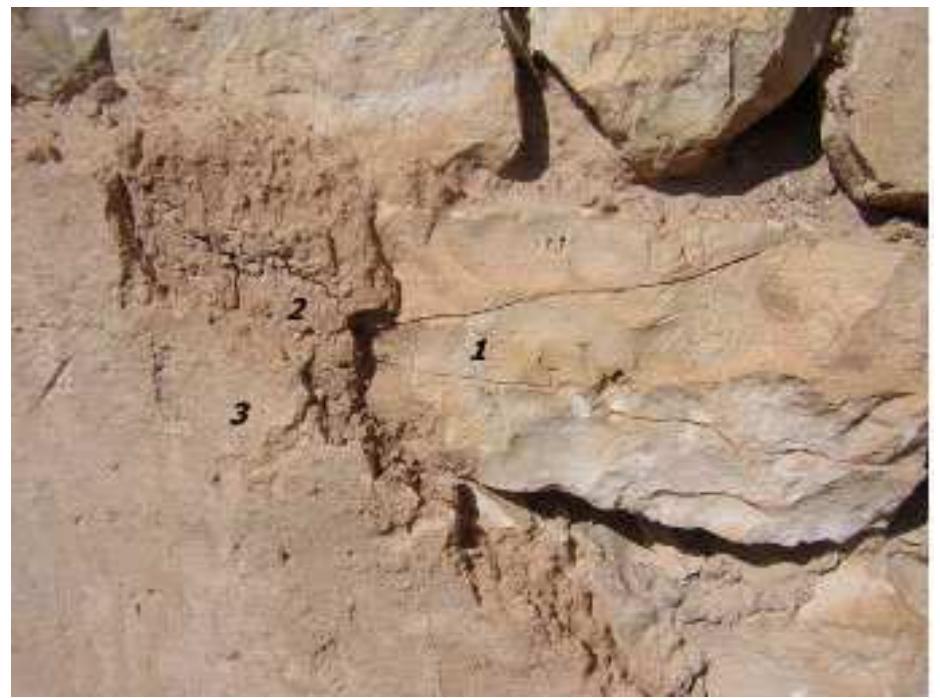
Fig. 7. Wall made of roughly worked stones assembled dry and plaster: samples of stone (1), coating (2) and plaster (3).

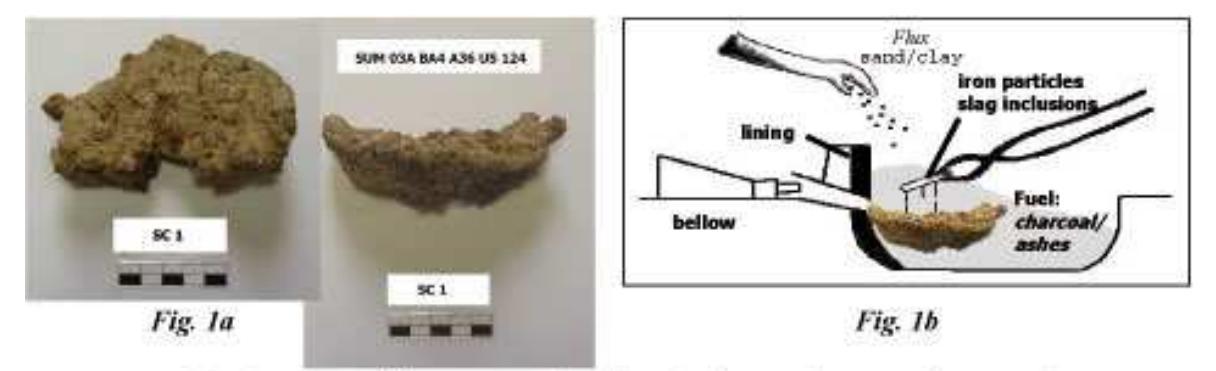
Fig. 1a - Typical plano-convex slag from Sumhuram (section and top views). Fig. 1b – Formation of plano-convex slag on the bottom of smithing hearth.

All iron slags from Sumhuram so far analysed can be attributed to the smithing step. They are planoconvex slags, (Fig. 1a), formed by accumulation of fused material (metallic particles, slag inclusion, fluxes, furnace lining fragments, charcoal...) in the lower part of the smithing hearth (Fig. 1b).

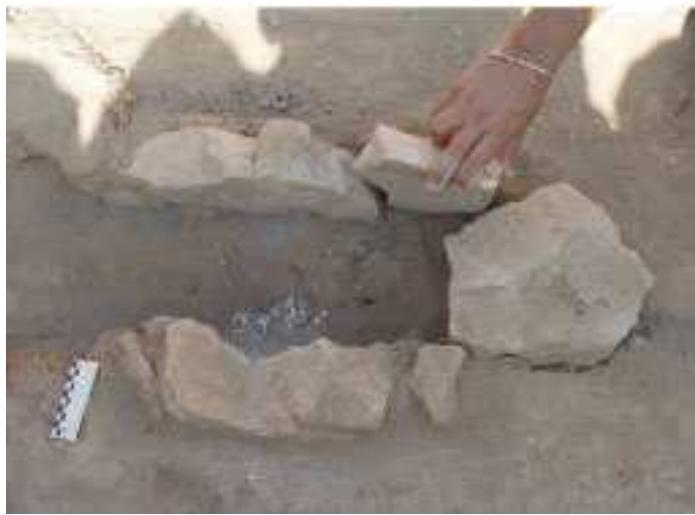
Fig. 2 – The smithing heart found in Room A73

Only scanty evidences of furnaces have been identified. This is not surprising, since in most ancient sites metallurgical structures are only poorly preserved. Thus we could observe "in situ" only the remains of one smithing earth, located in the B area, building BB1, on the ground floor of room A73. It consists of a fireplace dug into the floor. It was an elongated furnace (0.75 m long, 0.44 m wide and 0.26 m deep) made by stone blocks (Fig. 2). The furnace was completely filled with light grey ashes mixed with few burnt bones, marine shells and pieces of charcoal.

Some slag portions was still attached to furnace wall and abundant hammerscales were scattered around the furnace. This finding suggests the presence of very simple organization of smithing workshops. Furnaces were probably partially excavated into the soil and made up with stone blocks. From the size of plano-convex slags we can deduce that the inner size of these furnaces should have been comparatively small.

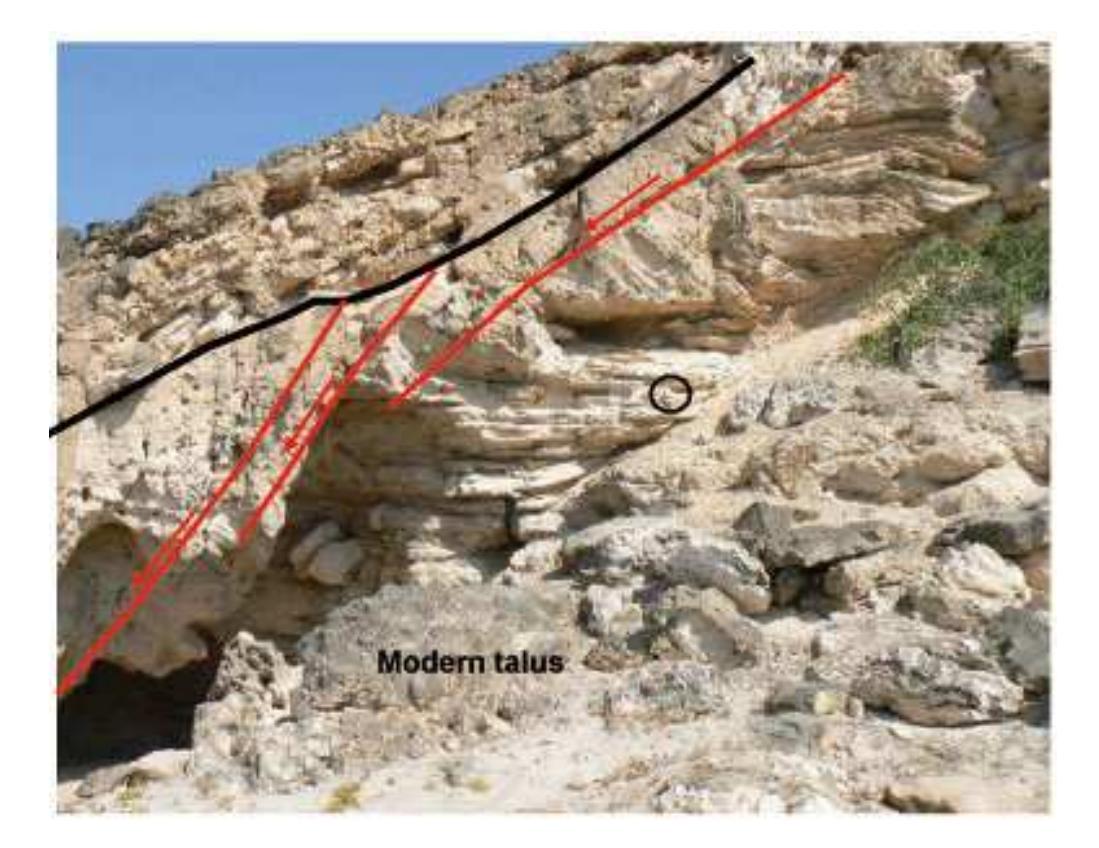
Fig. 6: Outcrop of presumably upper Quaternary coastal deposits few km east Khor Rori, encircled hammer for scale. Faults (red lines, arrows indicate downthrown blocks) crosscut plane-bedded, calcarenites indicating an ancient shoreface. These deposits are sharply overlain by a slope breccia unaffected by faulting. This outcrop reveals an active tectonics at this site in recent times.

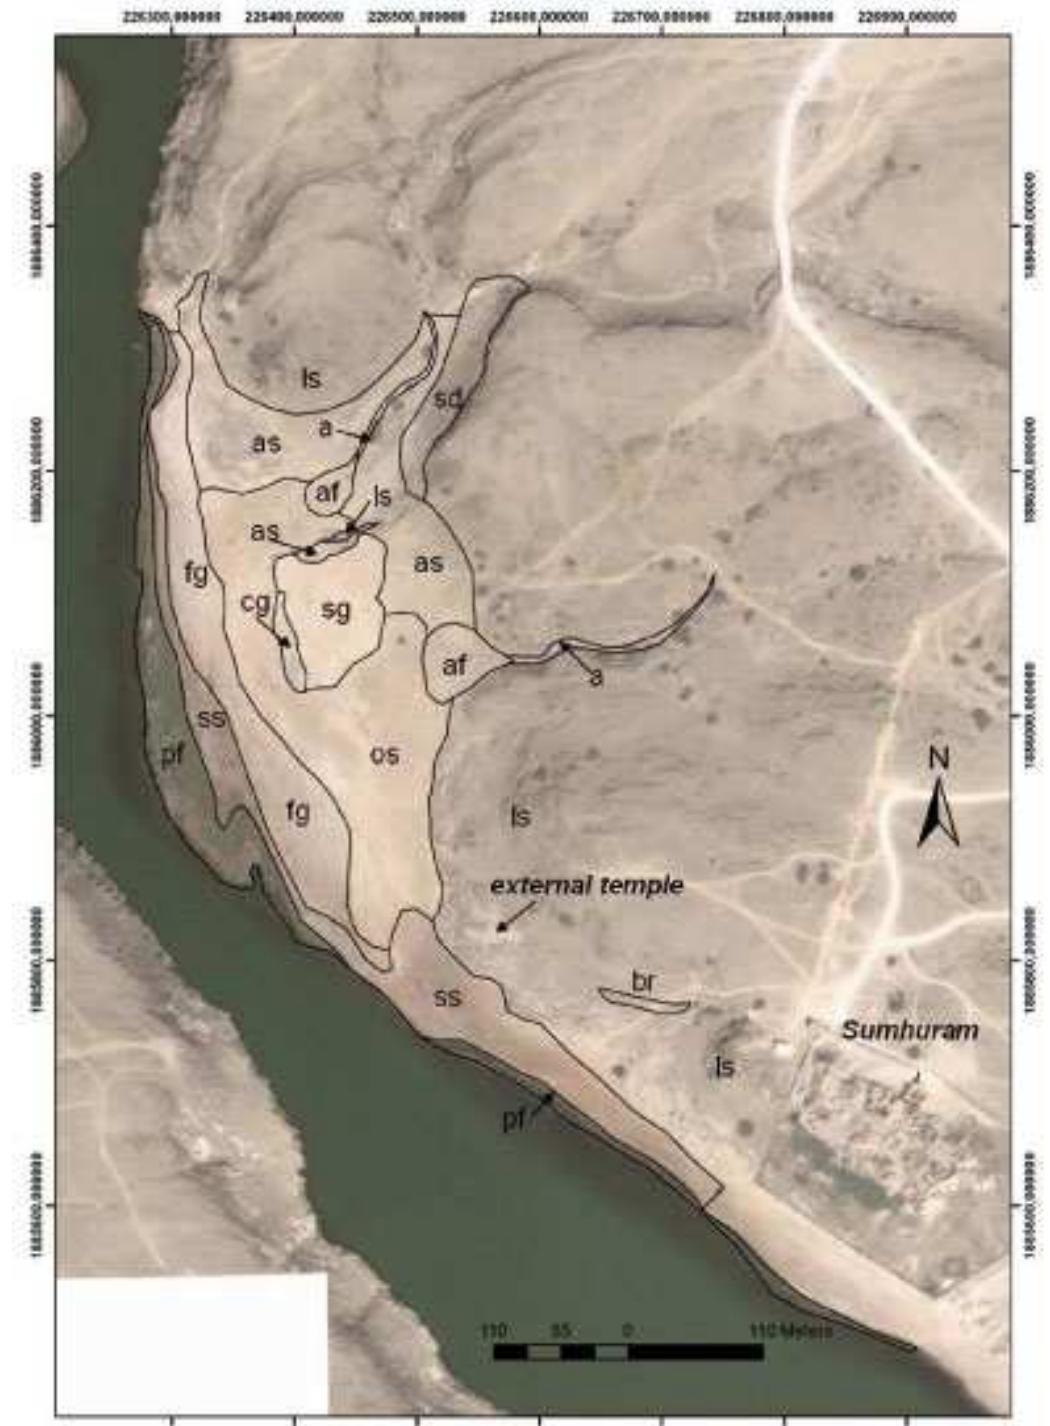
Fig. 7: Preliminary geomorphic map of the Late Quaternary surrounding Sumhuram, annotations are made on a high-resolution satellite image available in Google Earth, numbers in the grid refer to UTM coordinates. Legend for codes: pf: palustrine fringe; ss; salty soil; fg: flood gravel; os: overbank silt; sg: loose sand and gravel; af: alluvial fan; a: alluvial; sd: slope debris; as: abrasion surface; cg: cemented gravel; br: beach rock: ls: limestone

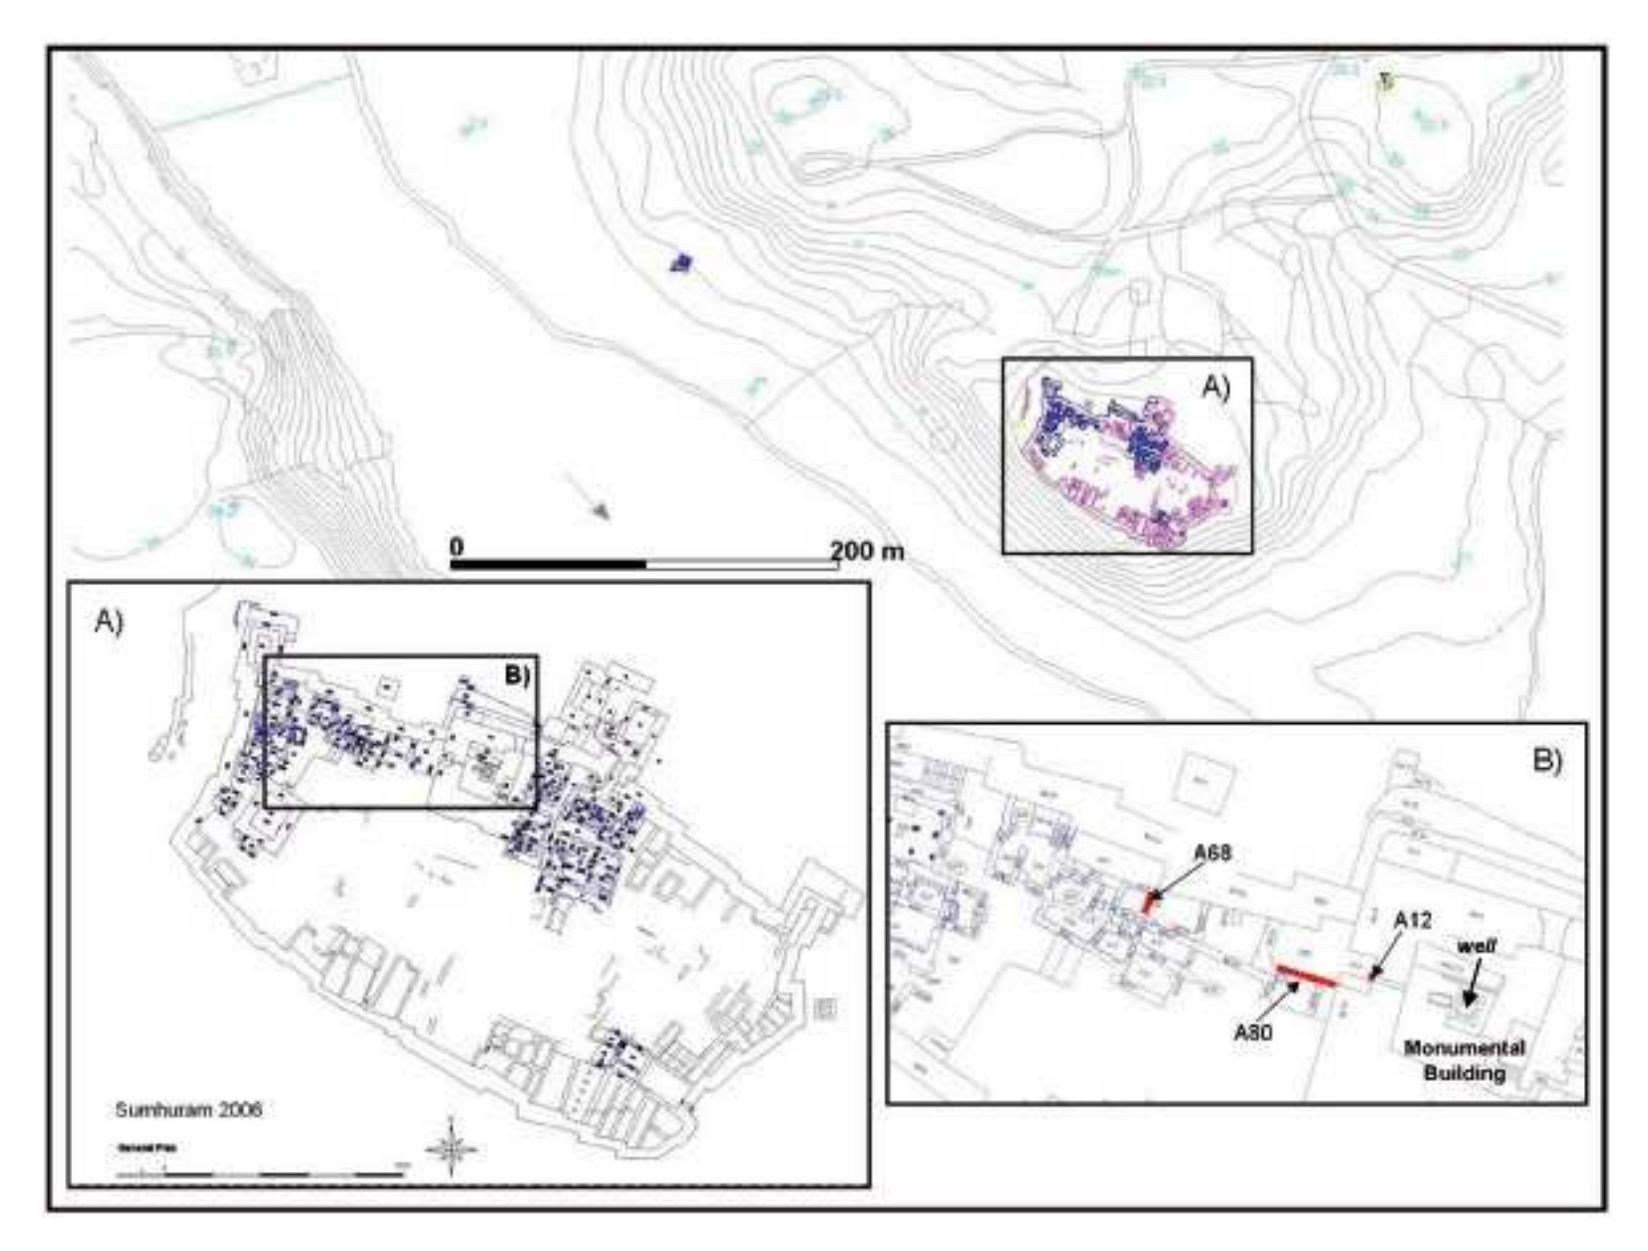
Fig. 9: Location and topography of Sumhuram. A) the excavated areas in February-March 2006; B) details of the NW portion with location of the studied sections

Basing on the available topography (Fig. 9), the examined part of Sumhuram is 5-3 meters lower than the surrounding areas, suggesting an original topographic gradient of the limestone plateau on which it was built, that could have regulated an eventual internal drainage of the town. In agreement with this consideration, archaeological sections in more elevated parts of the town, such as section A77 (Fig. 14), lack such waterlain sediments being exclusively characterized by a complex interfingering of anthropogenic debris and deposits related to the degradation and fall of walls.

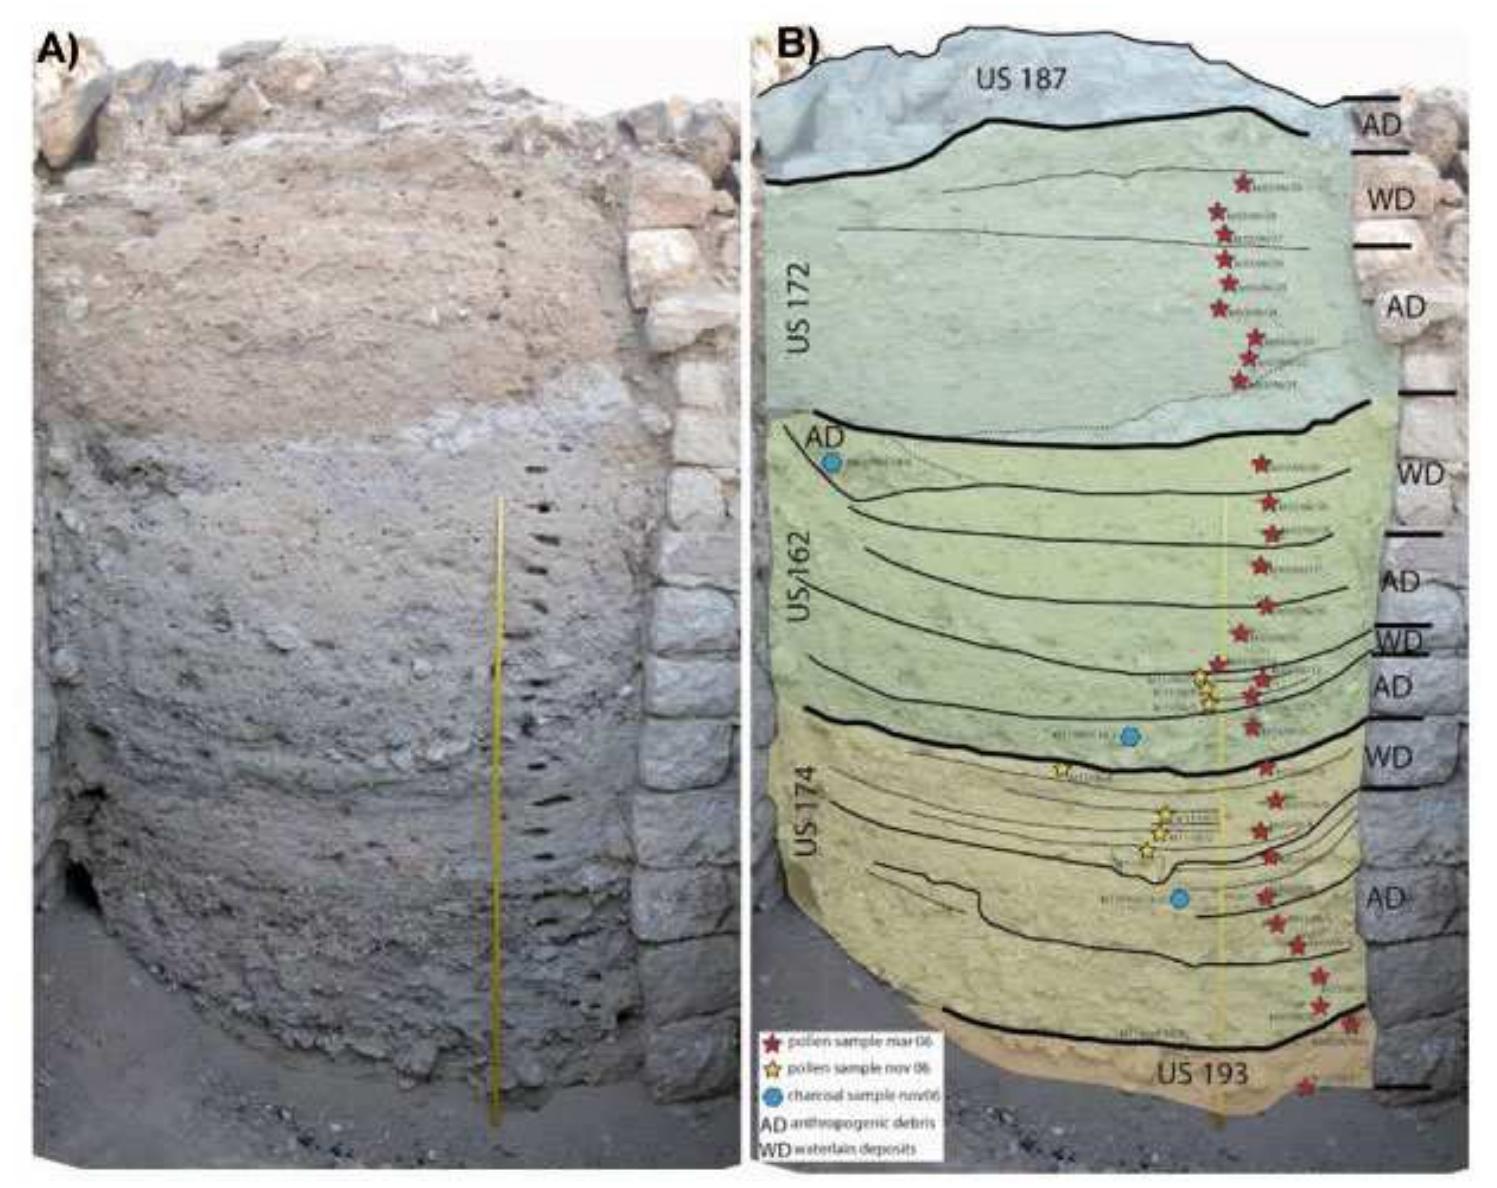
Fig. 10: Section A68. A) photograph taken on November 2006, rod is 2 m long; B) stratigraphic interpretation and position of the pollen and charcoal samples. The reference to the US stratigraphy is shown: US 193-172 should record the entire lifespan of the town. US 187 is referred to recent re-occupation or frequentation of the site. To notice that the US may bear one or more units made of waterlain deposits (WD) whereas periods of frequentation are recorded by debris made by a mix of sediment, bones, charcoal and other debris related to building waste or to human activities (AD).

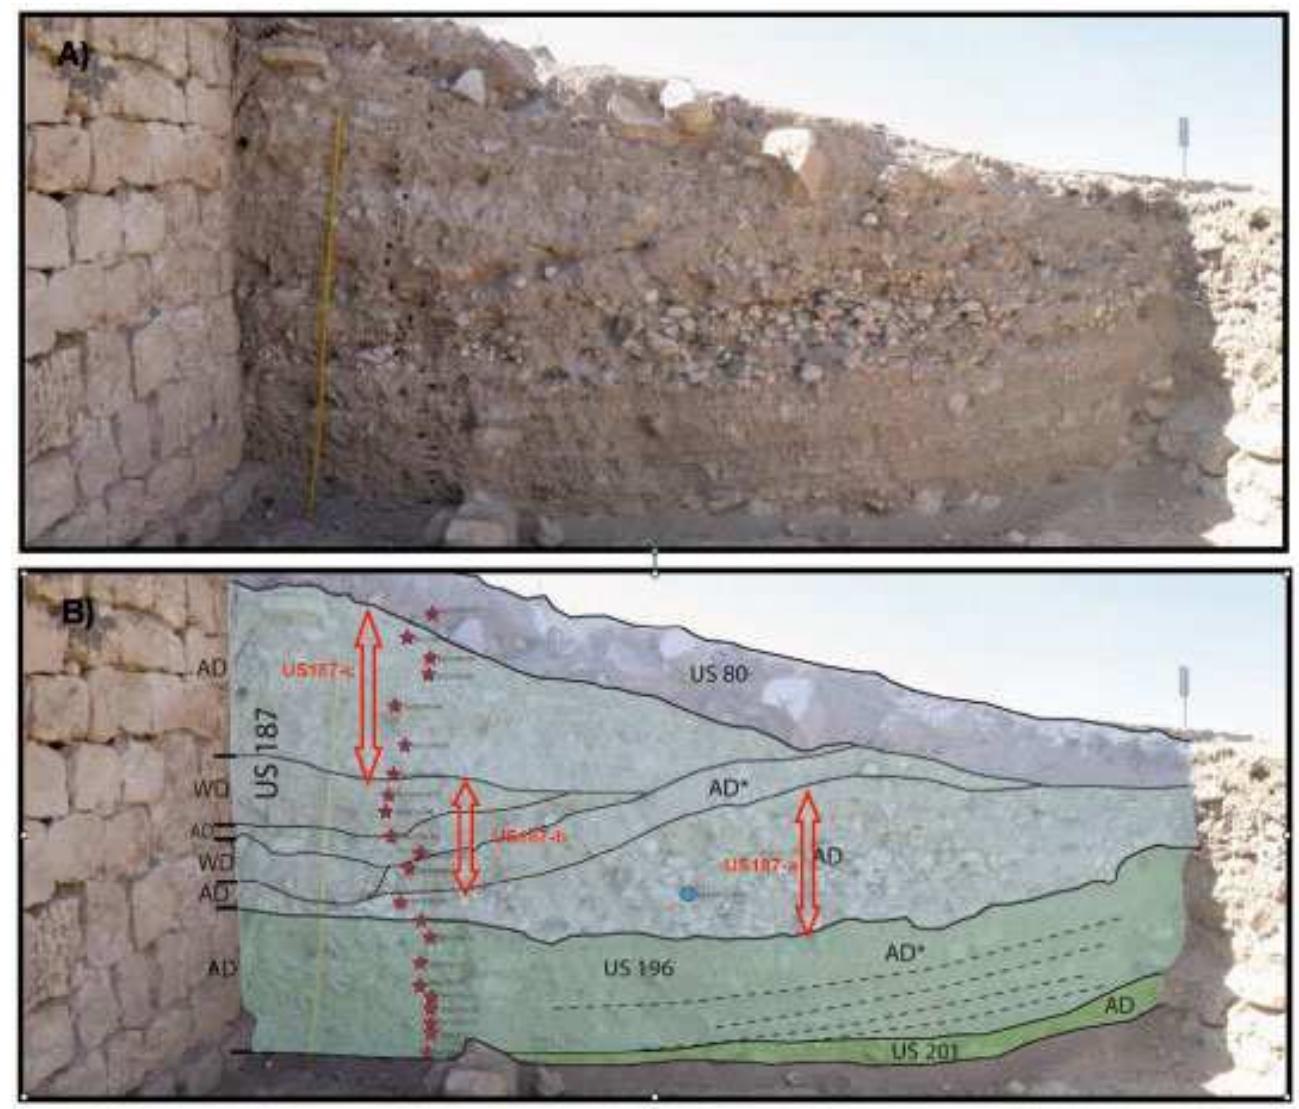
Fig. 11: Section A80. A) photograph taken on November 2006, rod is 2 m long; B) stratigraphic interpretation and position of the pollen and charcoal samples: reference to the archaeological stratigraphy is shown. Codes and symbols as in Fig. 9. In analogy with section A68, US 187 is considered to record the abandonment of the town. Nevertheless, its internal architecture suggests a complex sequence of events: US187-a outlines a lobe of anthropogenic debris including dispersed large fish bones, charcoal, lenses of stones free of interstitial sediment; US187-b records a phase of intermitting waterlain and anthropogenic sedimentation (AD*: anthropogenic debris possibly reworked by some fluidal flows as indicated by the inclined layering in US196); US187-c records a further phase of massive anthropogenic deposition. In terms of sedimentary features, US187-c strictly resembles US 172 in section A68 whereas US 80 shows a closer similarity with US 187 and appears related to recent wasting of walls.
