IMTO -Italian Mission To Oman-

SUMHURAM

PRELIMINARY REPORT

November – December 2006

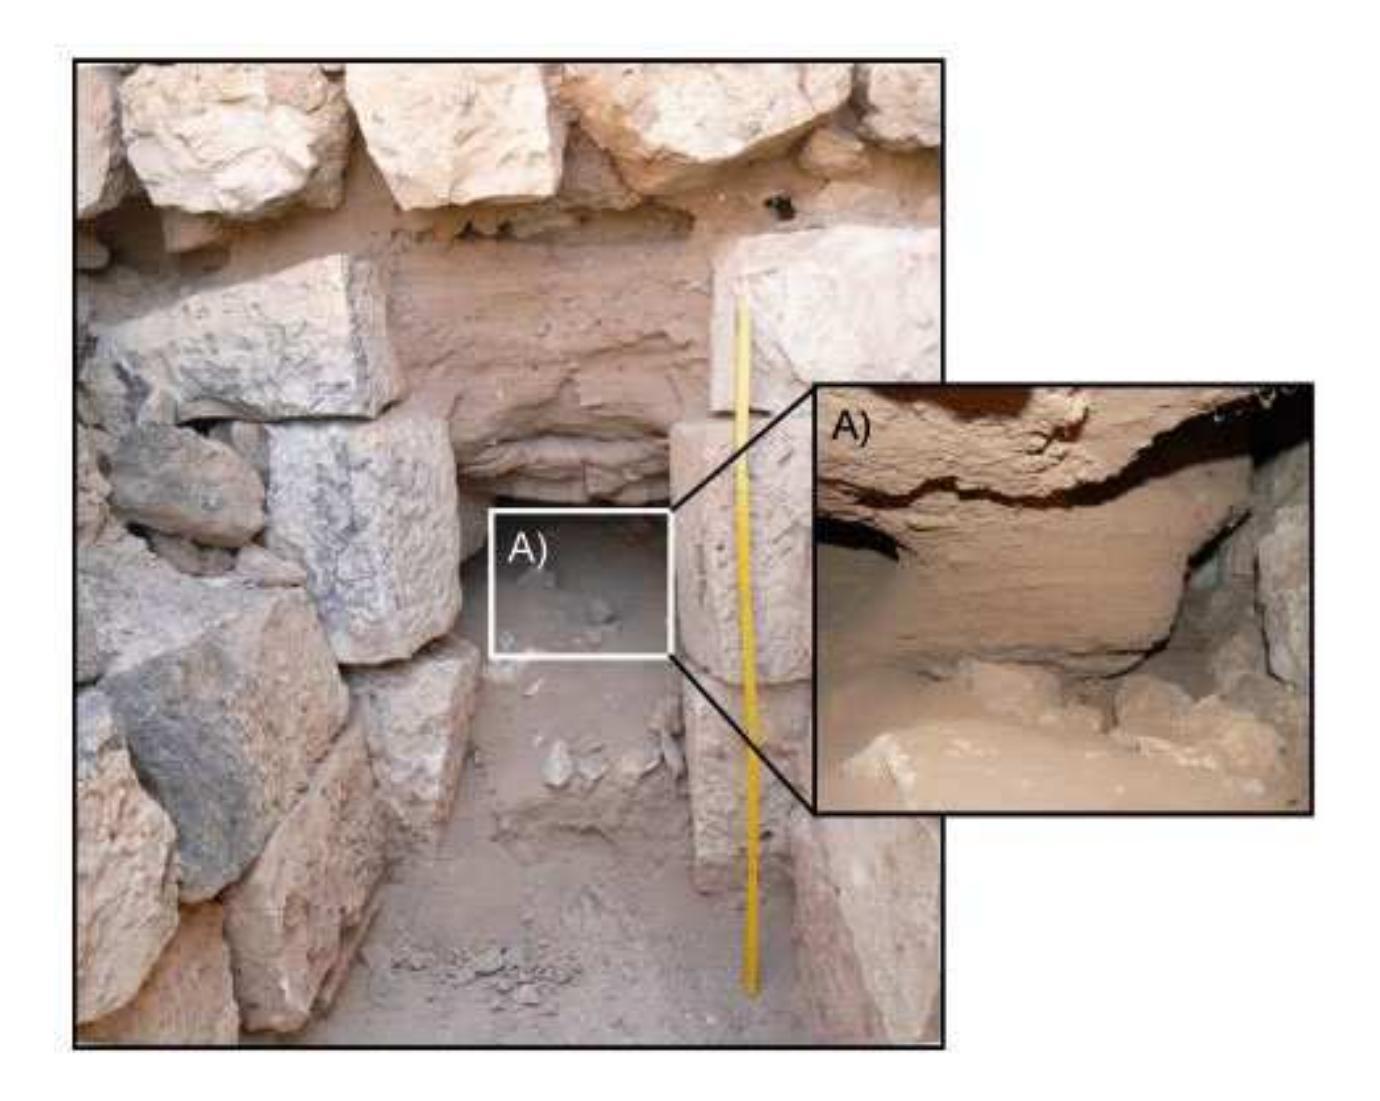
Fig. 12: Laminated sand and silt in section A12, rod is 1 m long. The waterlain deposits filling the fissure have been partially excavated during the American Archaeological Mission. A) photograph taken inside the fissure showing the complete filling by the laminated deposits.

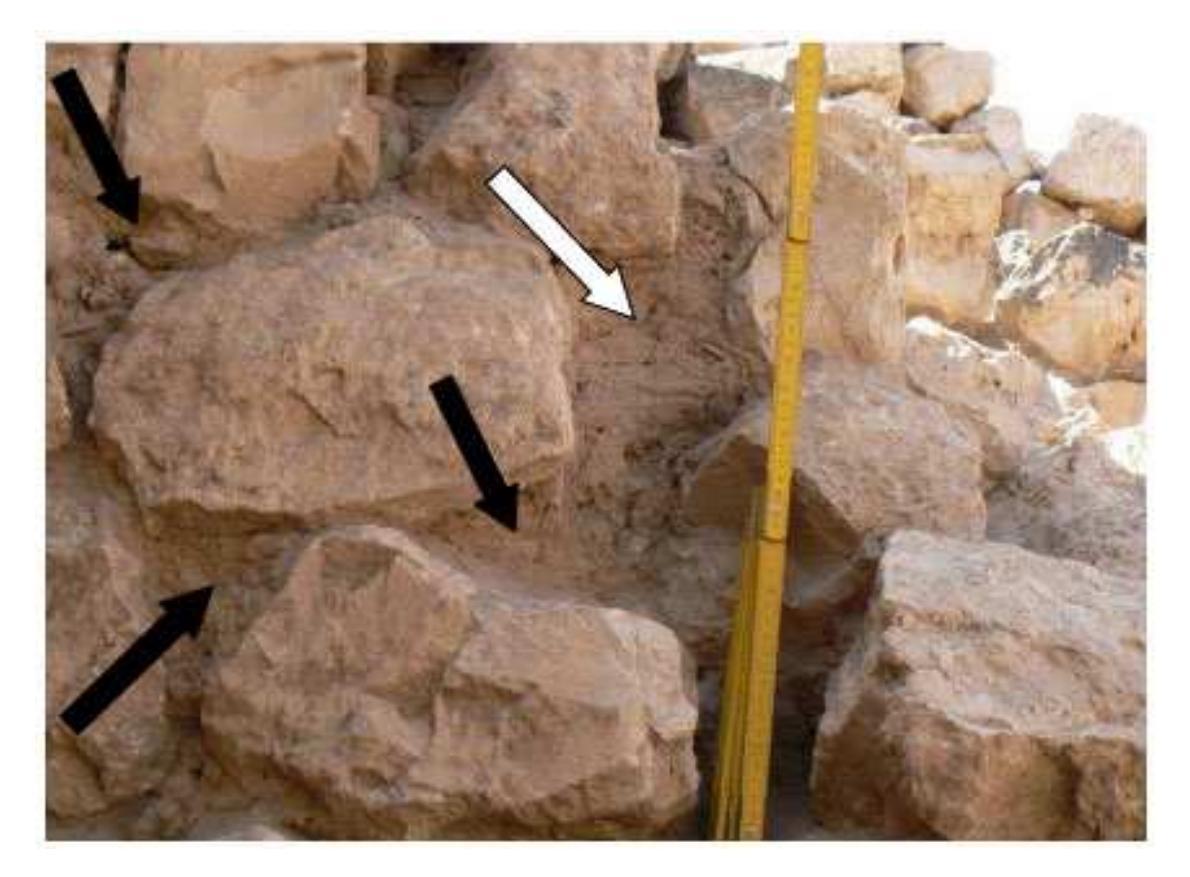
Fig. 13: Evidence of waterlain sediments within the M175 wall, section A68. White arrow indicates laminated sand and silt which differs in texture and sedimentary structure from the massive earth (black arrows) originally used to fill the stony framework.

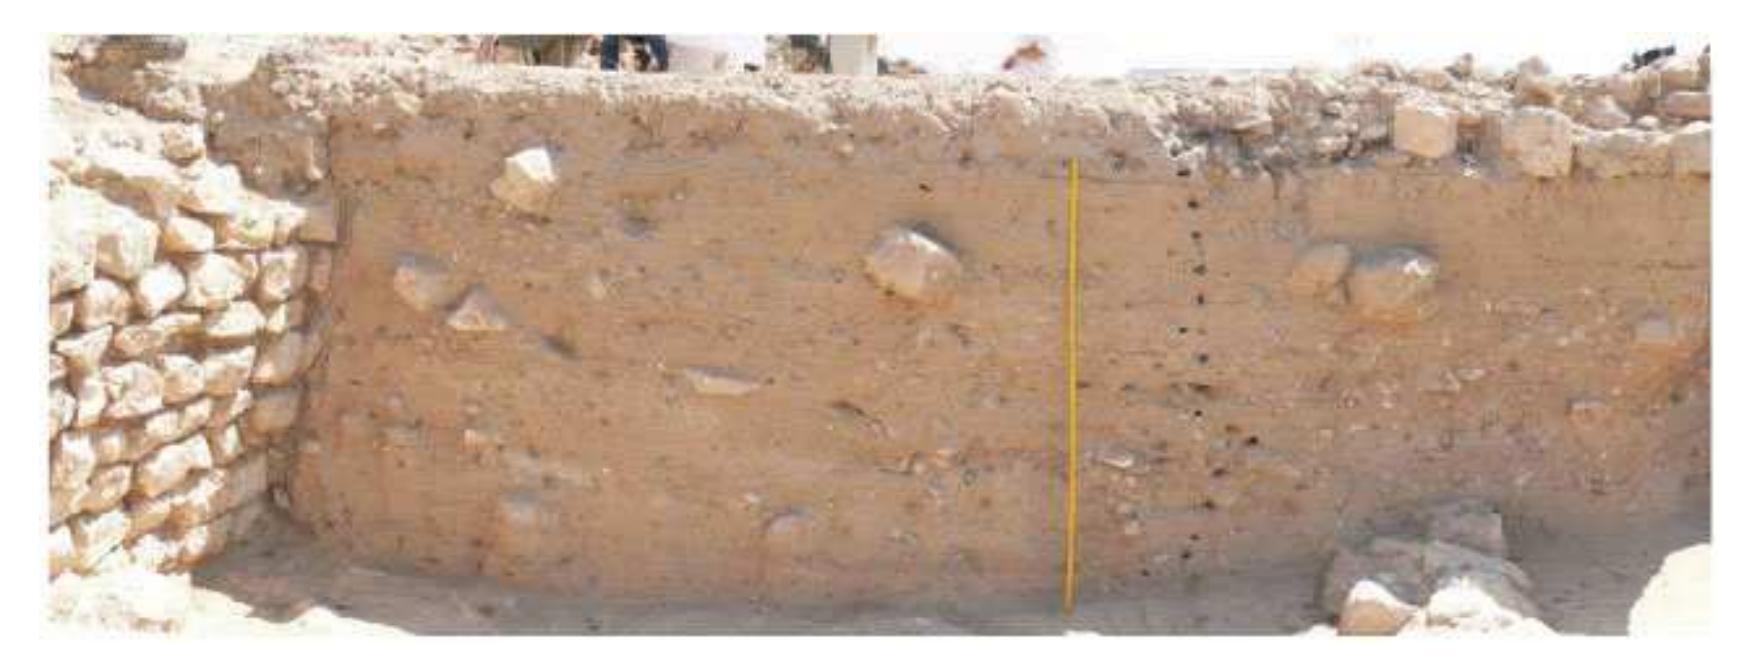
Fig. 14: Section A77 (south-eastern and more elevated portion of the town) on November 2006, rod is 1,4 m long. The stratigraphic architecture is characterized by sub-horizontal beds of mixed debris derived from human activity. Large clasts floating in the fine-grained sediment could reflect fall of stones from the adjacent walls. No clear evidence of flowing water has been detected.
