**IMTO – Italian Mission to Oman**

**SUMHURAM**

**Preliminary Report**

July 2009 (SUM09B)

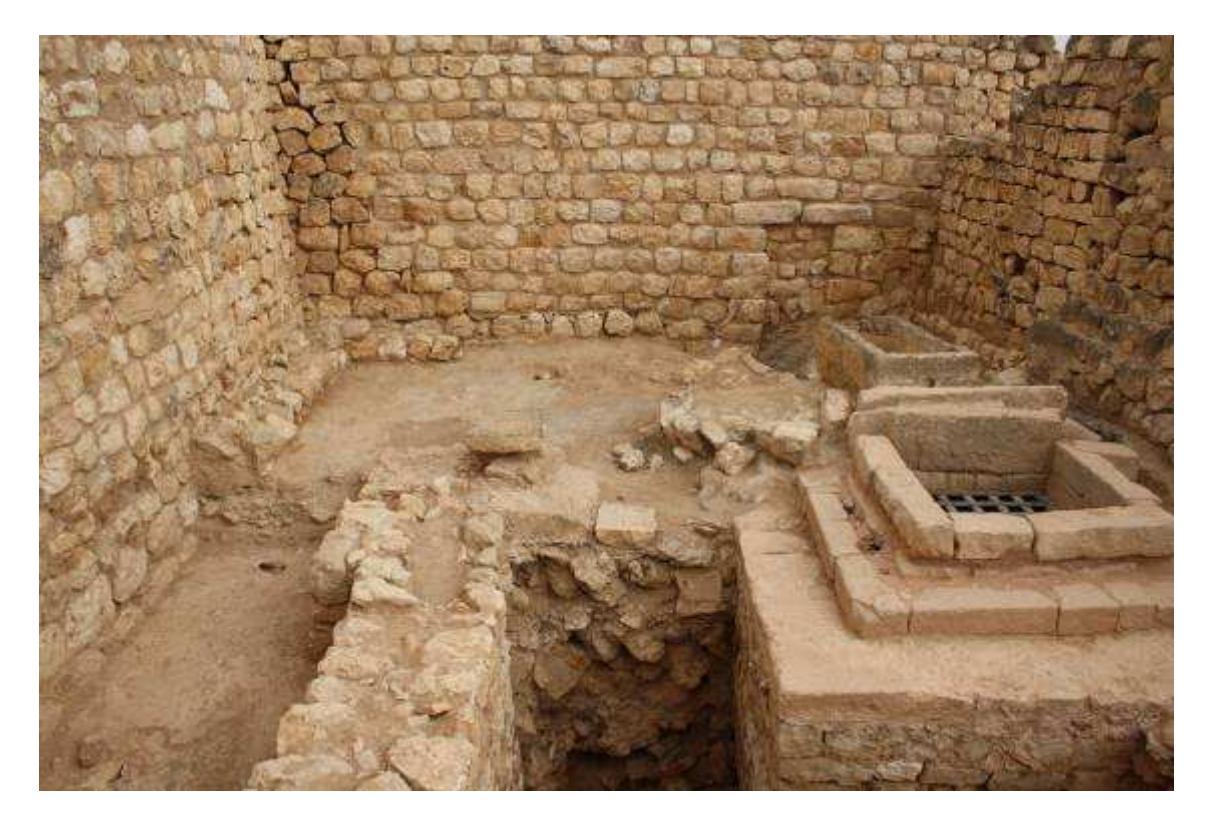
Fig. 1:Area A - the Monumental Building (MB) before the excavations

The campaign carried on during the three weeks of July (figs. 1-2), although short, let us to confirm the existence of two big constructional phases of the MB with quite numerous different works concerning maintenance and rebuilding during the long occupation of the structure.

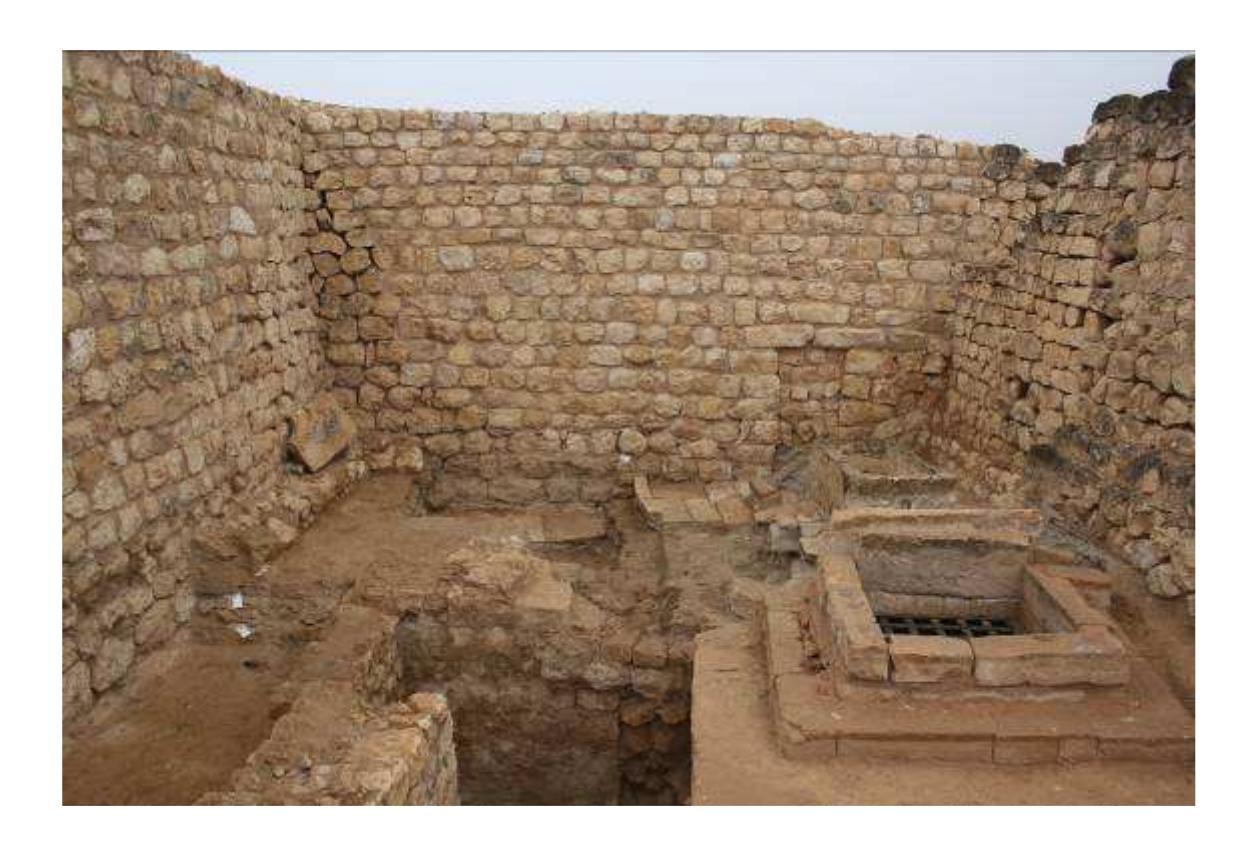
Fig. 2: Area A - Monumental Building (MB) after the excavations

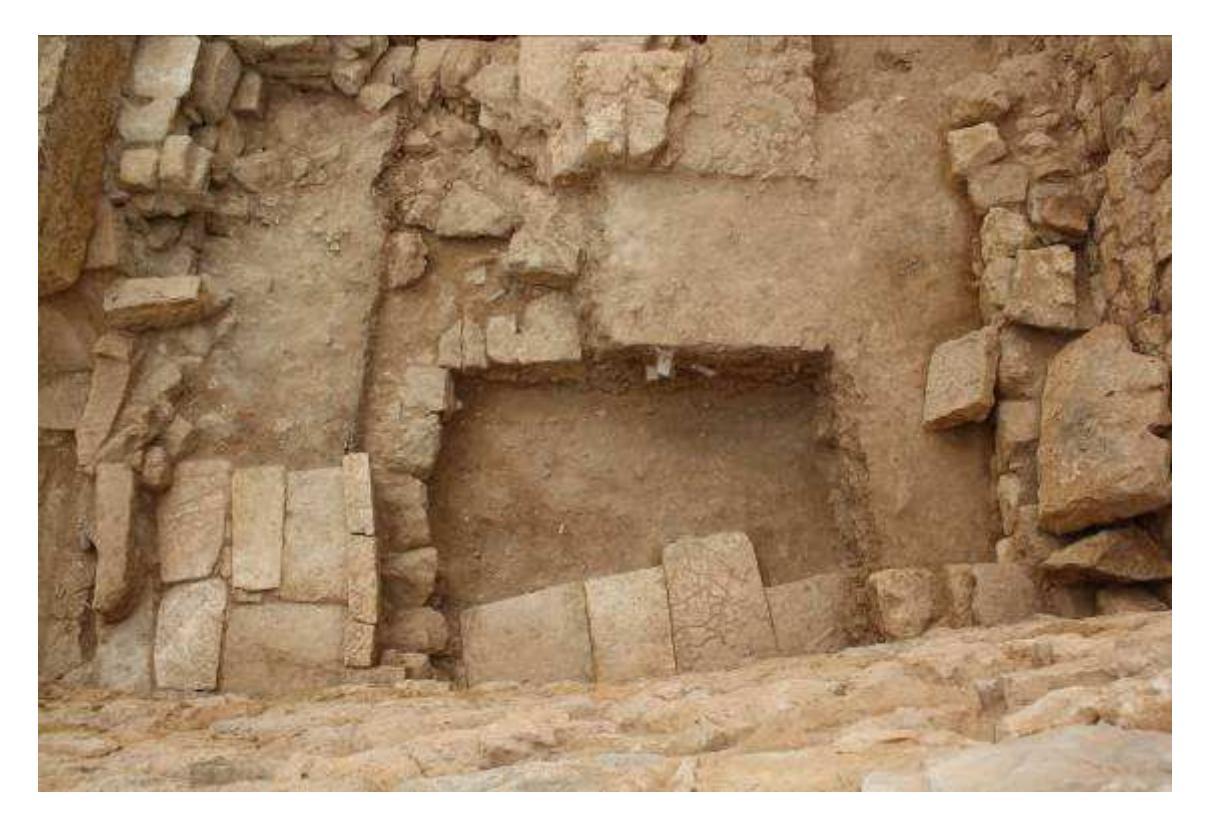
Fig. 3: Area A - Monumental Building (MB), the paved floors

Contemporary we started to dig a trench near wall M18 with the goal of reaching the foundation of M18 (dimensions of the trench: 1.8x2.4 m circa, see sketches 3, 4). It has not been possible to satisfy our purpose because of the finding of some slabs which are interpretable as what remains of the first floor of the MB in its second phase (US337floor) as confirmed also by the elevation (26.84) which is at the lowest level among the floors brought to light in the court of MB (fig. 3).

US337 floor (elevation: 26.84) actually consists in a series of 4 slabs (but a fifth is recognizable under wall M346 and some others are supposed to stay in the un-excavated area southward, towards M17, below the benches and the floors) with the dimensions of 0.66x0.58; 0.43x0.62; 0.47x0.80 and 0.46x0.51. The average thickness is 9.5 cm. Traces of plaster, probably used as binding material, are visible on the short sides.

The idea is that M346 as well M347, perpendicular to it and also made from just a row of 4 sandstone blocks, have been used to raise up the foundation of a second floor, US341floor, made, this too, of flat and polished limestone slabs (elevation: 27.24).

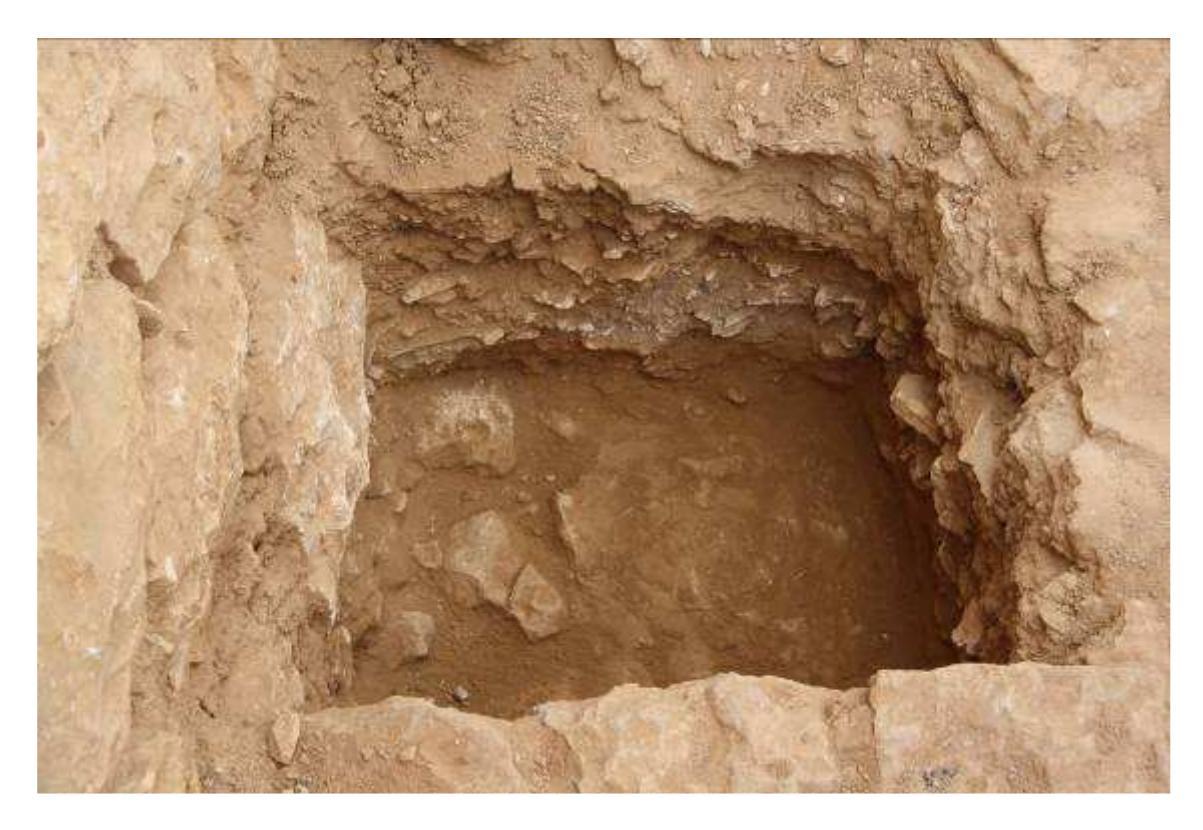
Fig. 4: Area A - Monumental Building (MB), deep sounding in the corridor near M17

The last operation performed in SUM09B was the digging of a deep sounding in the corridor (fig. 4) with the goal of checking the existence of steps of an hypothetical staircase connecting the entrance with the shaft of the well in its first phase.

A square of 60x60 cm has been excavated in the corner between M17 and the last step going down to the corridor, starting from an elevation of 27.02 (= US262floor).

As already noticed with the deep sounding in room A108 also inside the MB, wall M17 does not insist directly on the bedrock but covers a thick and very hard layer of chips and earth, i.e. the foundation filing which has always been individuated upon the bedrock.

The foundation of the wall is at an elevation of 26.57; the bedrock has been reached at an elevation of 26.24.

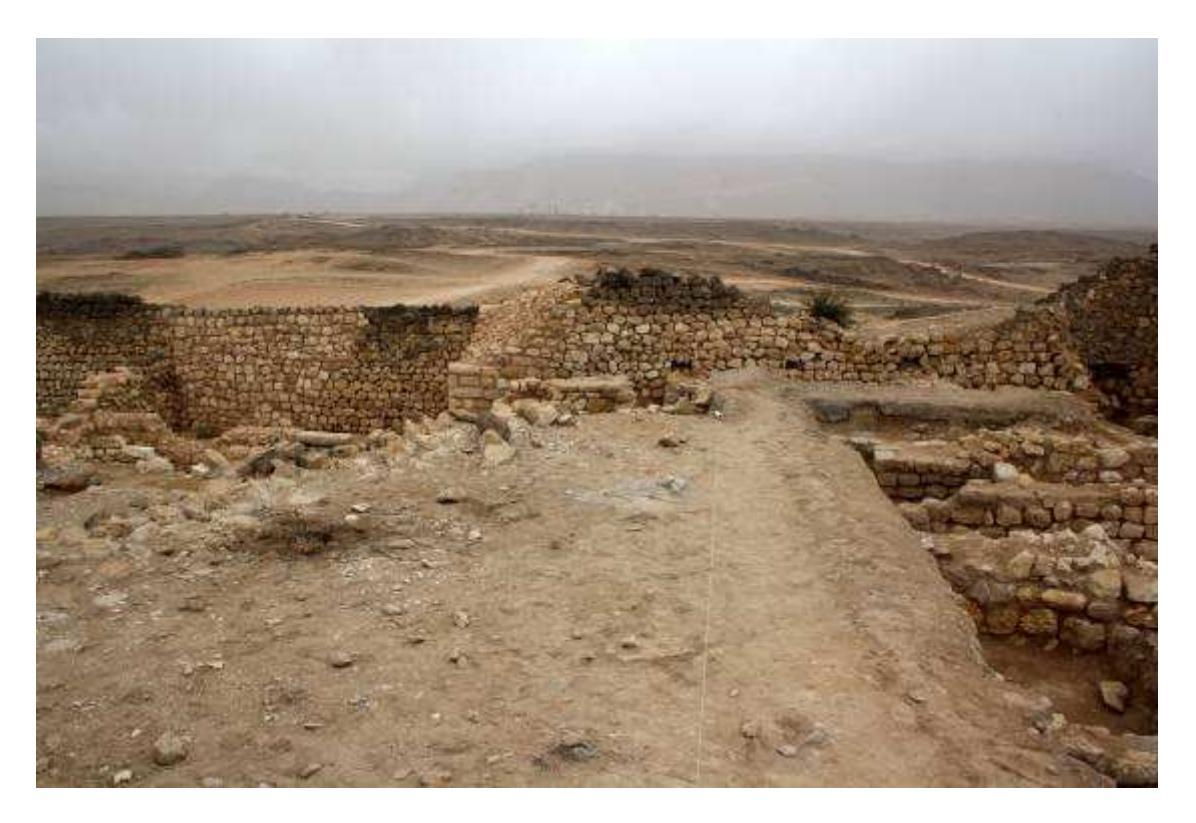
Fig. 5 - Area F: the sector before the excavation works (from the south).

The limits of the trench were the following: the modern raised platform of the tourists path to the south; the wall – partially excavated – of the building BF6 (M155), to the north; the bulk itself to the east and, at least at a first moment, an accumulation of surfacing stones, placed obliquely, to the west (fig. 5).

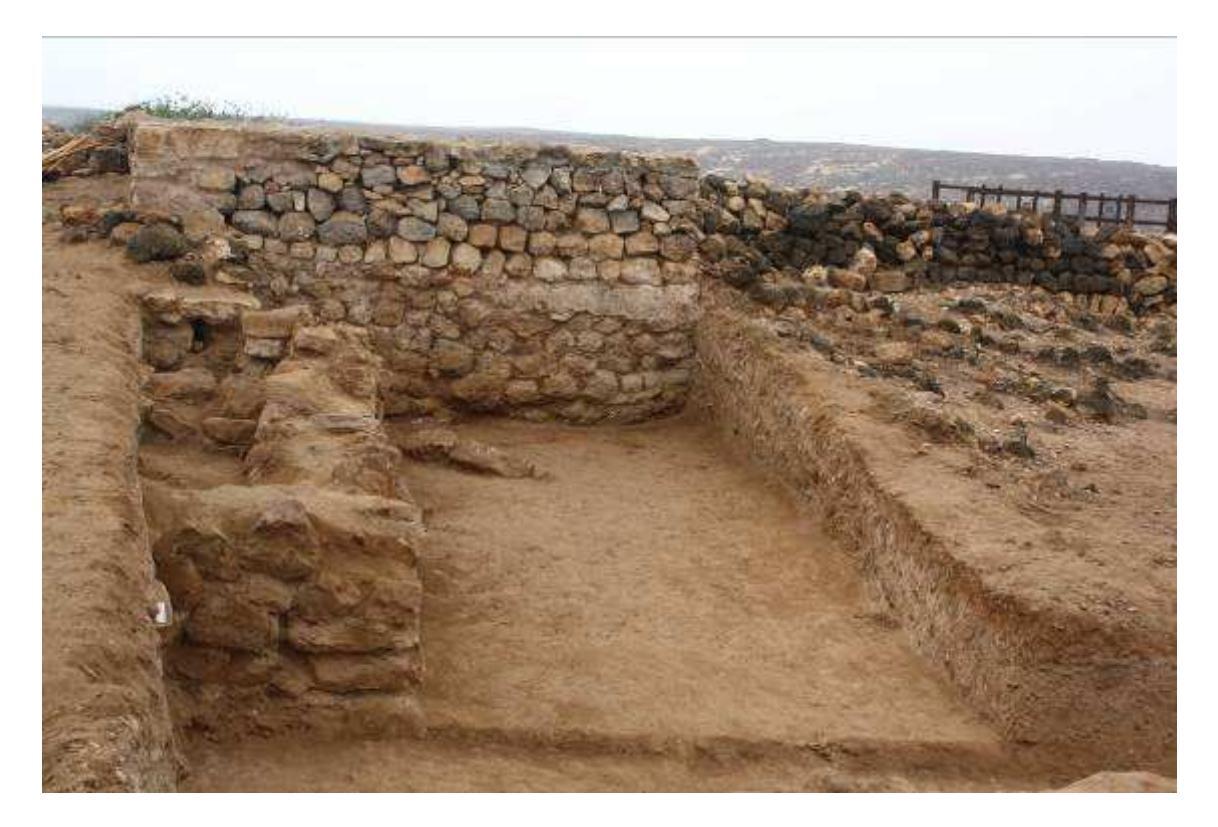
Fig. 6 – Area F: the excavated trench with the modern platform and the wall M340 (from the north).

Under the southern modern platform an ancient wall (M340), oriented east-west, was visible from the beginning. This wall, excavated only in its northern face, goes down until the level reached in the trench (placed at an elevation of 28.08 m). It was clearly related with another perpendicular wall (M339), whose top was emerging from the surface. The masonry of the two walls is tied and, in addition, both the walls are covered (at the same high level) with an unique stratum of whitish plaster (fig. 6).

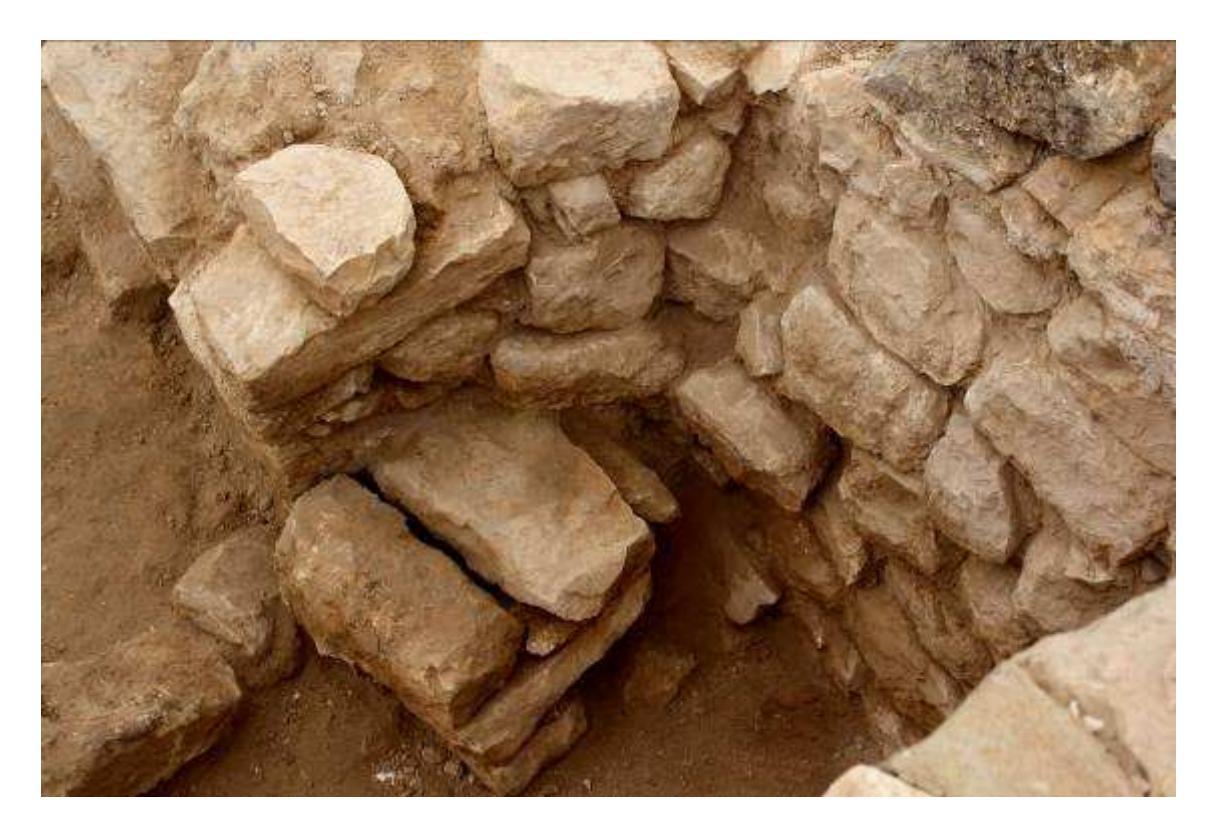
Fig. 7 – Area F: particular of the walls M343, M344 and M339.

Rather close to the eastern limit of the trench the perimeter wall M343, which closed the building BF7 to the western side, has been unearthed and excavated for a height of 1.10 m, i.e. for 5/6 rows of stone blocks. The type of masonry is the same of the others walls of BF7, M306 and M307: medium size limestone blocks, roughly worked and not perfectly aligned, tied with a very coarse clay mortar. Its northern corner, tied with the perpendicular wall M307 is well preserved, while its southern corner probably was collapsed and restored in ancient times. In fact, at a lower elevation (28.32 m) of about 0.75 m compared with the top of the wall (and clearly in relation with the layer US313), the original south-western corner of the wall has been unearthed. This small portion of wall, which constitutes also the southern perimeter wall (M344) of the building, appears completely ruined and filled with a clay reddish mortar. It is very probably that this corner was restored in ancient times: the wall in its upper sector was shortened and, in order to strengthen the unstable structure, it was tied to the adjacent wall M339, which appears to be part of a probable more recent building (fig. 7).

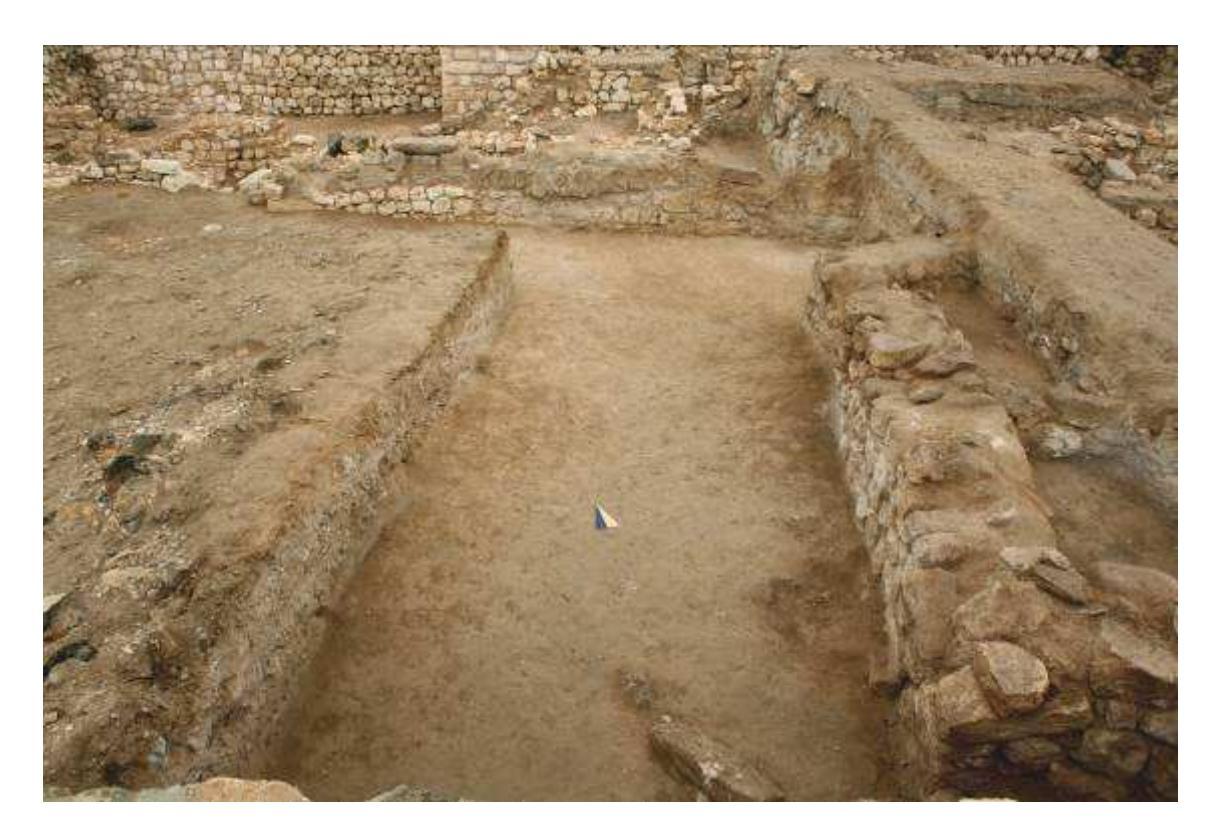
Fig. 8 – Area F: the open space A135 from the south.

After its demolition it appeared clear that the area excavated in front of BF7 was originally an open space (A135), crossing at the north with the street A129. At the present it is difficult to know if this open space A135 was part of the square A20,

constituting its eastern limit, even if this hypothesis is not to be excluded. The area A135 has been excavated until an elevation of 28.08 m, inside the filling US313. For the short time available the floor is not been reached (fig. 8).

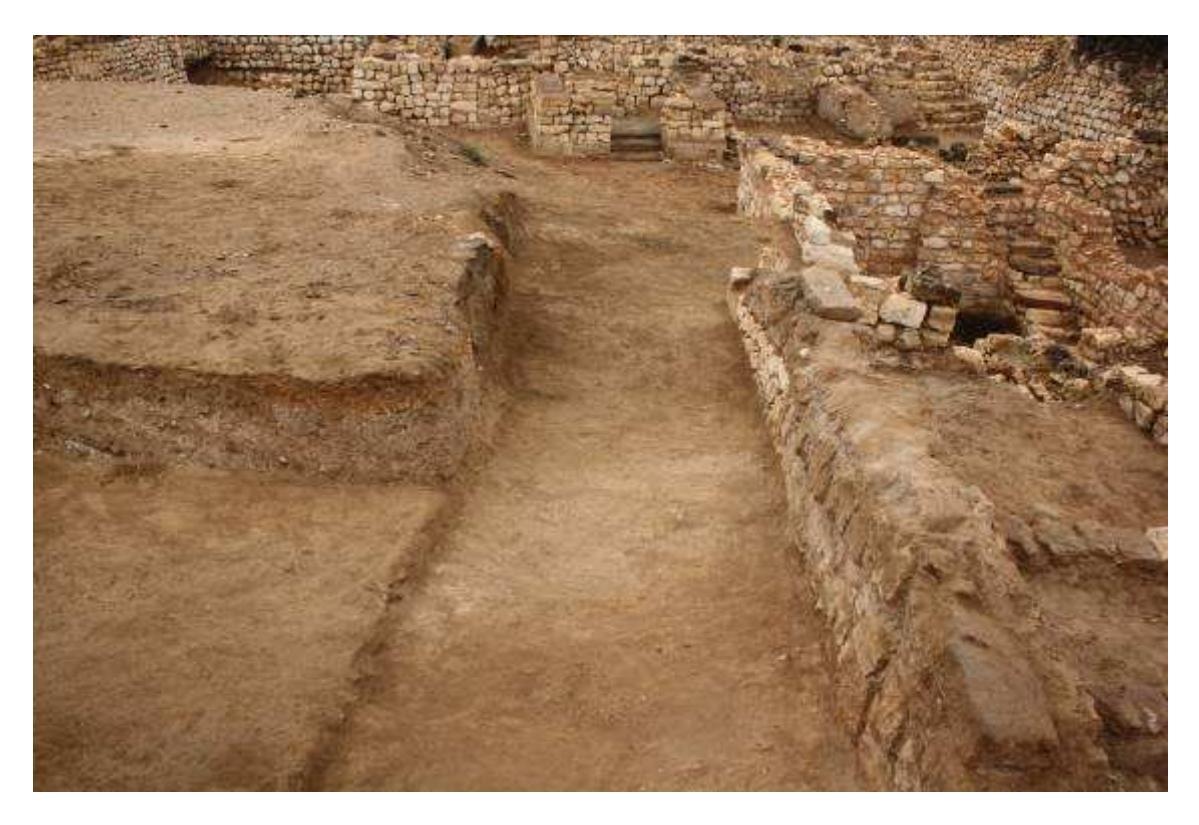
On the right the wall M343 of the building BF7.

Fig. 9 – Area F: the street A 129, from the east. On the right the wall M155 of the building BF6.

The demolition of the wall M341 allowed also the continuation in western direction of the excavation of the street A129, where we was able to reach the floor US313, as in the other eastern sector excavated during the previous mission, behind the bulk.

In addition, the possibility to join with the previous excavations in western direction of the Area F has showed that the street A129, starting from the eastern wall of the Monumental Building, was running directly towards the *intra-muros* temple (fig. 9).

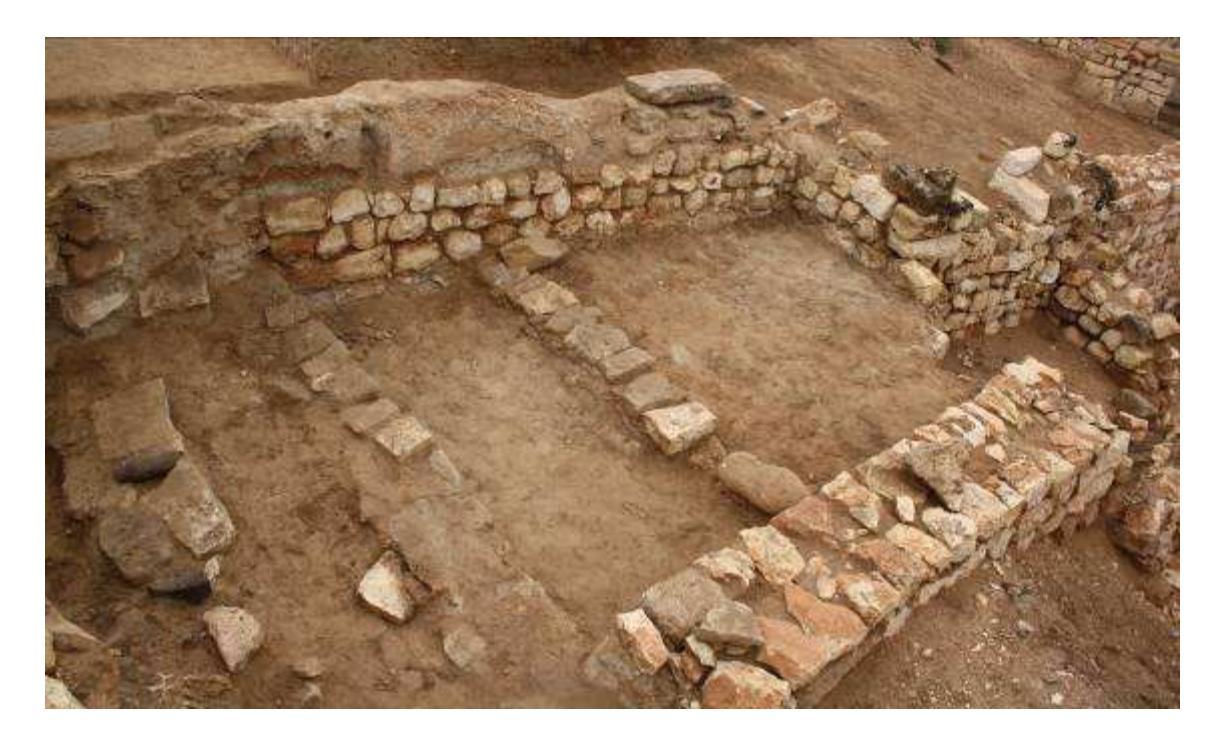
Fig. 10 -Area F: the west sector of the building BF6, from the north-east.

In order to carry out the works in the western part of this building (already investigated by the AFSM expedition), during this short campaign we was able only to excavate a little bit inside the rooms A72 and A72a (US336), to clean the partition wall M345 and the bad preserved wall M160. The presence of the bulk for wheelbarrows, which divides in two sectors the building BF6, doesn't allow to understand if the rooms A71, A72 and A72a was an integral part of the building BF6 or, more probable, constituted a separate new building which was attached later to BF6. In fact we can see, running parallel to M160, a second alignment of stones (which could be the original western perimeter wall of the room A127) and, between the two walls a very hard filling, composed of light brown mud bricks (fig. 10). This filling probably joined the two originally separate buildings, but we have to verify it in the next mission (sketch 5).

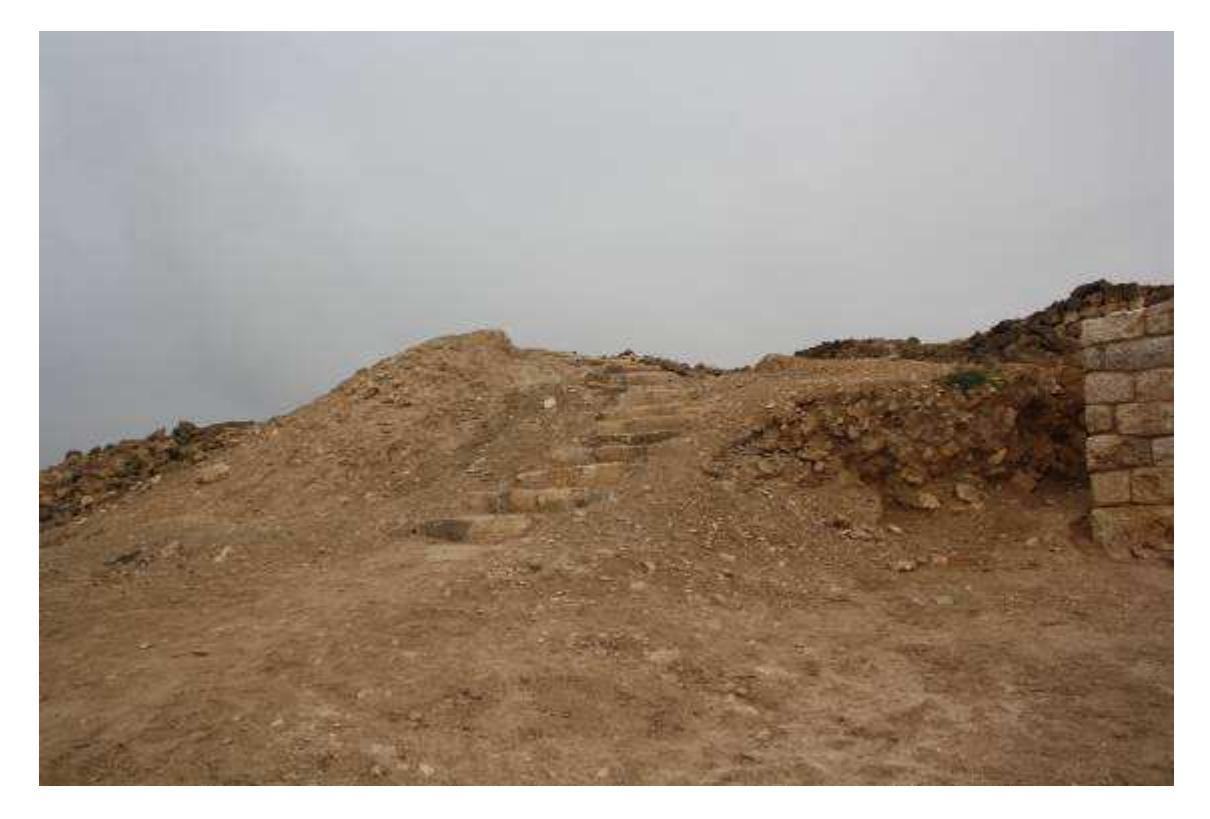
Fig. 11: Area E before the cleansing operations

In order to expose the eastern side of the city wall we started, in this campaign, an important operation of cleansing to remove the dumps accumulated by previous excavations and wind deposition.

The same work of cleaning made by JCB and manually has been performed between the modern staircase and the eastern isolated tower. A large amount of stones collapsed from the city wall and accumulated from previous excavations has been removed.

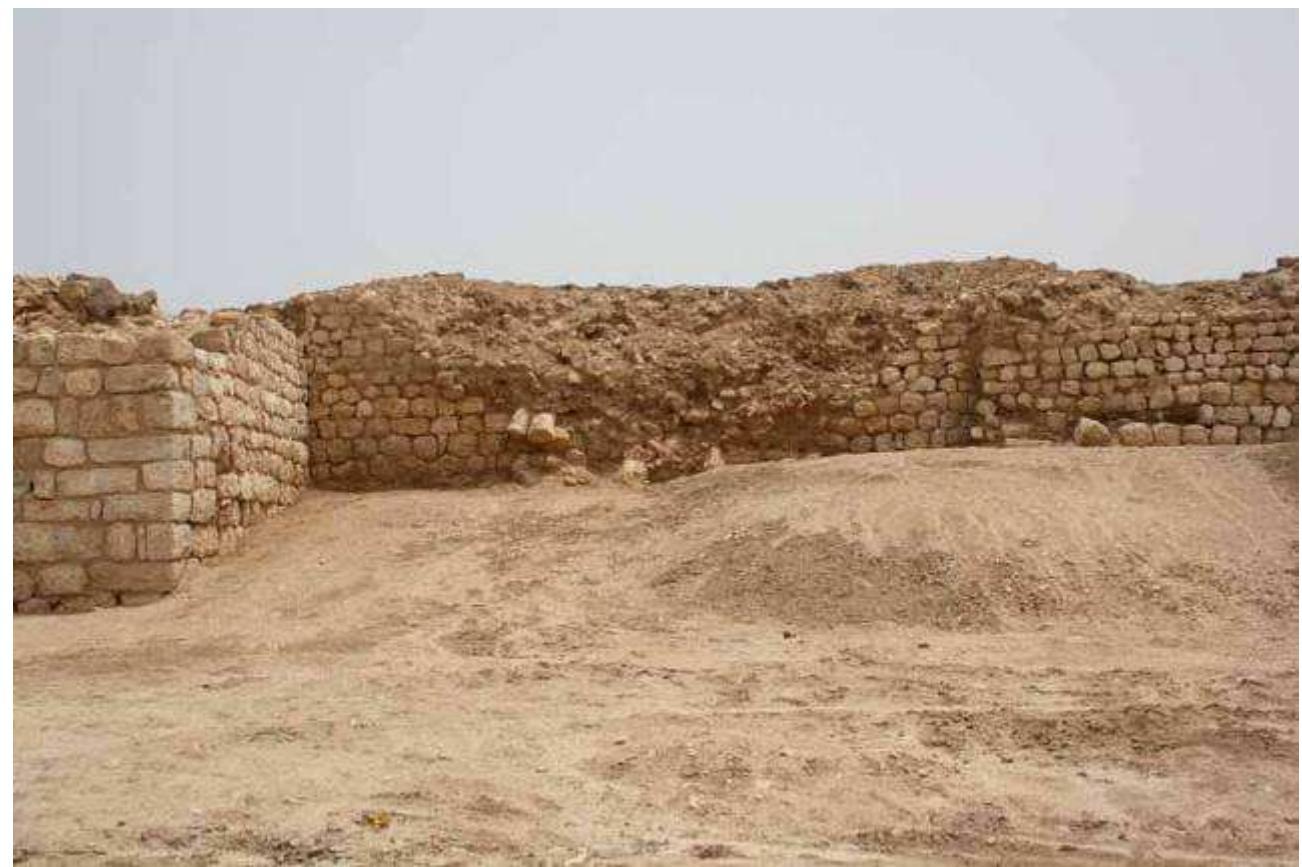
Wall M281 before the restoration from North

The restoration works on wall M281 began on July the 6<sup>th</sup> with the dismantling operations of the damaged parts of the wall itself with a few number of workmen. The stones and the earth forming the wall body were heaped nearby, in the outlook of a following usage during the wall reconstruction. No stone was removed from those parts of the wall featuring structural integrity and a proper masonry arrangement.

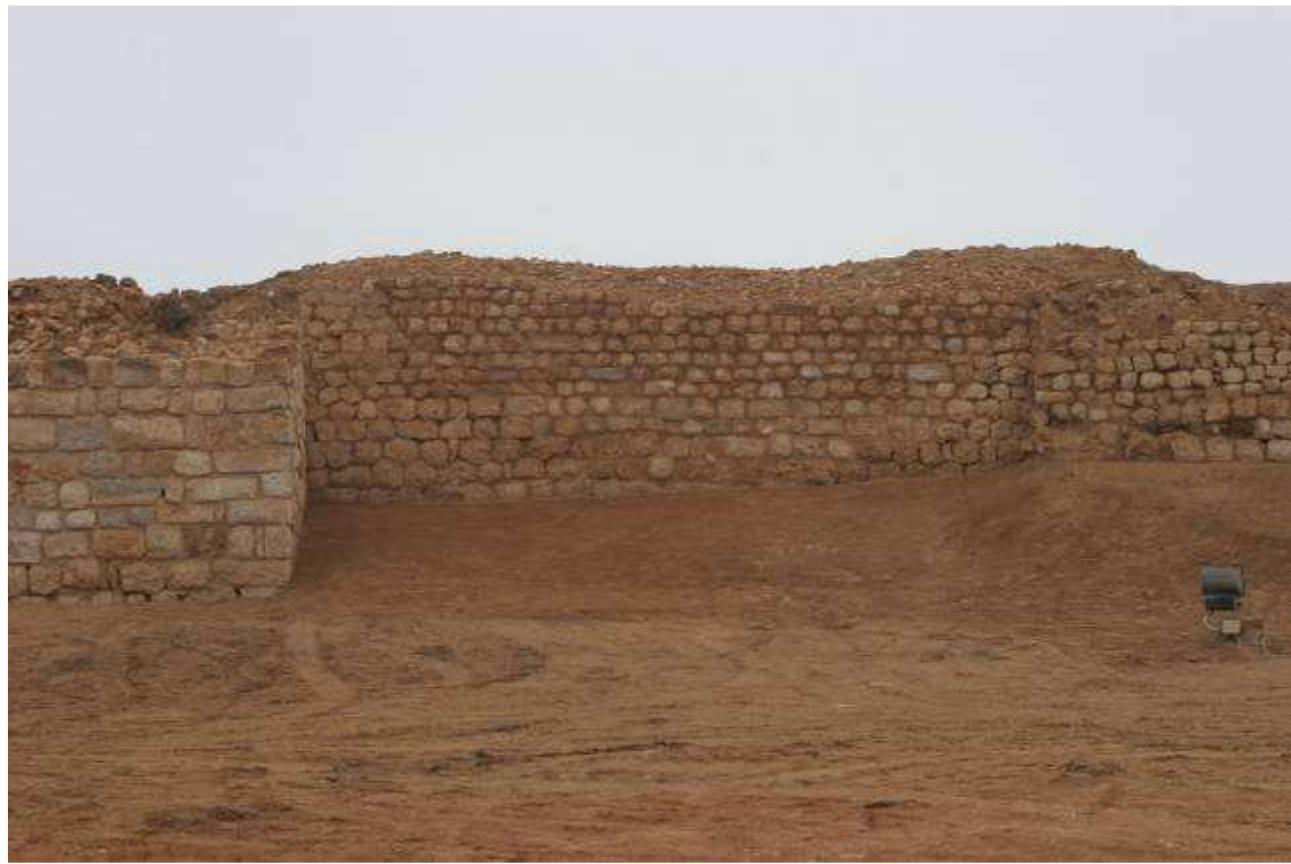
Wall M281after the restoration from North

- *external sides*. Beginning from the structures remained essentially undamaged over the centuries, they have been rebuilt according to the same procedure, elaborated through the walls restoration in the previous campaigns. A film of geo-textile has been posed in the first mortar joint to separate the new rebuilt part of the wall from the old one. At the end 10 completed lines of stones have been rebuilt in the external side with some "steps" made on the top in order to harmonize the wall with the others near by.

- *internal region*. The wall body was rebuilt using stones and layer of mortar. The lime percentage was fixed to 1:20.
- *upper closure*. It was realized arranging stone irregularly, to reproduce the appearance shown by the tops of the other walls. The gaps between stones were filled with the same kind of mortar used for the external sides, and afterwards they were likewise refined, using the described technique.
