IMTO – Italian Mission to Oman

SUMHURAM

Preliminary Report

**RESTORATION WORKS AT SUMHURAM
(ARCHAEOLOGICAL PARK OF KHOR RORI)
(Sultanate of Oman)
CAMPAIGN JANUARY-MARCH 2012**

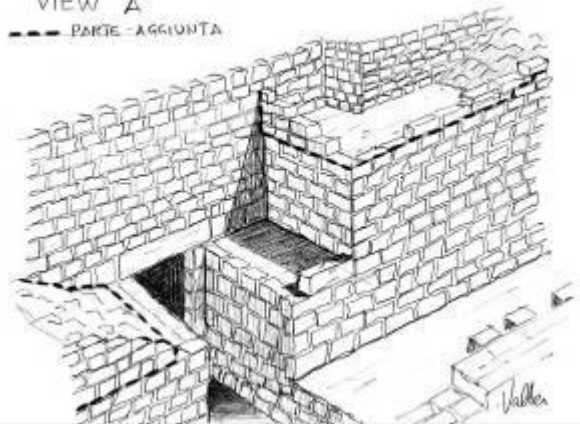
VIEW A
--- PARTE AGGIUNTA

On 18th February 2012, we received confirmation to our suggestion to modify the shape of the walls beside M23 as follows:

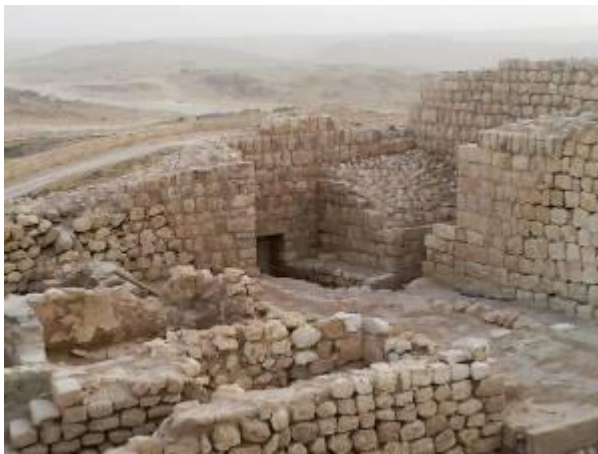
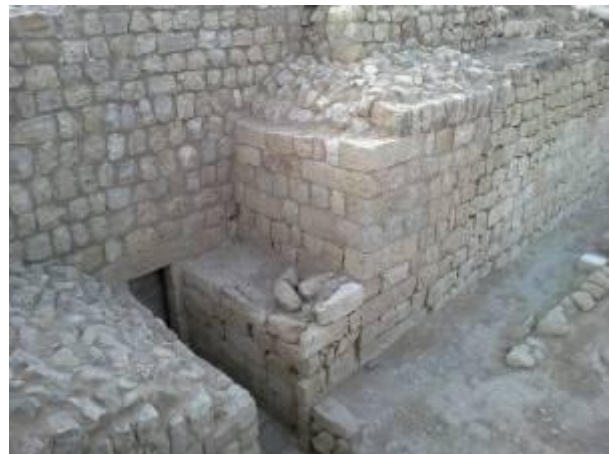
Sequence of photos on the wall M23 – up to 2nd March 2012

This work has been completed on Saturday, 3rd March 2012.

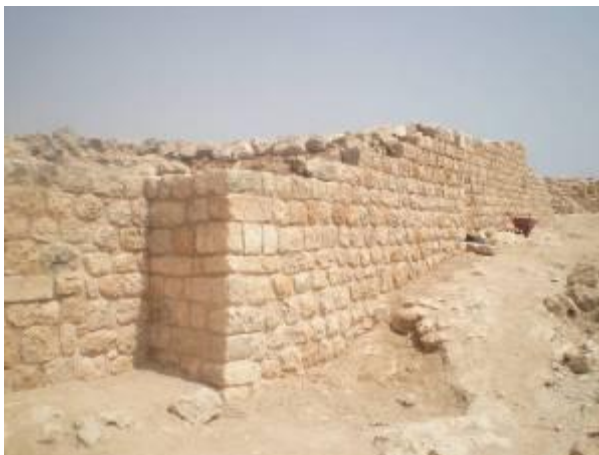
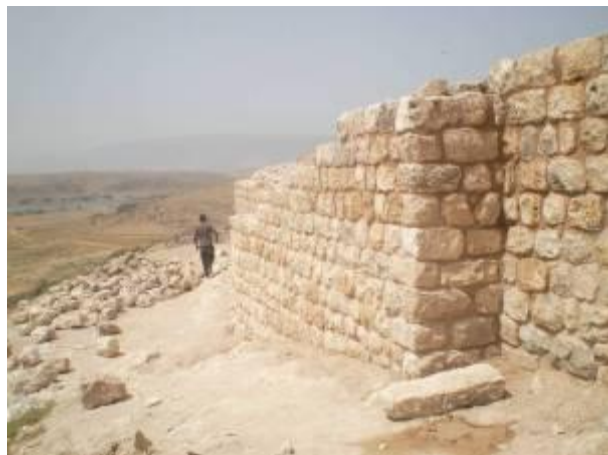
Sequence of photos on the wall M499 – up to 2nd March 2012

This work has been completed on Tuesday, 6th March 2012.

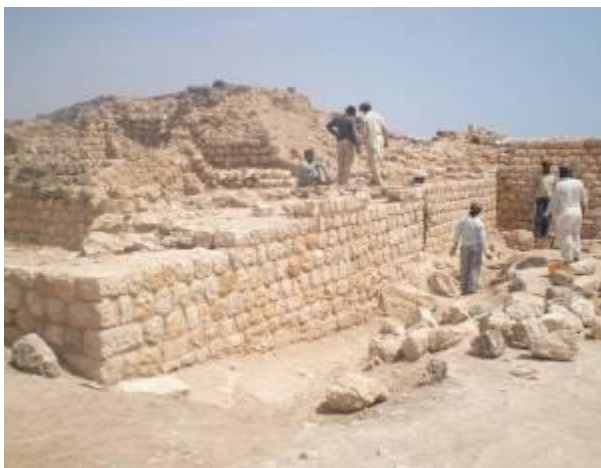
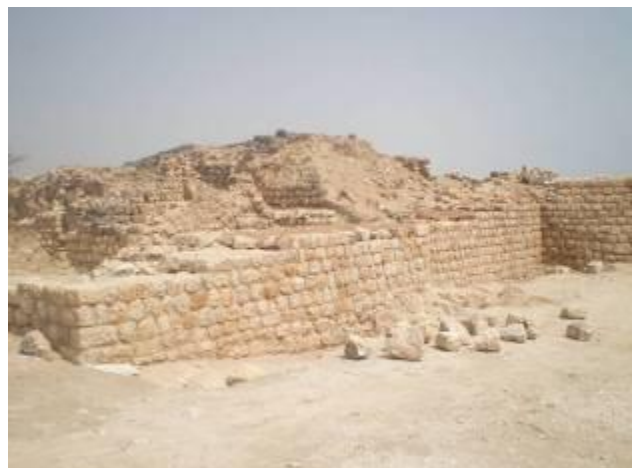
Sequence of photos on the wall M350 and M351 – up to 2nd March 2012

On 3rd March 2012 we stopped the restoration due to the fact we had to make the excavation in front of both these walls for taking a final land survey of the path to be constructed as soon as possible. Therefore, during the excavation time, we had not any chance to reach the place with stones and mortar.

During a visit on site of the Prof. Mrs. Avanzini, it has been decided to rise the wall M350 increasing the number of the stone lines well enough to interrupt the horizontality of that part of the city walls. Therefore, we stop the works and the rise of these walls will be started again after the new proposal design for the landscape of the city walls, during a new campaign.

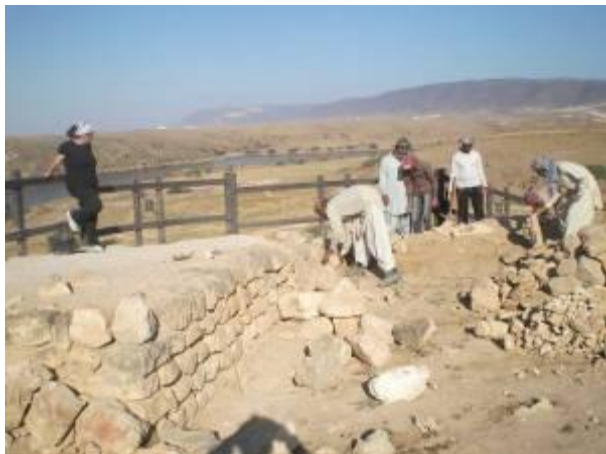
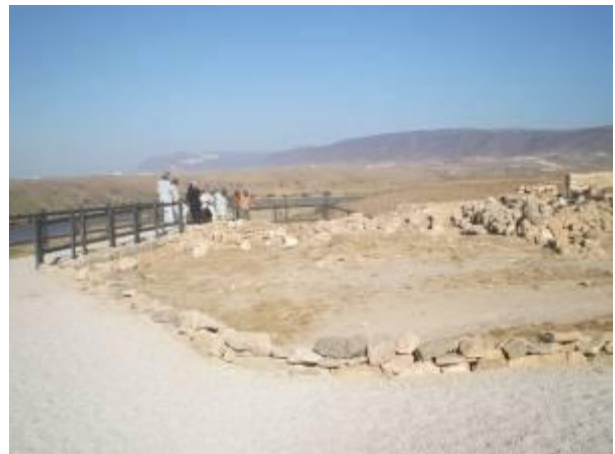
Sequence of photos on the modern staircase – up to 2nd February 2012

The demolition of the staircase was necessary to uncover the original walls and to modify the pedestrian path around the west and south walls of the city.

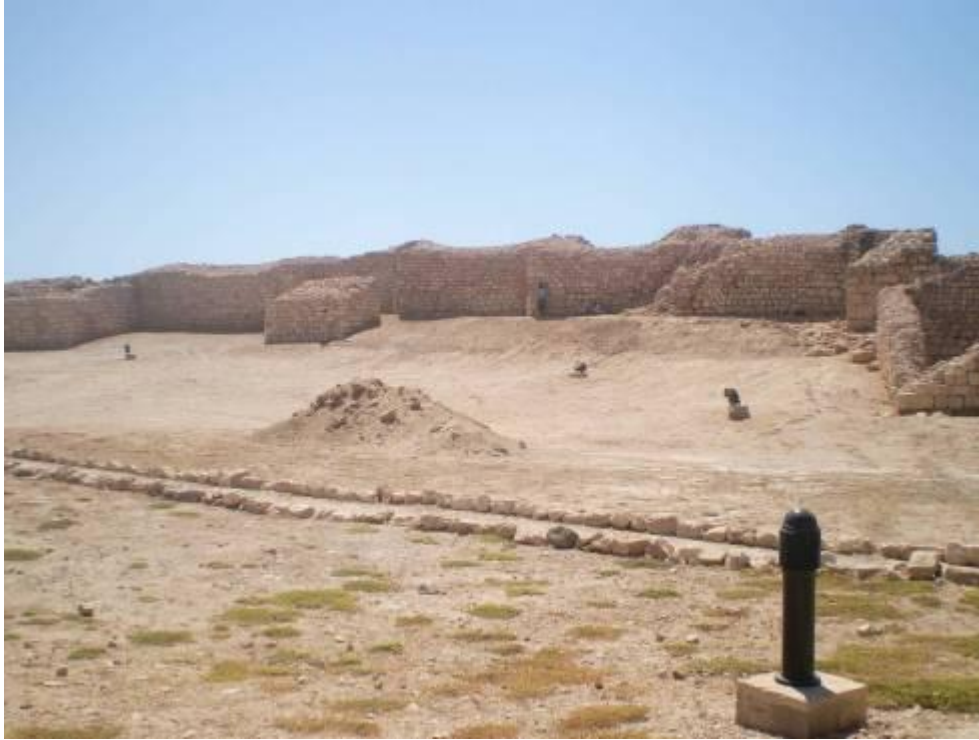
Sequence of photos at the ground slope in front of wall M14
up to 23rd February 2012

On 18th February 2012, the black stones on the wall M14 have been dismantled for their cleaning and then mounted again at the same position. The beautification has been remade by the use of new small stones. In the meantime, the slope of the ground in front of the M14 has been reduced for a better view of the front elevation of the city.

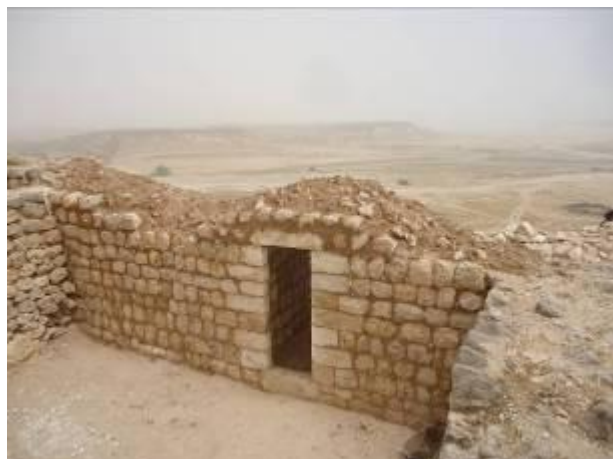
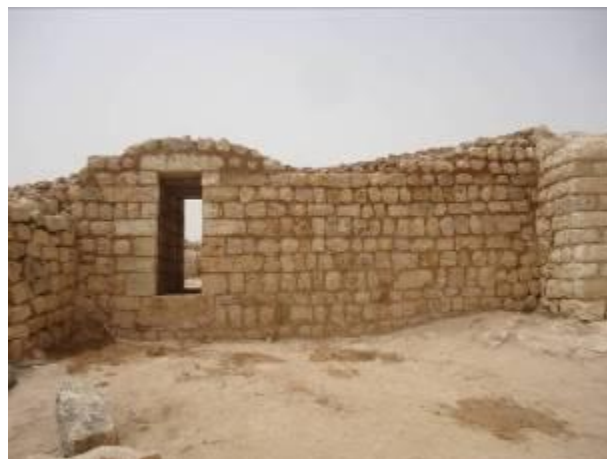
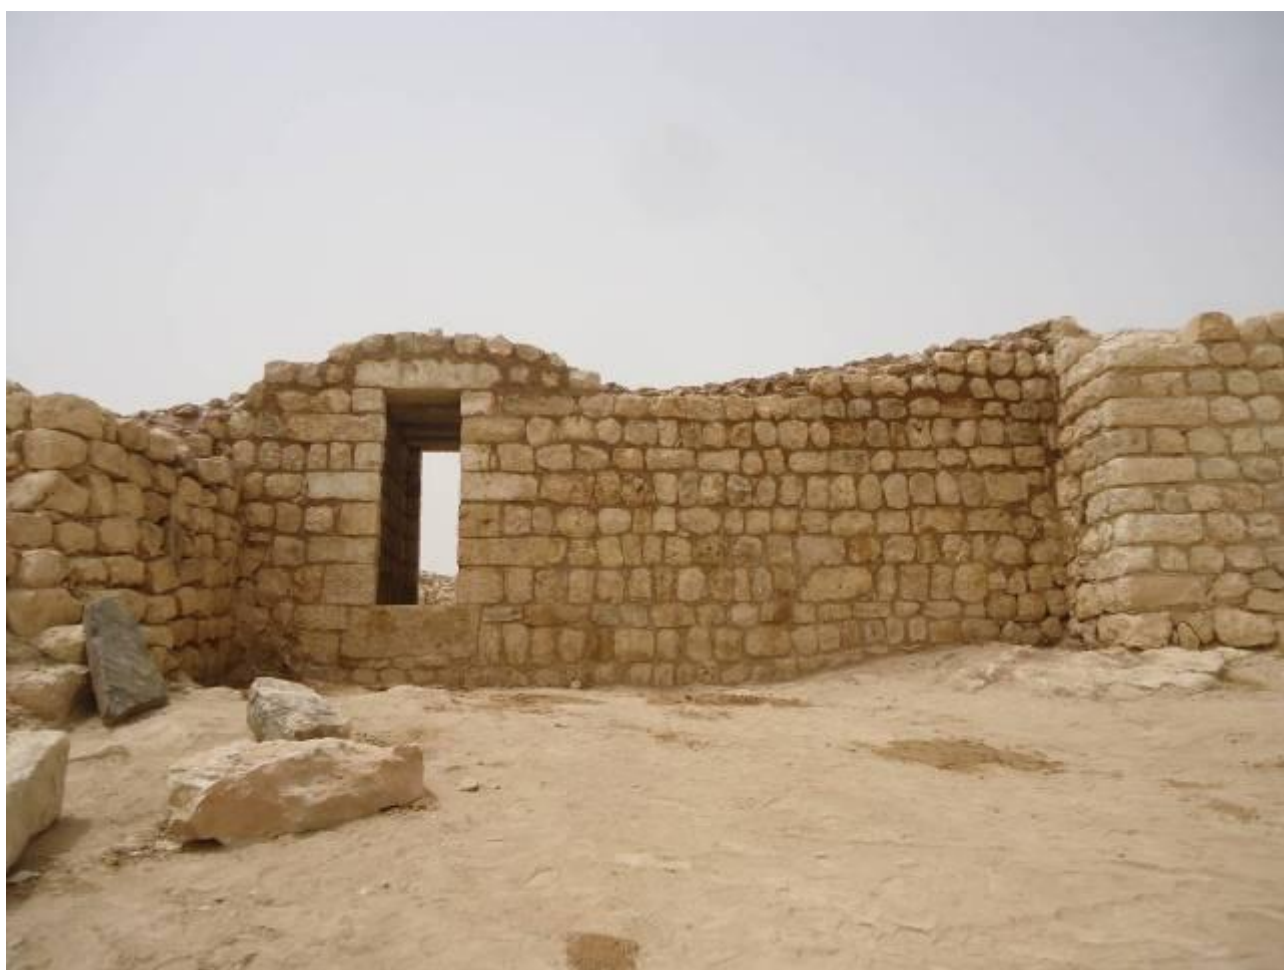
Sequence of photos on the wall M139 and M140 – up to 22nd March 2012

This work has been completed on Thursday, 22nd March 2012.

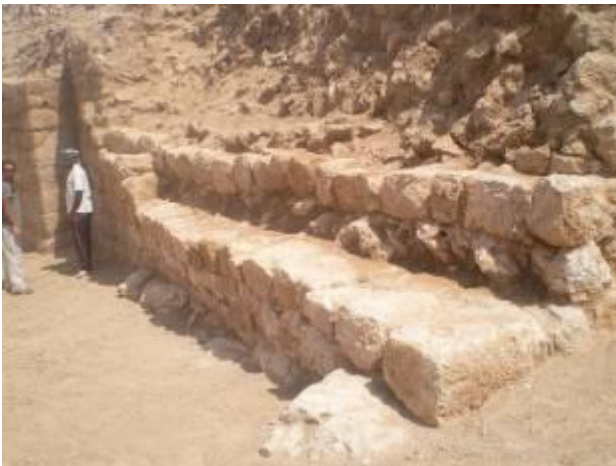
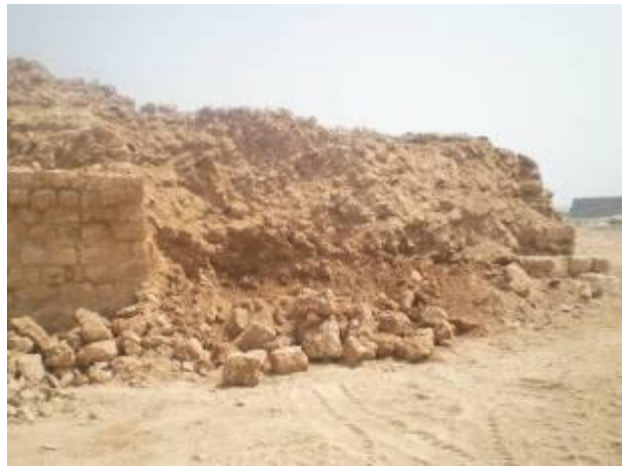
After the demolition of the staircase, we started the cleaning of the uncovered wall M118. We started to dismount the stones and to remove the inner filling. We discovered two different alignments of the external finishing. The first one supported on the bedrock and the second one inside the first one but not supported by the bedrock. Therefore we decided to keep the first alignment and kept the first run of stones supported on the bedrock.

Sequence of photos on the wall M118 and M545 – up to 23rd February 2012

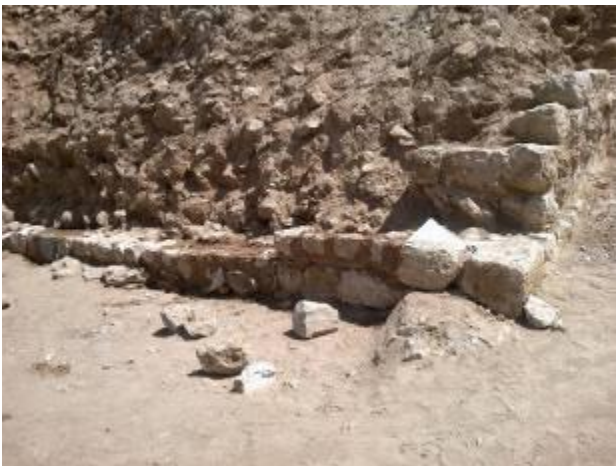
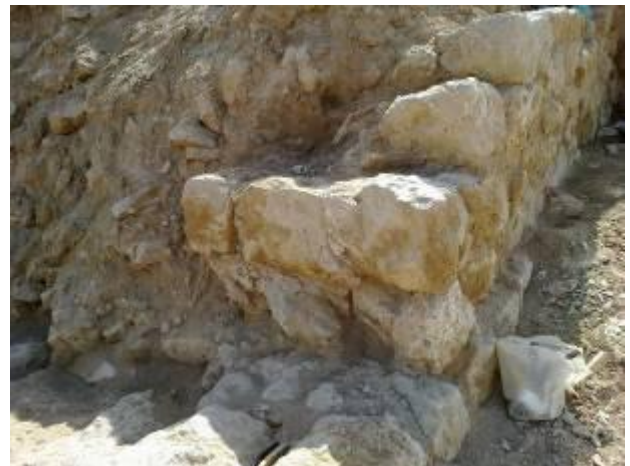
Sequence of photos on the wall M118 and M545 – up to 2nd March 2012

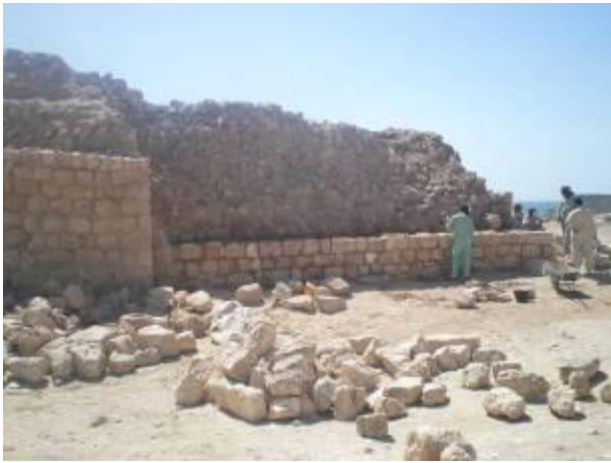
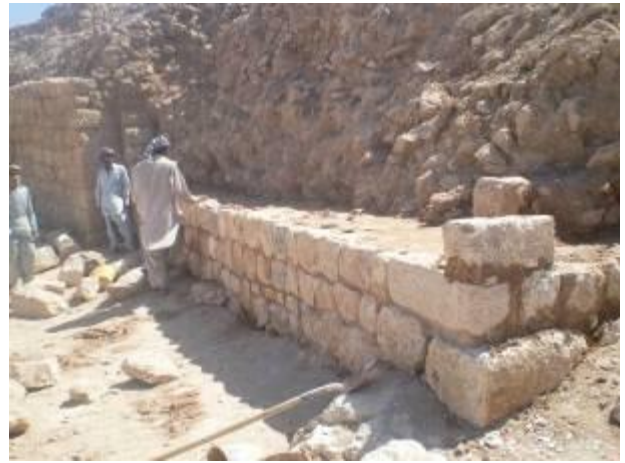
Sequence of photos on the wall M118 and M545 – up to 8th March 2012

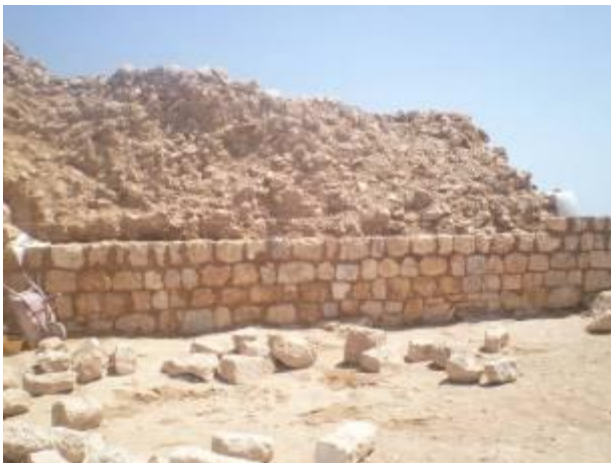
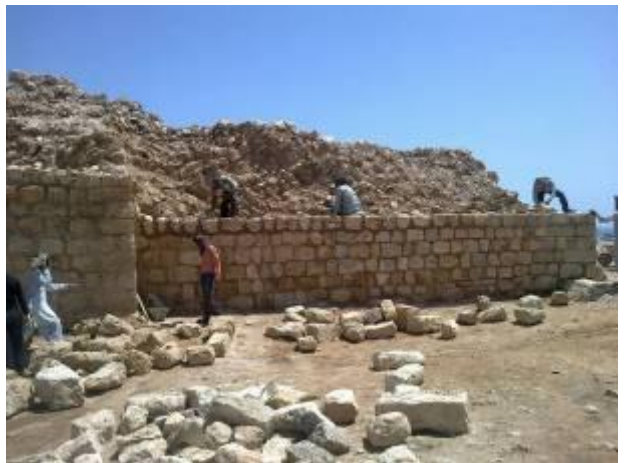
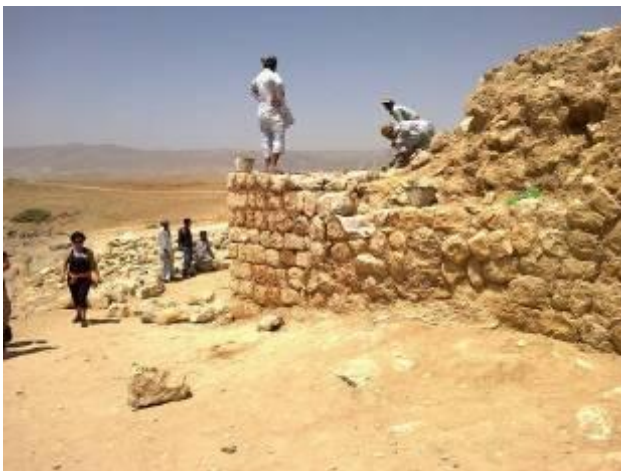
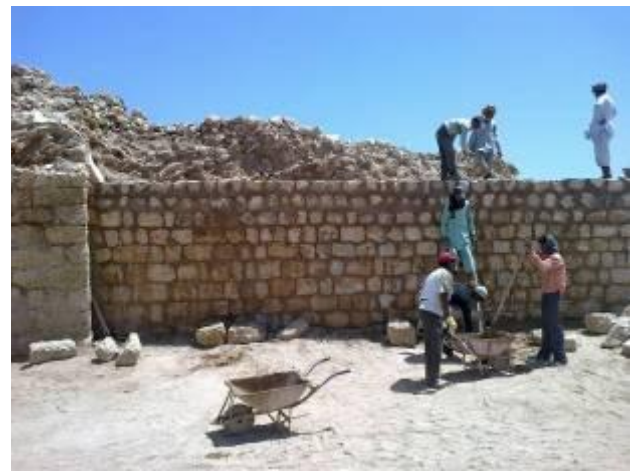
Sequence of photos on the wall M118 and M545 – up to 15th March 2012

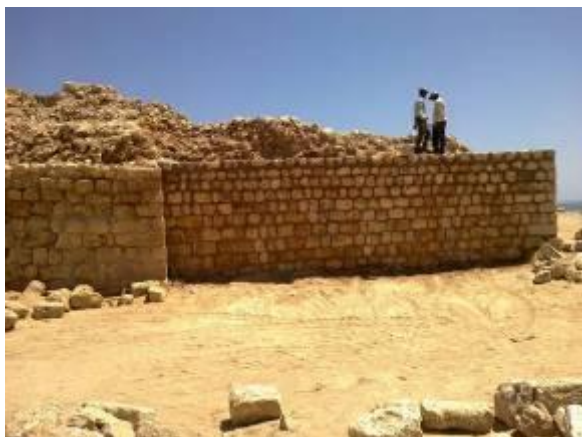
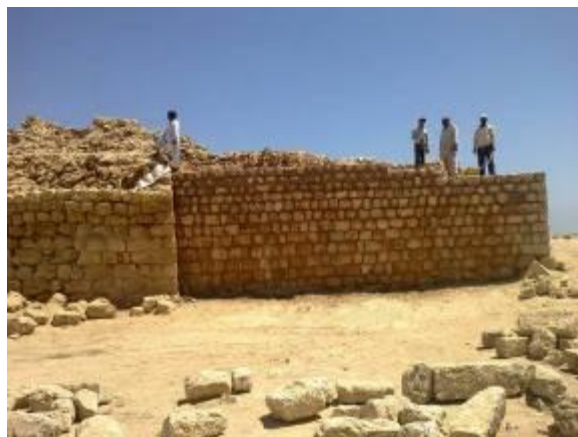
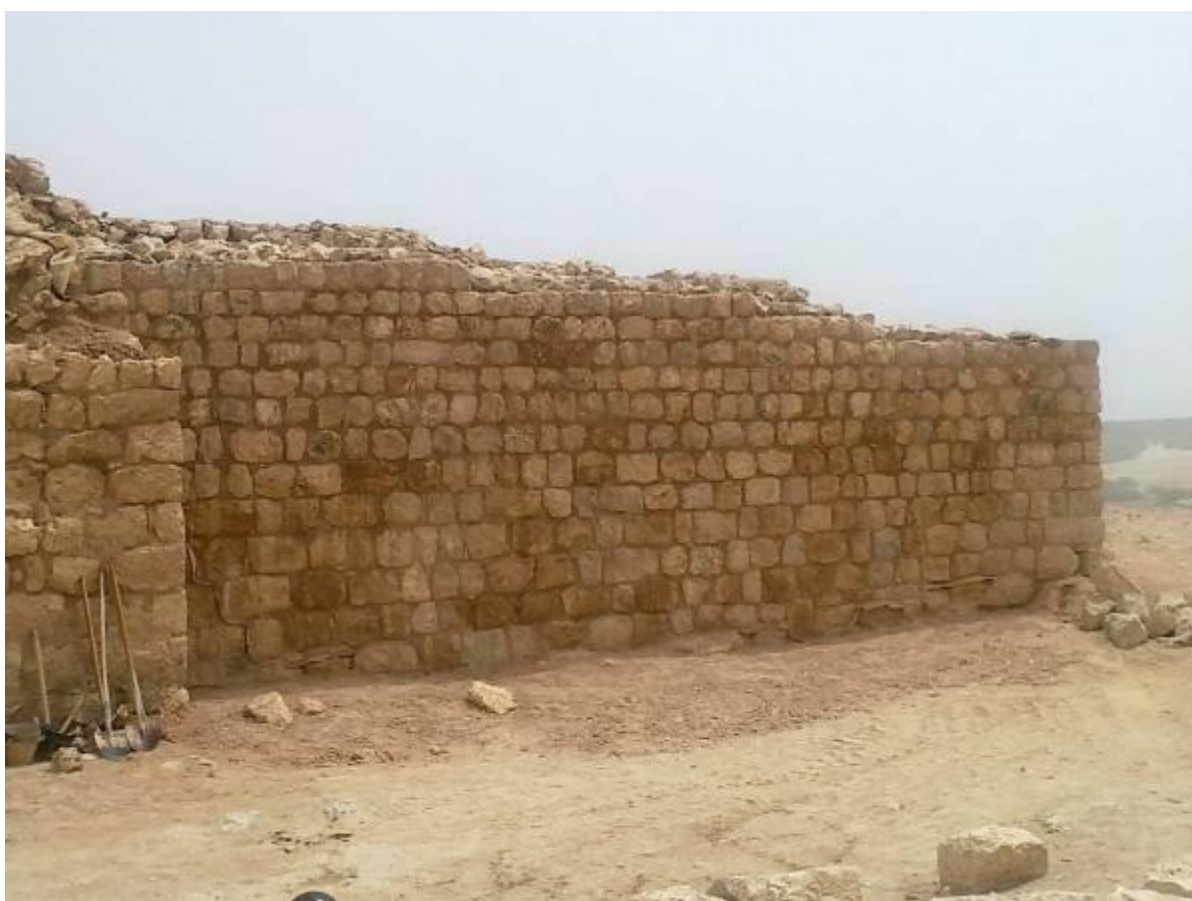
Sequence of photos on the wall M118 and M545 – up to 22nd March 2012

This work has been completed on Thursday, 22nd March 2012.

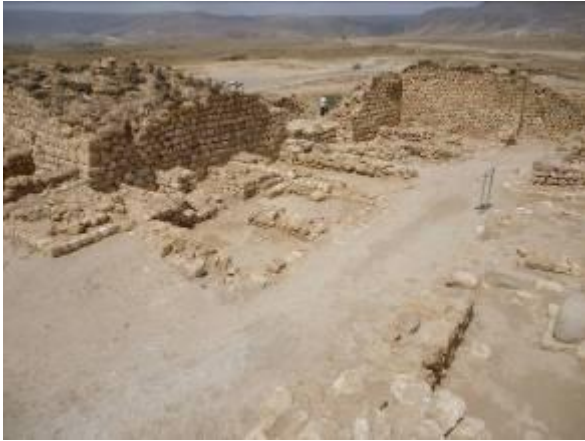
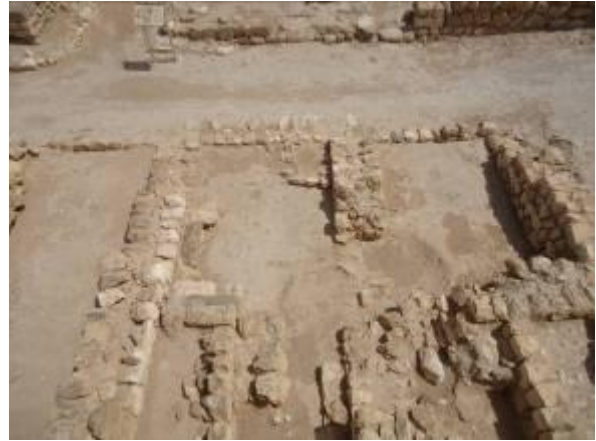
Sequence of photos on the wall M26 and M66 – up to 2nd March 2012

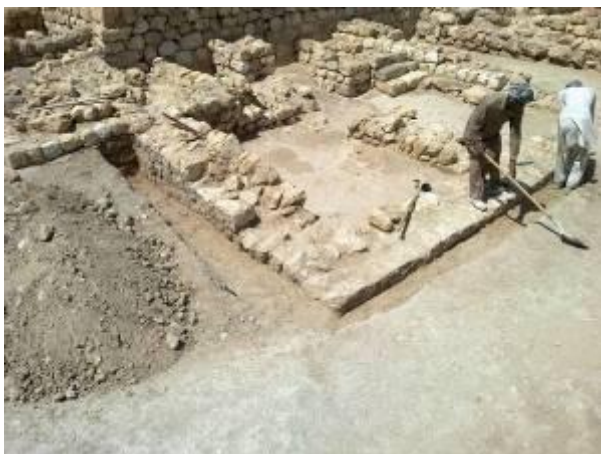
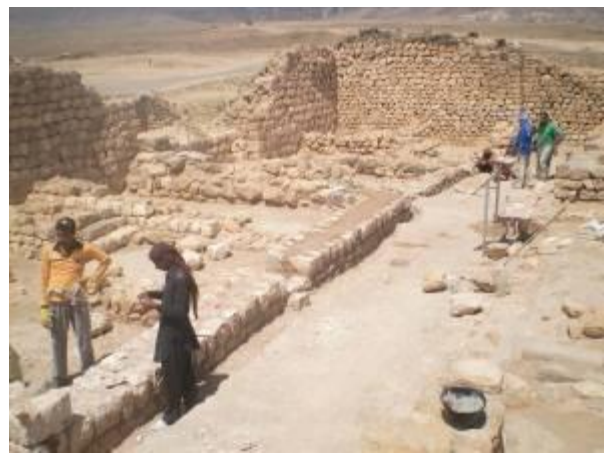
Sequence of photos on the wall M26 and M66 – up to 8th March 2012

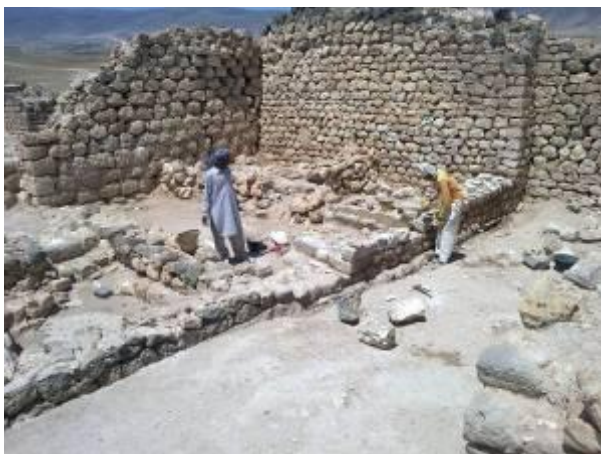
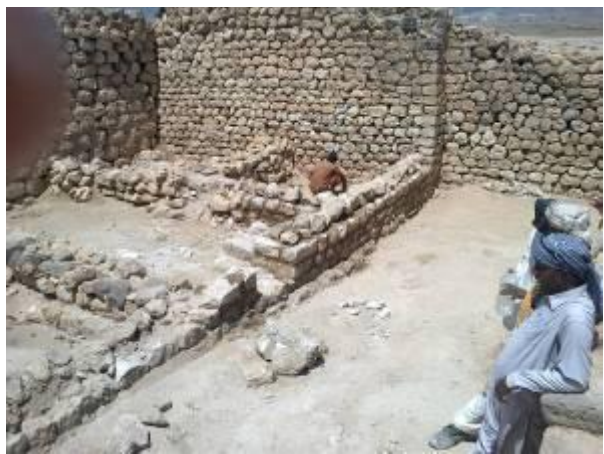
Sequence of photos on the wall M26 and M66 – up to 15th March 2012

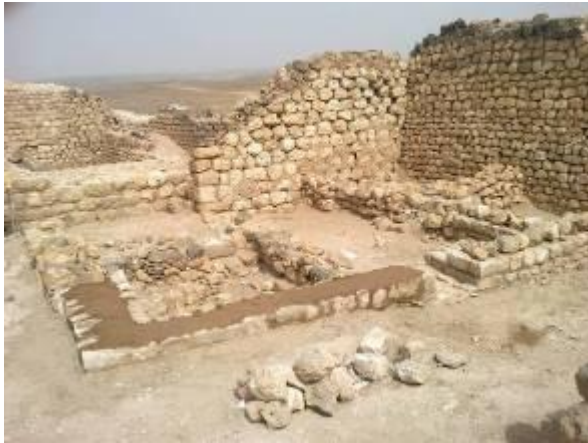
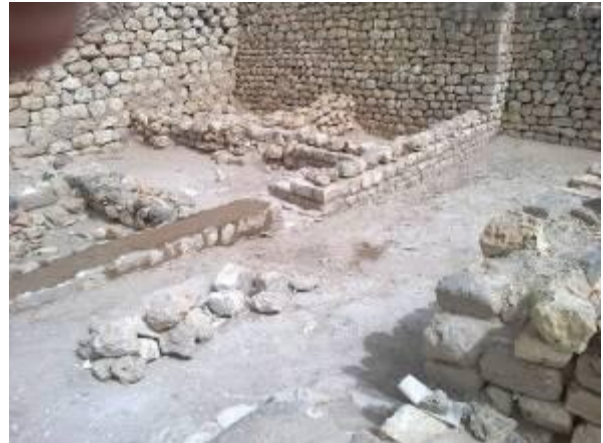
Sequence of photos on the wall M26 and M66 – up to 20th March 2012

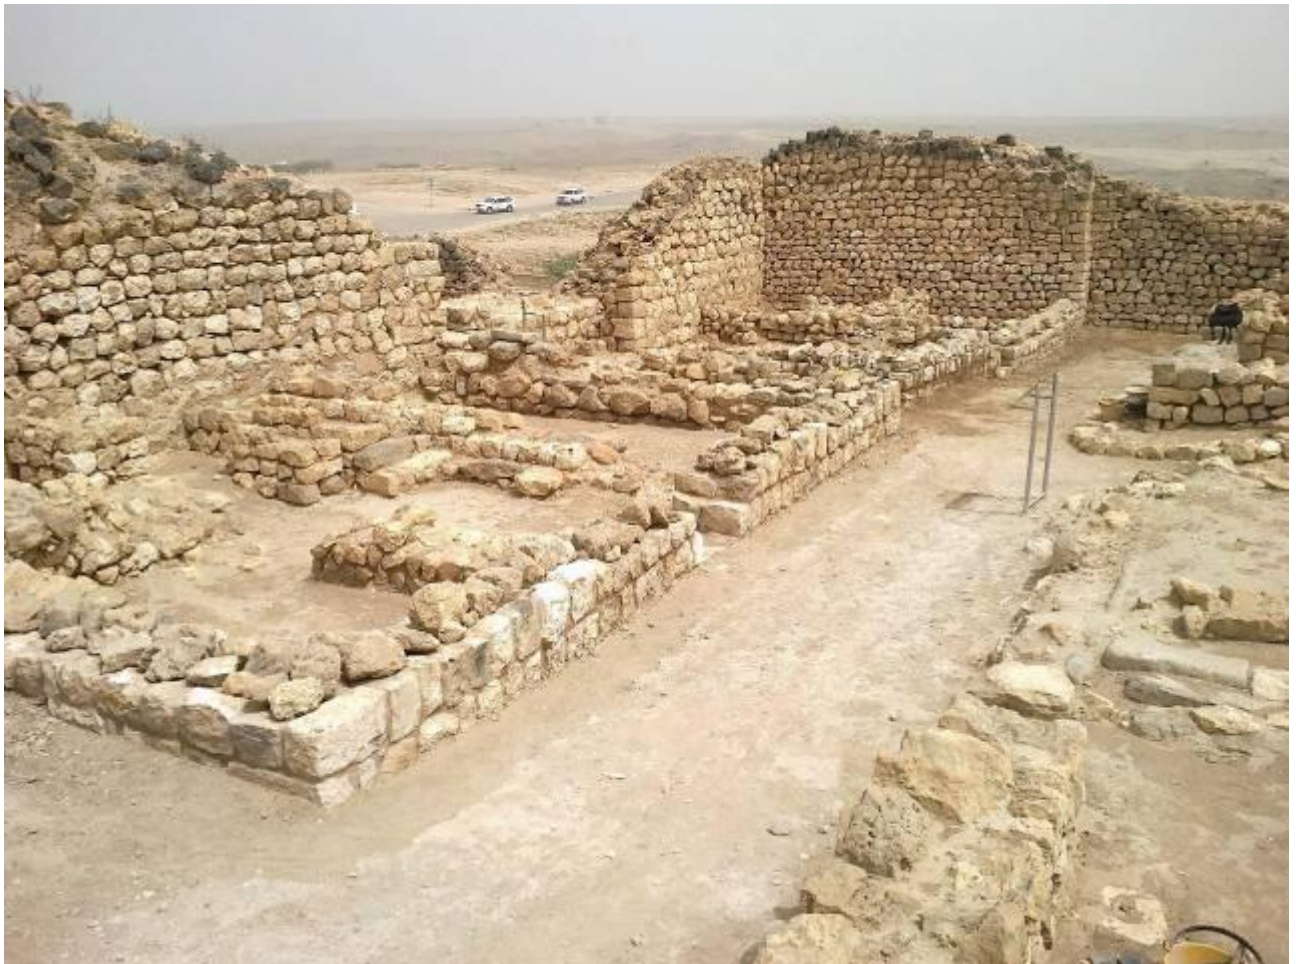
Photo on the wall M26 and M66 – up to 22nd March 2012

This work has been completed on Thursday, 22nd March 2012.

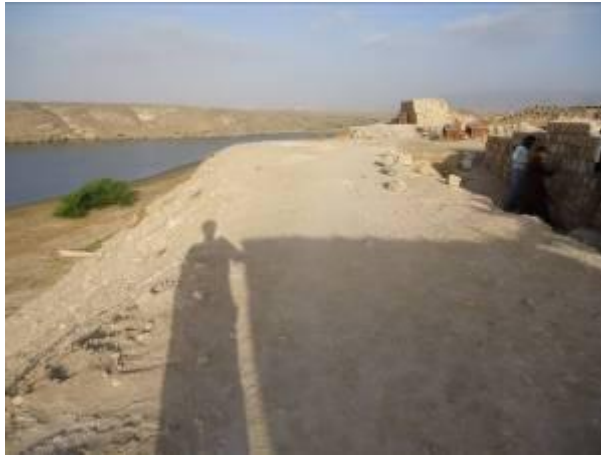
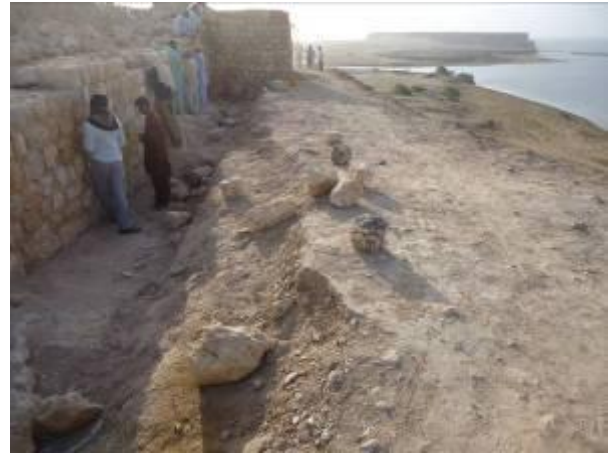
Sequence of photos at the ground slope - up to 2nd March 2012

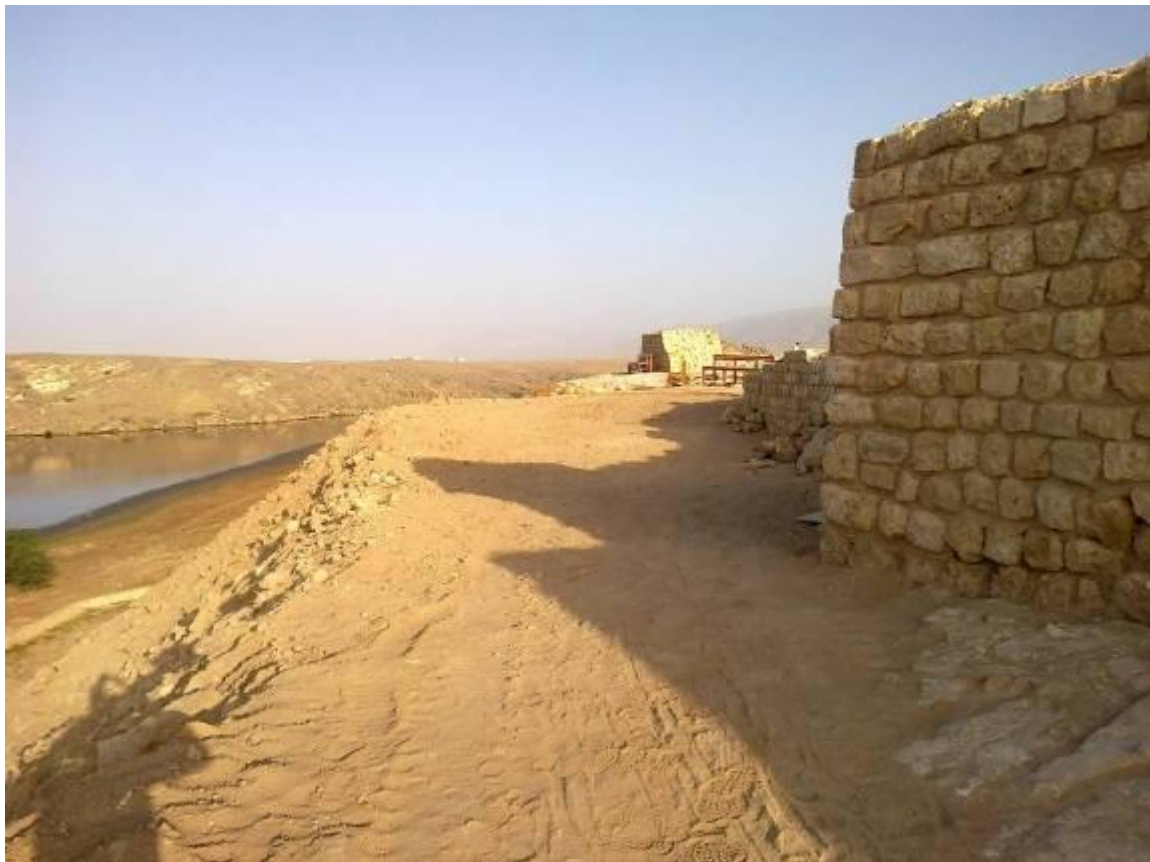
Sequence of photos at the ground slope - up to 8th March 2012

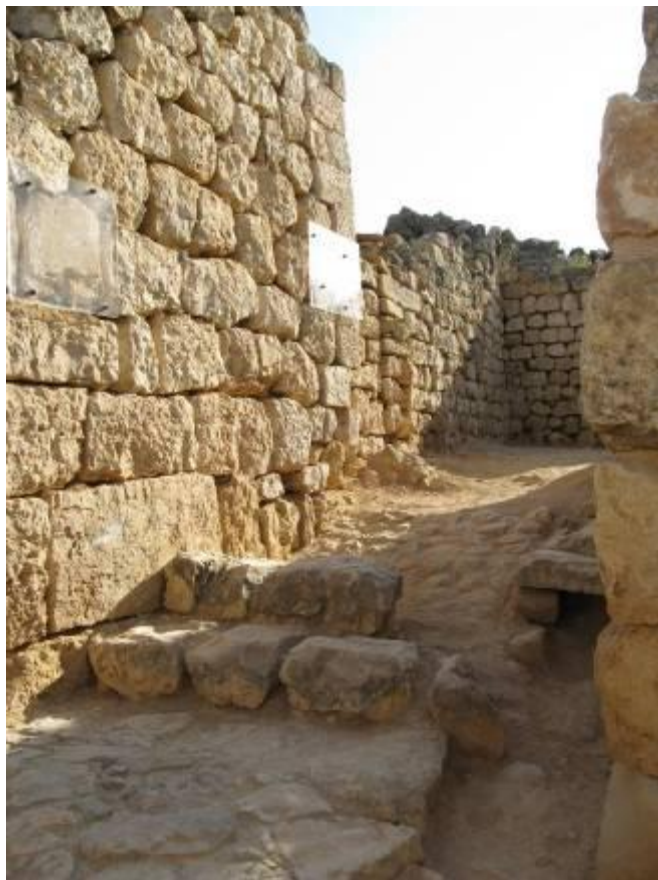
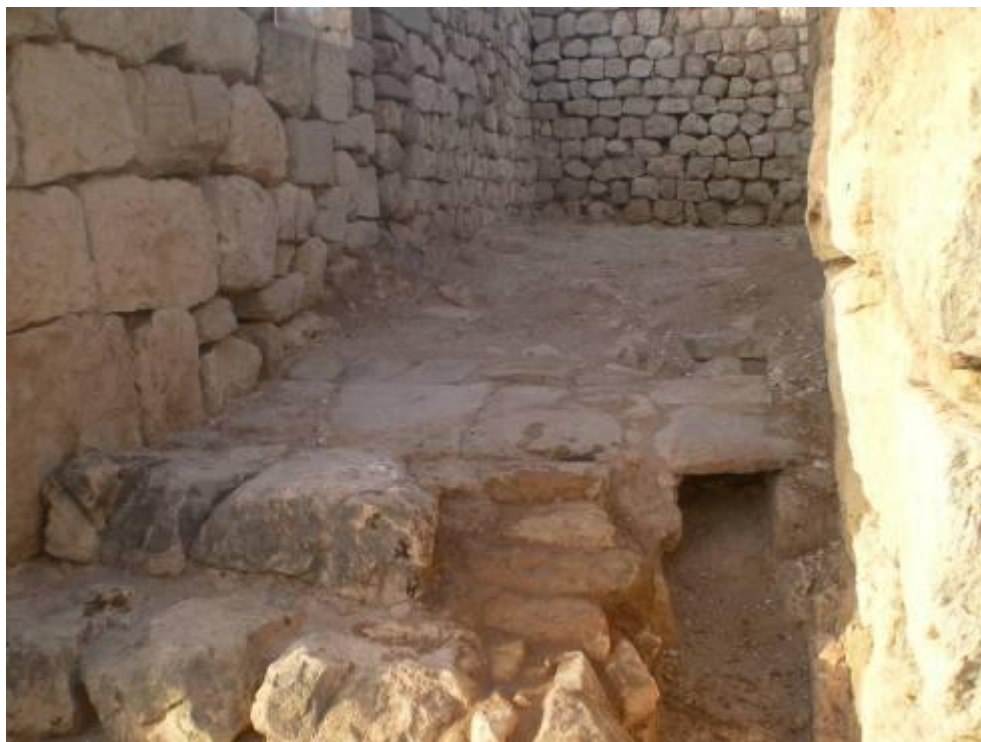
Restoration of the pavement at the main entry

before and after restoration

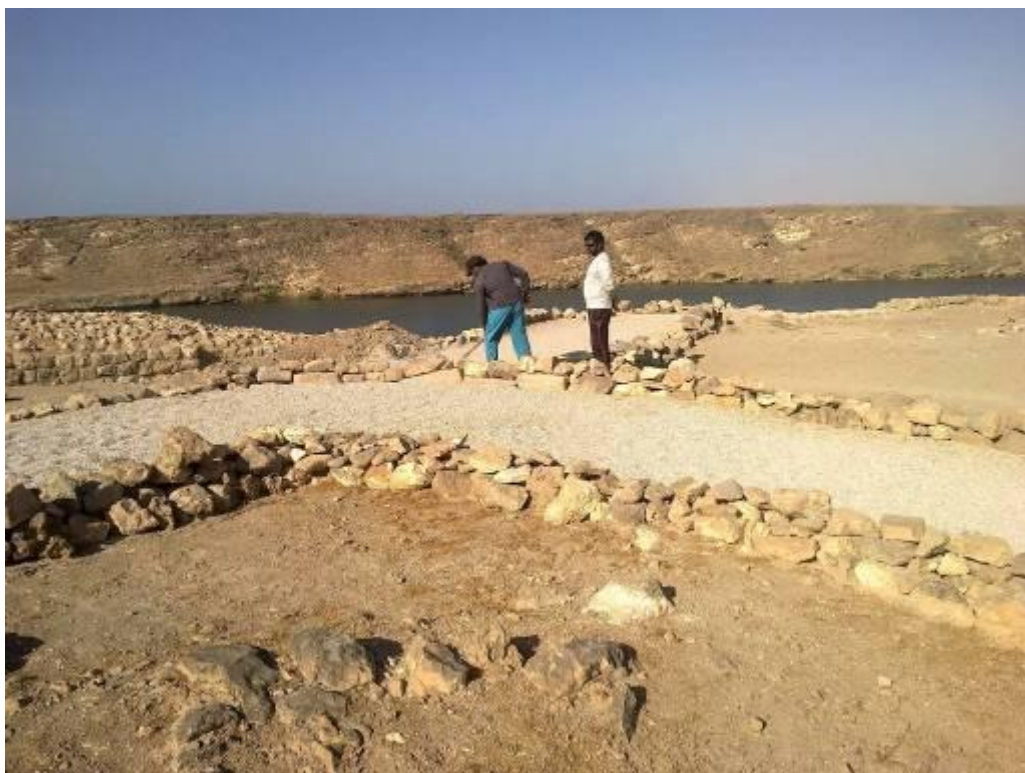
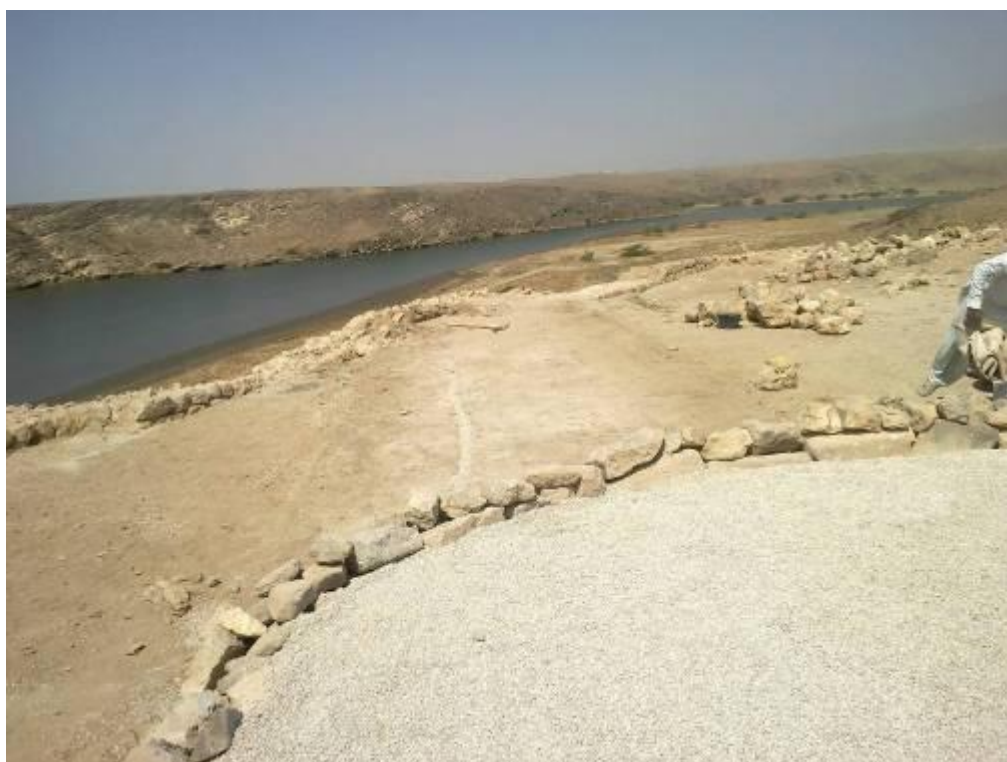
Modification of the internal path close to wall M499

during and after the works

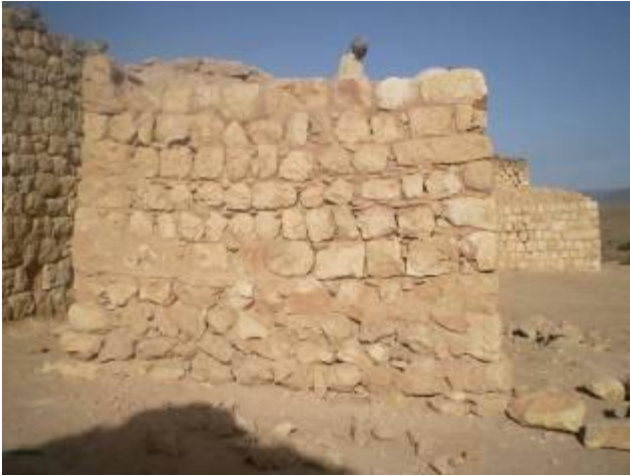
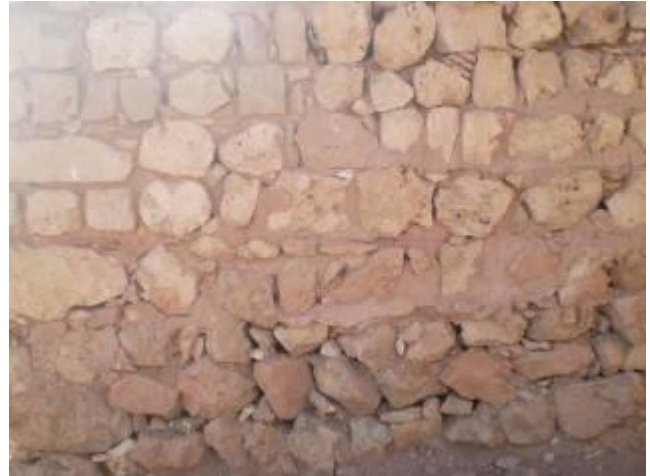
On 7th March 2012, the restoration of the two towers A61 and A97, the first on right side and the second on the left side of the main entry of the city, had taken in place. We started with the A61 tower but, due to the bad condition of the foot stones (the stones on the runs beneath 70cm. from the ground), we decided to rise the tower with two runs instead of four runs as we were asked.

- a) actually the high of the tower is 2,7m. (2 meters over the bad stones). The load per square centimetre is 4,4kg/sqcm.
- b) we supposed to increase the high of the tower with 60 centimeters and therefore the load per square centimetre will be 5,72kg/sqcm.
- c) With four runs the final high of the tower will be 3,9m. (3,2 meters over the bad stones). In this case the load per square centimetre will be 7,04kg/sqcm.

Sequence of photos at the tower A61 - up to 7th March 2012

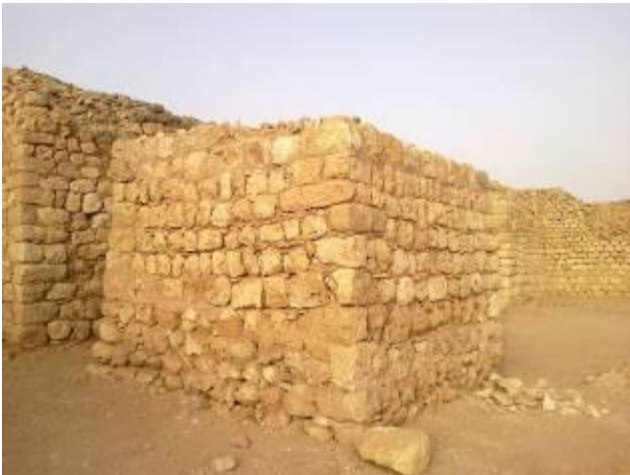
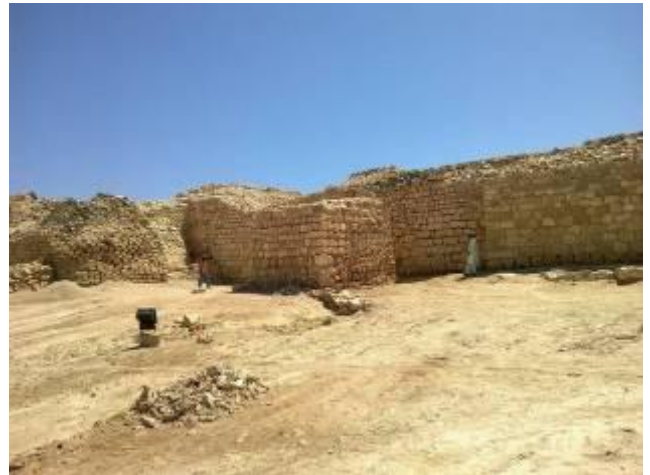
Sequence of photos at the tower A61 - up to 15th March 2012

This work has been completed on Thursday, 20th March 2012.

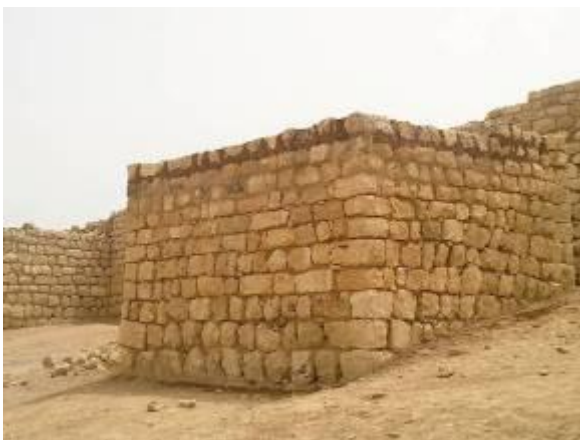
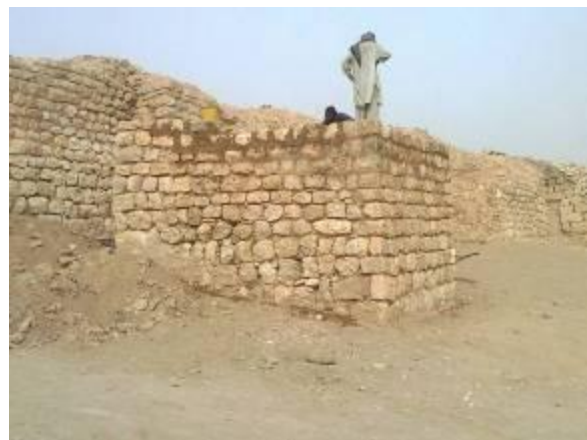
Sequence of photos at the tower A97 - up to 20th March 2012

This work has been completed on Thursday, 22nd March 2012.

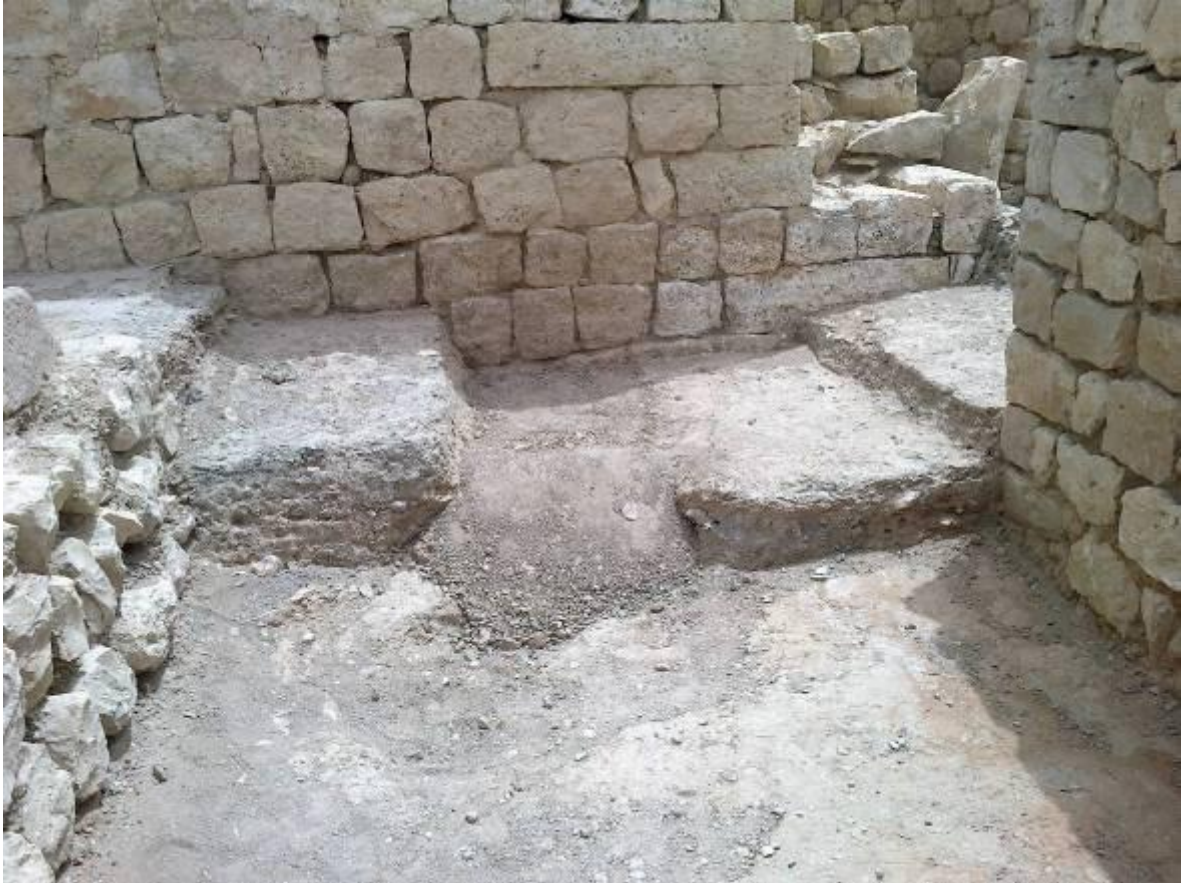
Modification of the path close to the Monumental Building
